# Twelve Apostles - Saddle Lookout Port Campbell National Park, Victoria

## Annual Compliance Report (1 July 2021 to 30 June 2022)

EPBC Approval Number 2019/8571

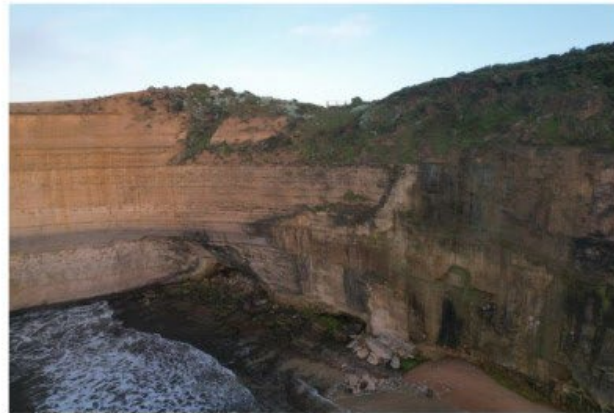
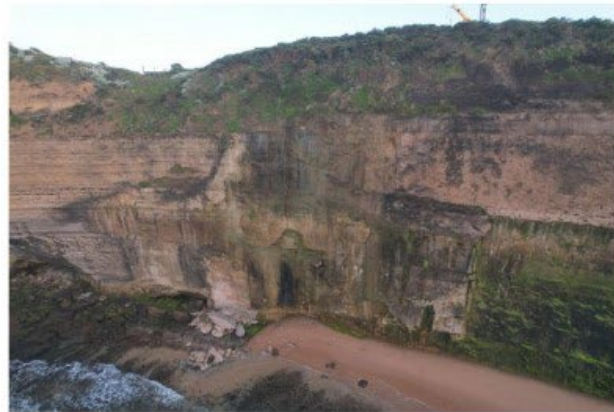
Activity being completed at the time	The actual time of the rock fall is unknown. Piling works were being conducted onsite during this period
Description of the event	During our piling works onsite a section of rock has been dislodged on the south cliff face off Castle Rock. We notified the design Geotech and Client as soon as we knew. Additional inspections were completed by a drone to see if any additional cracks or issue were present before work was allowed to commence.
Had the risk of the event been considered prior to it occurring?	Yes
What controls had been put in place ?	Vibration monitoring of the piling works was being conducted through each day, with specified limits imposed by designer ARUP. We didn't see vibration levels rise much above .5m/s during our works. Regular cliff inspections were completed and photos sent to ARUP for review. Due to high winds and high tides along the south beach, photos were not able to be taken every day. ARUP completed an assessment prior to works starting, comparing photos from 2018 to current day photos. A Geotech onsite inspected the pile bore and vibrations

Problem	Cliff failure
Why 1	Wave action, vibration, earth movement, cliff deterioration

Cause Factor	Unknown, but could be vibration from earth moving equipment
New Control to be implemented	ARUP to confirm

1. We have reviewed the provided photographs in detail. We note that the area that has failed is just above sea level and represents a overhanging bulge at the base of the cliff. It appears the width of the failure is approximately 1 m wide and extends over a few metres vertically and horizontally.

2. A failure of this type and magnitude is to be expected and the position and size of the failure does not materially effect the overall stability of the piling pad or stability of the lookout structure

3. The toe of the closest pile is about 30 m from the position of the failure. We note that you have installed vibration monitoring equipment that is reading vibrations typically less than 1 mm / sec at a position offset 10 m from the drilling rig.

4. We would therefore expect vibrations and stresses inducing by the drilling process to be very low at the point of failure of the cliff
5. The trigger for the cliff failure is therefore most likely related to wave action and natural weathering mechanisms and we believe it is unlikely that the failure has been induced by vibrations and stresses induced by the piling activity.

Action	Regular inspections of cliff face, check the type of equipment being used onsite and seek approval from the client before proceeding with heavy equipment
Person to Action	Noel O'Connell
Action by Date	2021-10-12
_emailed_pm	2021-10-08

6. Nevertheless we cannot rule out that the piling activity may have influenced the failure and we recommend the following moving forward:
  - A detailed visual inspection should be undertaken of both cliff faces (southern and western) prior to the mobilisation of the piling rig into position tomorrow. The visual inspection should confirm whether there have been any further failures beyond last weeks photographs. If

further failures are evident we recommend no further works are undertaken until a further assessment is completed. Please provide a photographic record of this inspection.

- When the weather permits, we suggest flying your drone to obtain further high resolution photographs of the cliff face. Please obtain photographs as best as practicable of the cracking that is observed immediately above the most recent block failure. If these cracks are found to widen with time - then we recommend no further works are undertaken until a further assessment is completed.
