Report to: Parks Victoria

Rye Pier Approach Reconstruction

**Retention of redundant piles as ecological
habitat for recreational divers**

July 2021

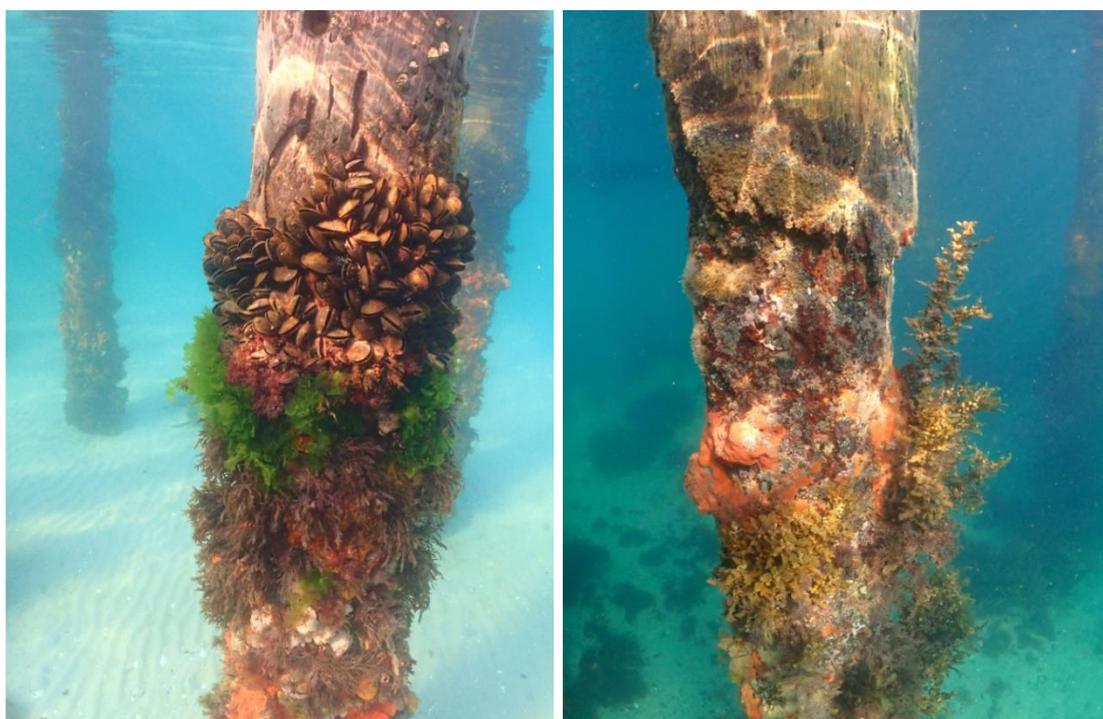
Figure 4. Intertidal zonation on piles: Limpets> mussels> macroalgae

This zonation pattern was not consistent between piles, which were often lacking in mussel and algal zones. In the absence of mussels and algae, the low tide mark was bare and a sharp reduction in the diameter and condition of the permanently submerged wooden pile below the low tide level was visible. It is likely that this point represents a position of potential structural failure of the pile.

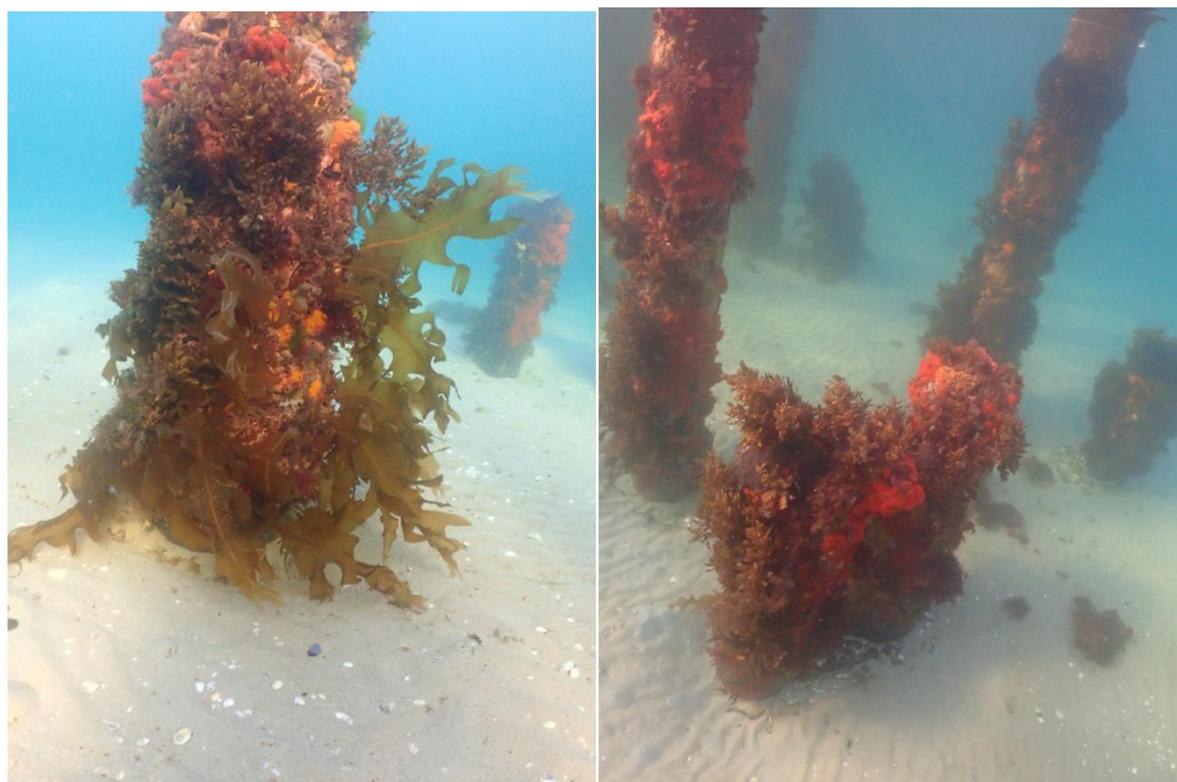
Figure 5. Pier piles chainage 140 and 160

Chainage 140, SD 1.9 m, CD 1.0 m Chainage 160, SD 2.2 m, CD 1.3 m

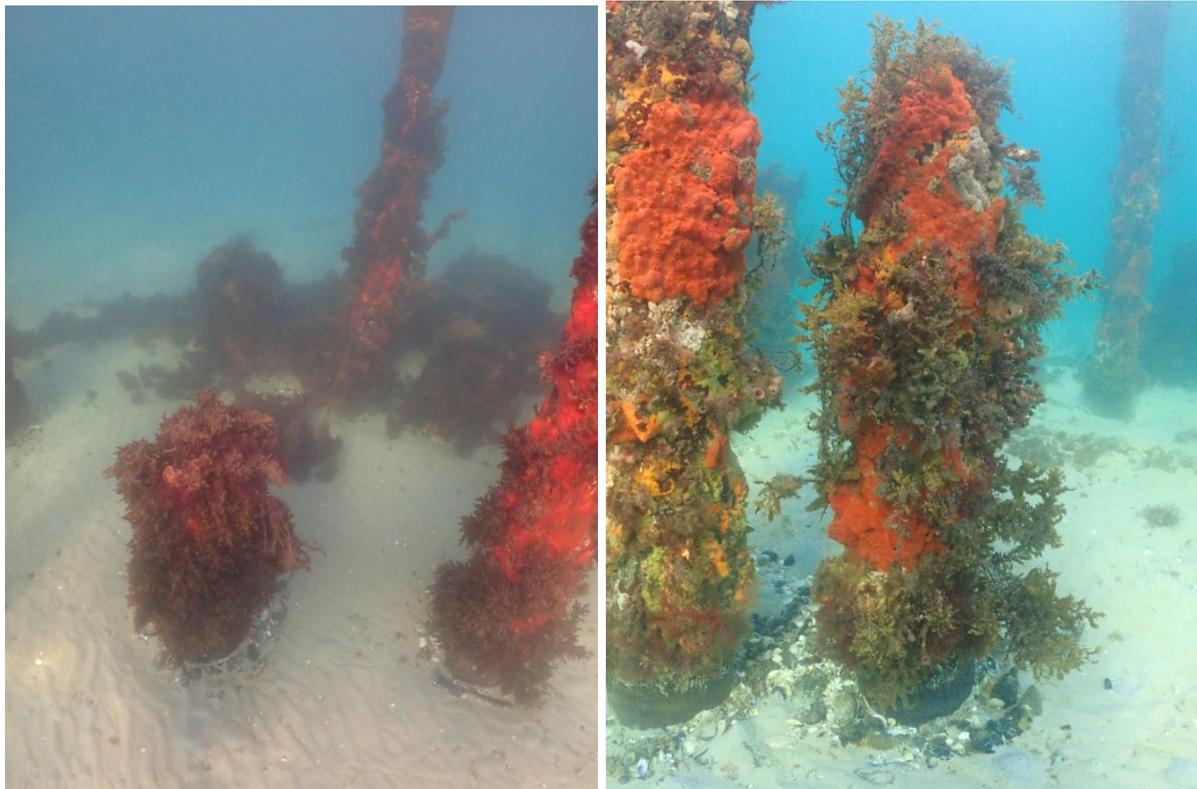
Chainage 180, SD 2.6 m, CD 1.7 m Chainage 190, SD, CD 1.8 m
Figure 6. Pier piles chainage 180 and 190

The local marine naturalists observations were consistent with CEE’s observation of generally of more abundant growth offshore from chainage 180 m, where water depth is approximately 1.7 m deep relative to chart datum (Figure 6). The conditions of denser encrusting invertebrate growth and presence of macroalgae noted by CEE provide good habitat for seahorses and pipefish as well as mobile invertebrates such as crabs and nudibranchs.

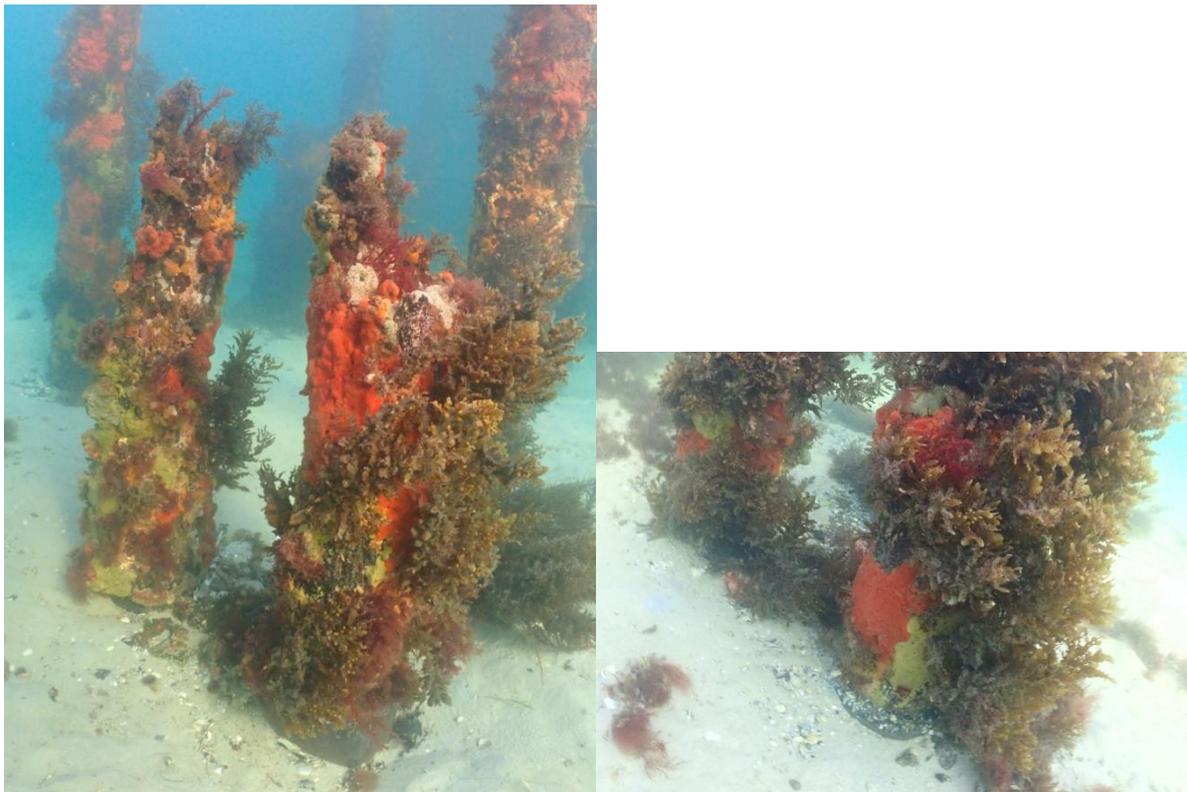
Chainage 200, SD 2.8 m, CD 1.9 m Chainage 220, SD 3.0 m, CD 2.1 m
Figure 7. Pier piles chainage 200 and 220

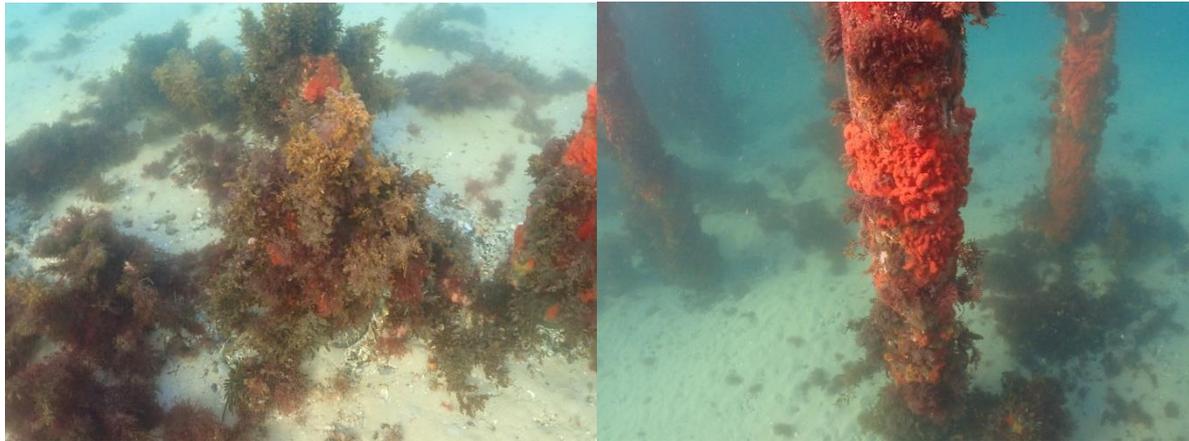
Figure 8. Pier piles chainage 230 and 240

Chainage 230, SD 3.0 m, CD 2.1 m Chainage 240, SD 3.2 m, CD 2.3 m

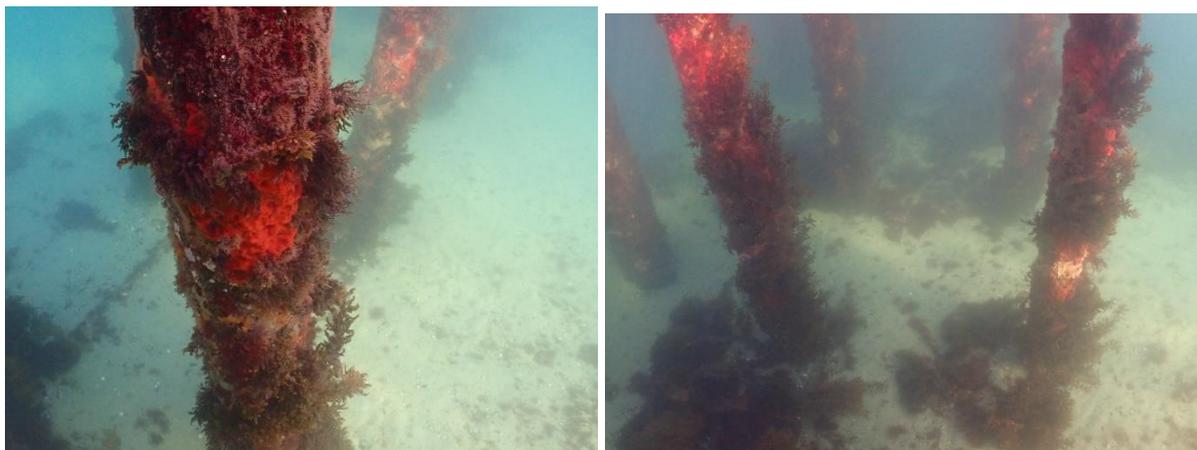
Figure 9. Pier piles chainage 250 and 270

Chainage 250, SD 3.5 m CD 2.6 m Chainage 270, SD 3.7 m, CD 2.8 m

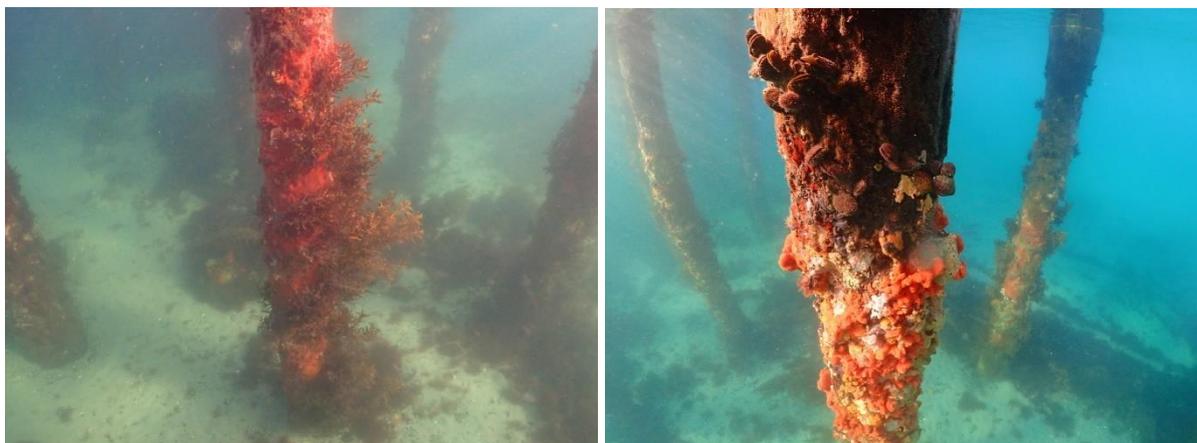
Figure 10. Pier piles chainage 280

Chainage 280, SD 3.8 m, CD 2.9 m

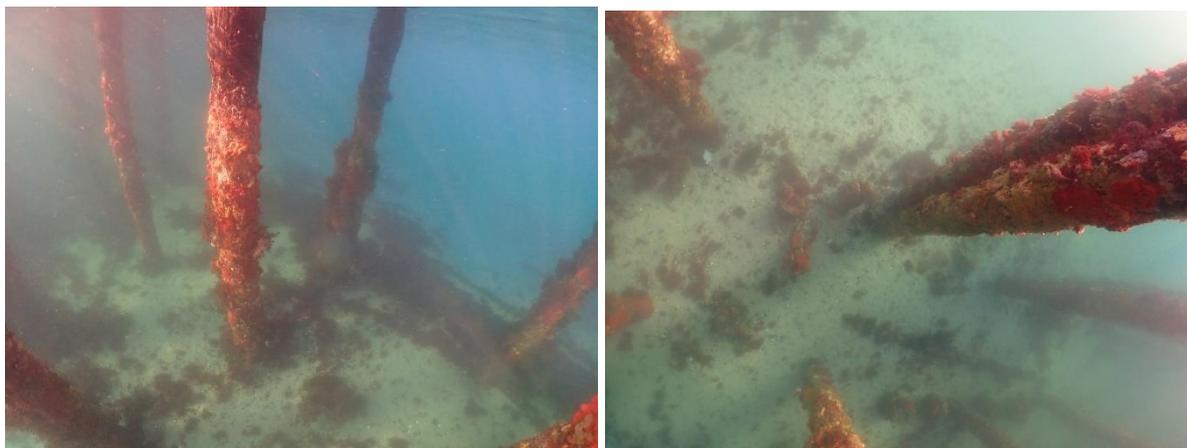
Figure 11. Pier piles chainage 290 and 350

Chainage 290, SD 4.0 m, CD 3.1 m Chainage 350, SD 5.3 m, CD 4.4 m

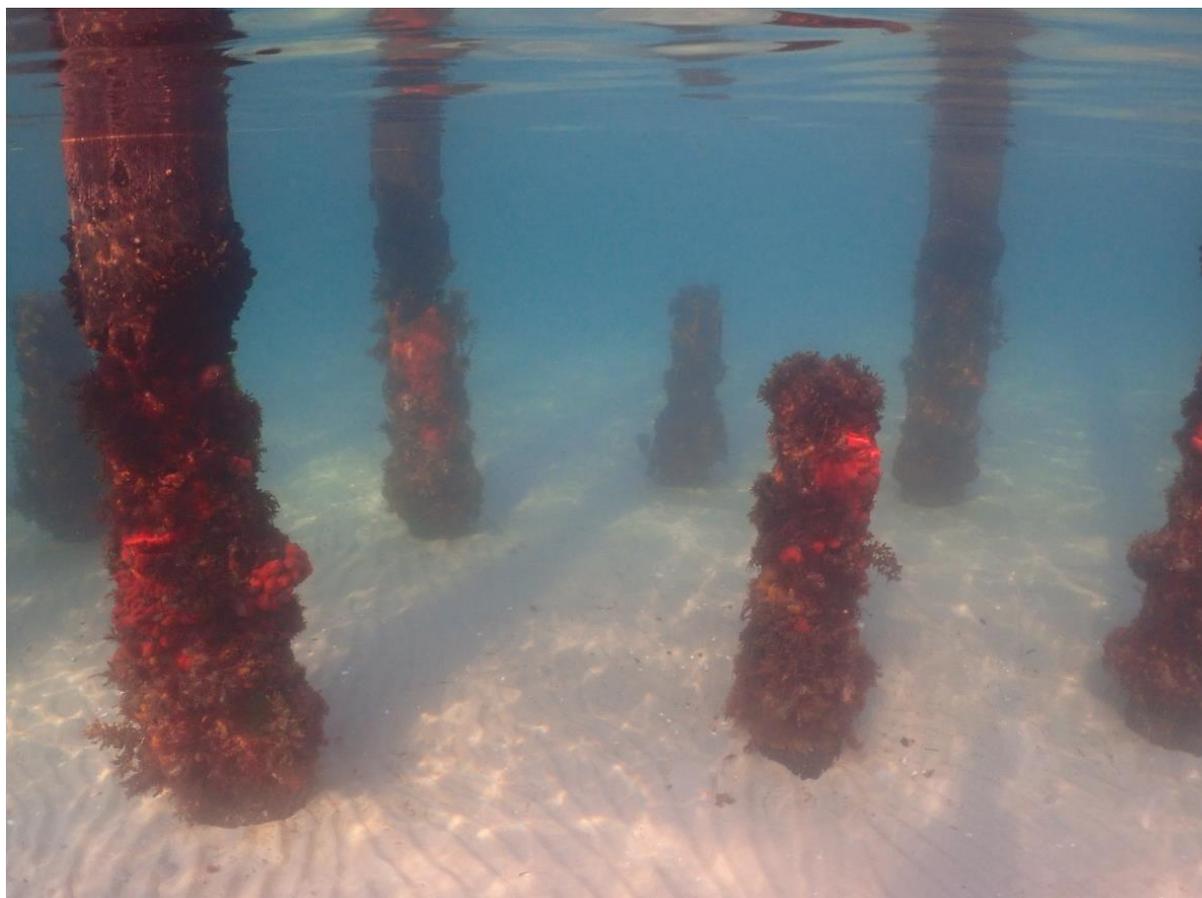
Pile stumps protrude from the seabed beneath the existing Pier all along the existing alignment. In the intertidal zone they are cut off close to the seabed, further along they are cut off at varying heights above the seabed but at a depth below the sea surface which appeared to correspond to the low water mark to about 0.5 m below low water. A detailed elevation survey of the pile stumps is required to determine the consistency of these observations. Marine growth on the pile stumps was similar to the adjacent complete piles.

Figure 12. Piles at around chainage 140, Survey Water Depth 1.9 m, Depth to CD 1.0 m

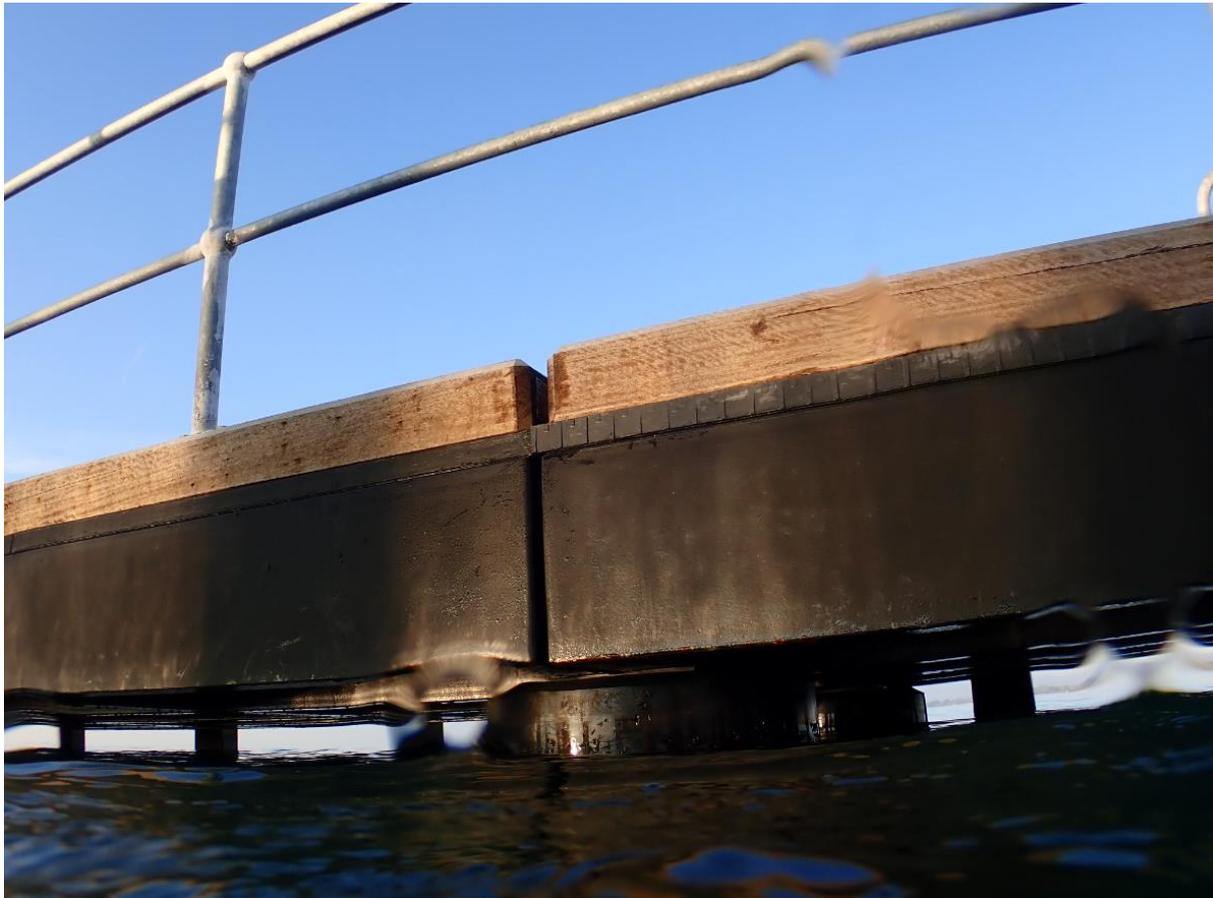
Figure 13. New lower landing Rye Pier July 2021

Parks Victoria installed a new lower landing and access platform for SCUBA divers at Rye Pier late in 2019. Observations of the landing during the July 2021 inspection showed that a range of marine invertebrates had colonised the HDPE jacketed steel piles and the landing structures.

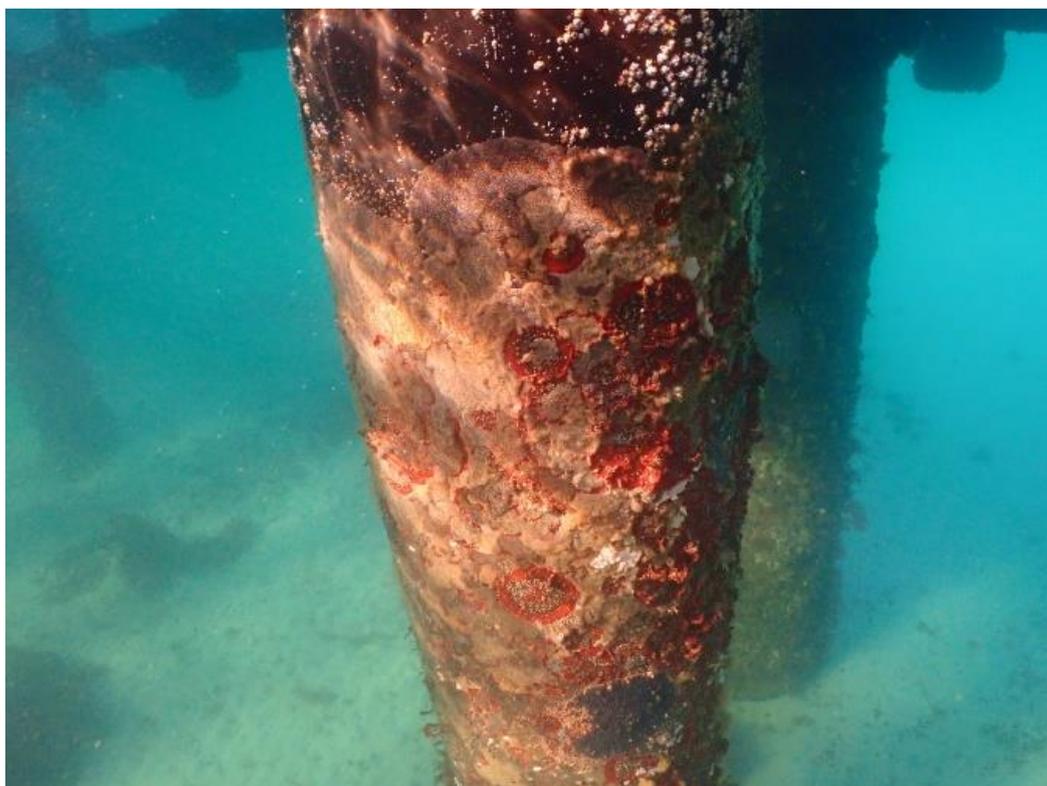
The upper parts of the HDPE coating of the piles were covered with a thin growth of encrusting bryozoans. Growth on the lower parts of the piles was considerably thicker than the upper parts. The assemblage on the lower parts included encrusting bryozoans and sponges, colonial and solitary ascidians, bivalve molluscs, hydroids and red and brown algae.

Figure 14. New lower landing HDPE jacketed steel piles: upper section of pile

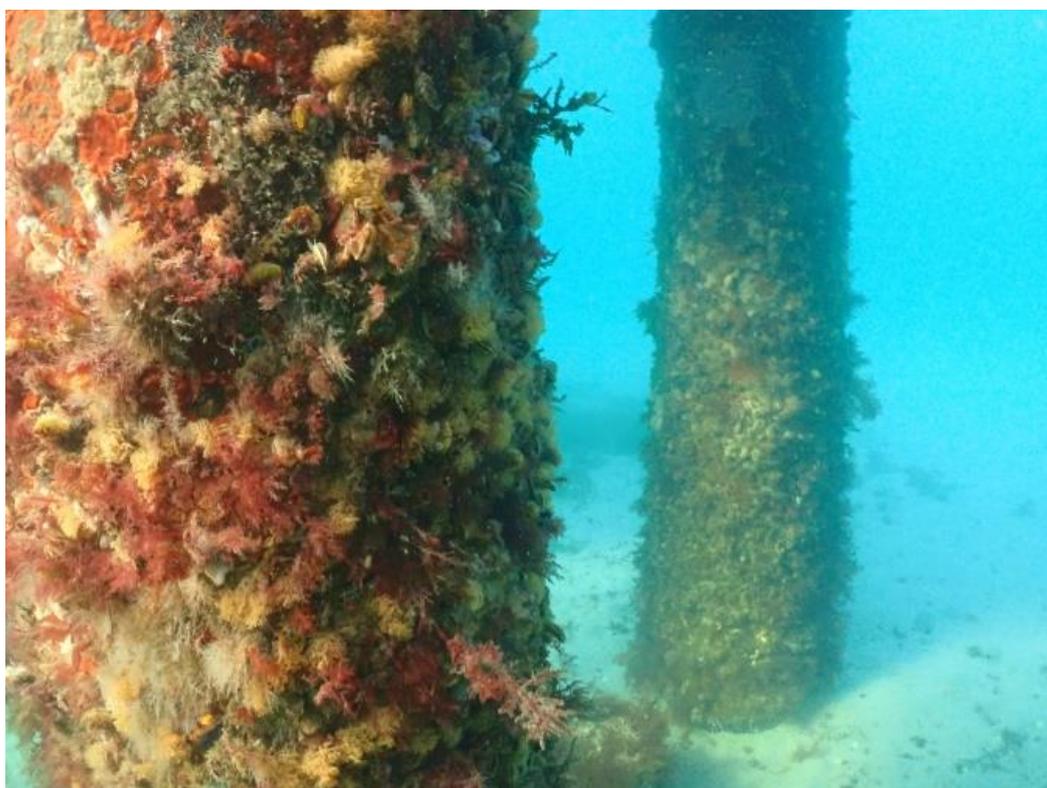
Figure 15. New lower landing HDPE jacketed steel piles: lower section of pile

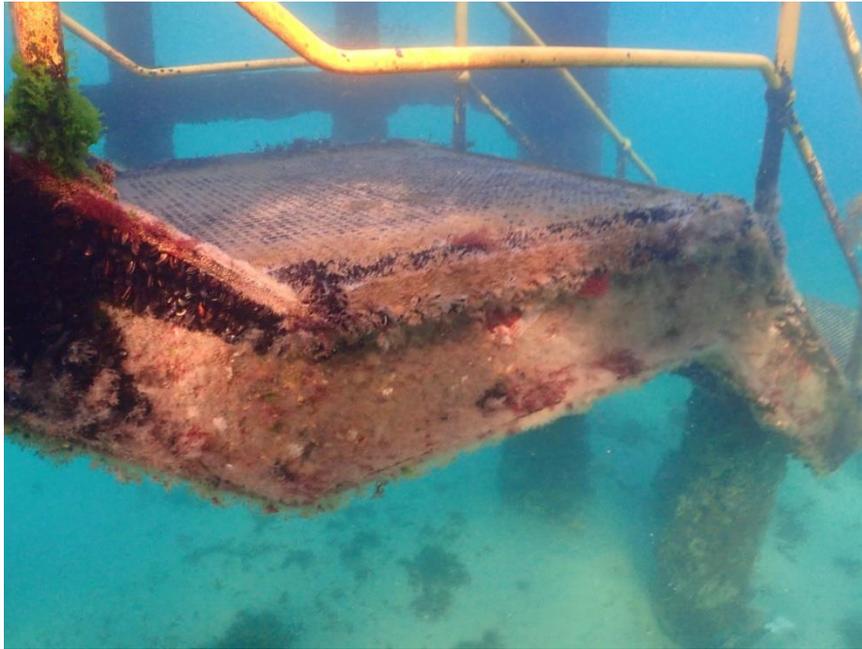
Figure 16. First stage at low tide mark, with mussel and hydroid growth

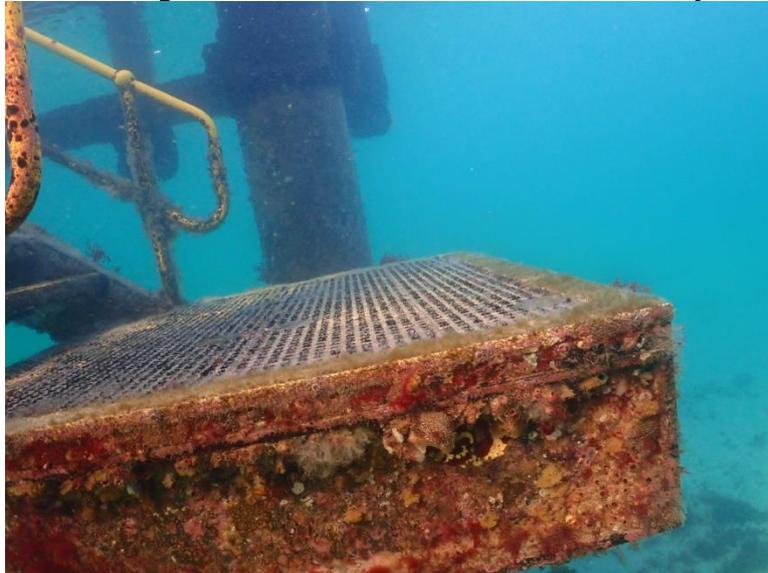
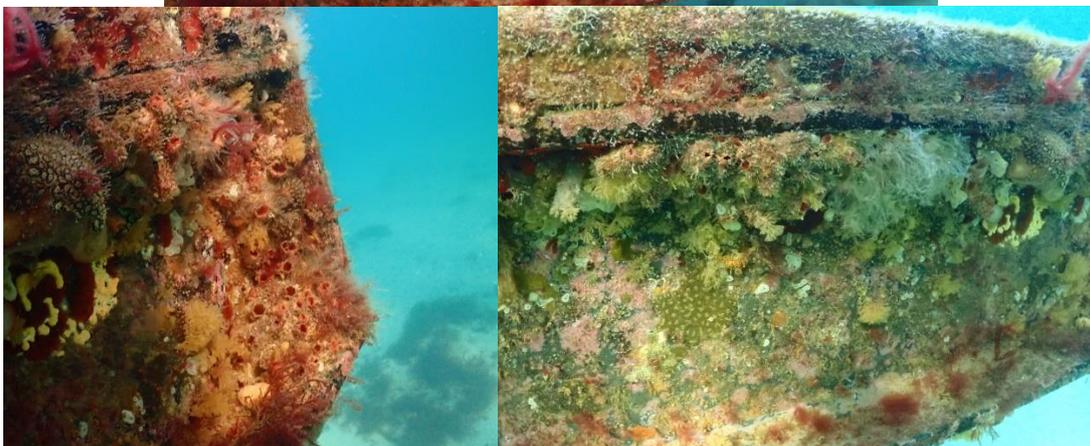
Figure 17. New lower landing - second stage at lowest landing
Encrusting growth of sponges, colonial ascidians solitary ascidians and hydroids

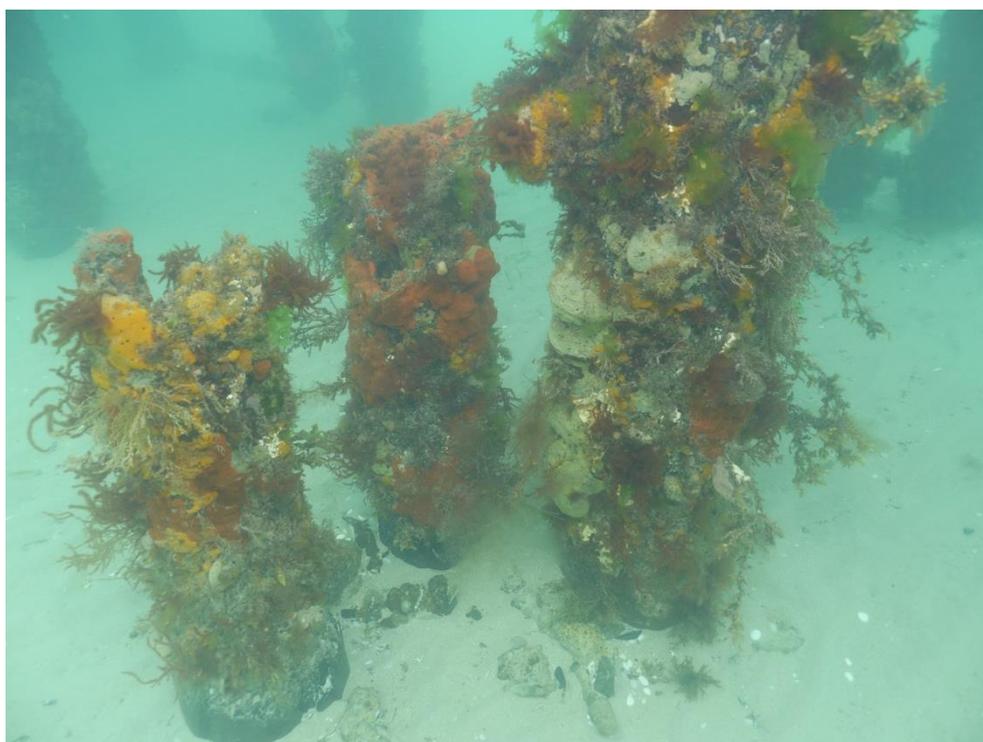
The marine ecological observations during this July 2021 and CEE’s previous September 2019¹ survey at Rye Pier show that vertical zonation of the *subtidal* community below the low water mark on the existing Pier pilings was relatively weak. No strong pattern of greater diversity or preference of biota for particular depth ranges was observed over the wooden piles. In contrast, observation of the new HDPE jacketed piles of the new lower landing at chainage 260 m in July 2021 showed greater diversity and abundance of the lower parts of the piles over the first 18 months since the piles were installed.

Figure 18 Marine life on existing cut-off piles at Rye Pier near lower landing, CEE September 2019
