**APPENDIX D      DATASHEETS - BUILDINGS OF SECONDARY  
SIGNIFICANCE**

QUARANTINE STATION, POINT NEPEAN

**BUILDING 5****DATE OF CONSTRUCTION:** 1965-67**LEVEL OF SIGNIFICANCE:** SECONDARY**PRIMARY NAME:** Officer Cadet Accommodation**OTHER NAMES:****LOCATION PLAN AND PHOTOGRAPHS:**

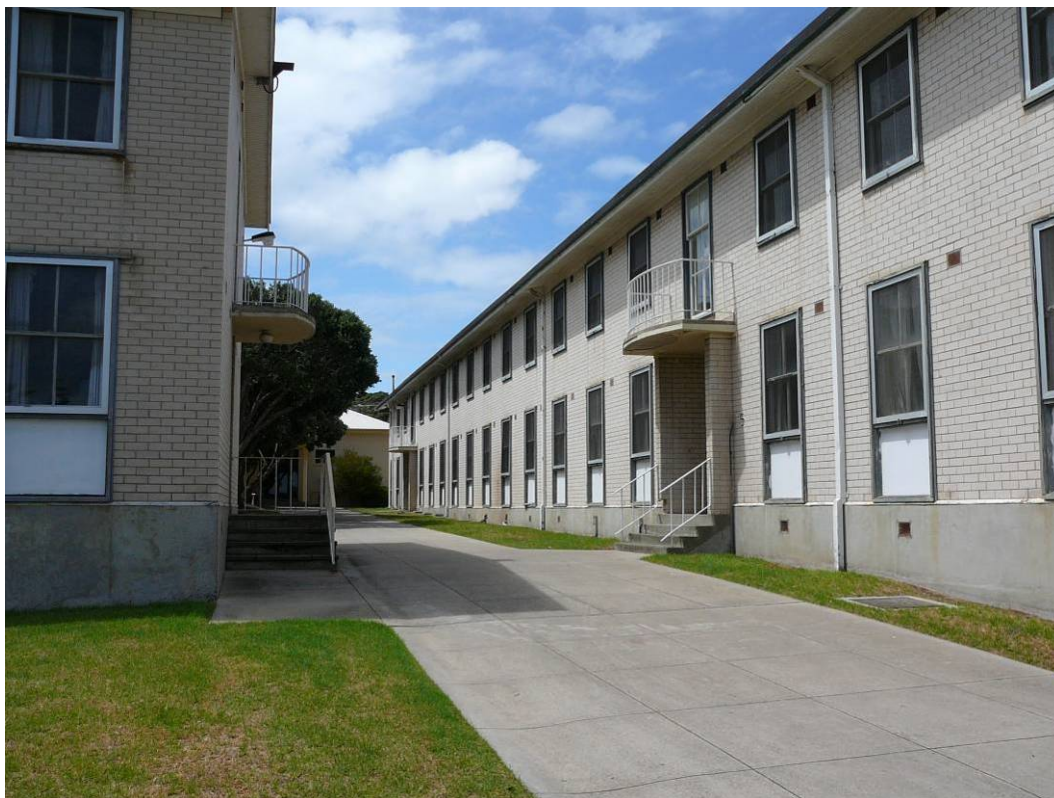
Figure 1 Building 5, north elevation.

Building 5 is a two storey building constructed of cream brick on a concrete plinth, with gable ends and a shallow gable roof with over-hanging eaves. It has a horizontal massing, and long rectangular plan on an east-west alignment. Fenestration includes timber framed windows located at regular intervals at both levels on the north and south elevations, with an infill panel located beneath the ground level windows. Two entrances are located on the north elevation, both with overhanging balconies surrounded by wrought iron balustrades. A double storey balcony is also located on the west gabled elevation, with an iron balustrade.

Any proposal to undertake works to the north side of this building should have regard for the Officer Accommodation landscape precinct (see Appendix F), which is a courtyard area located immediately to the north.

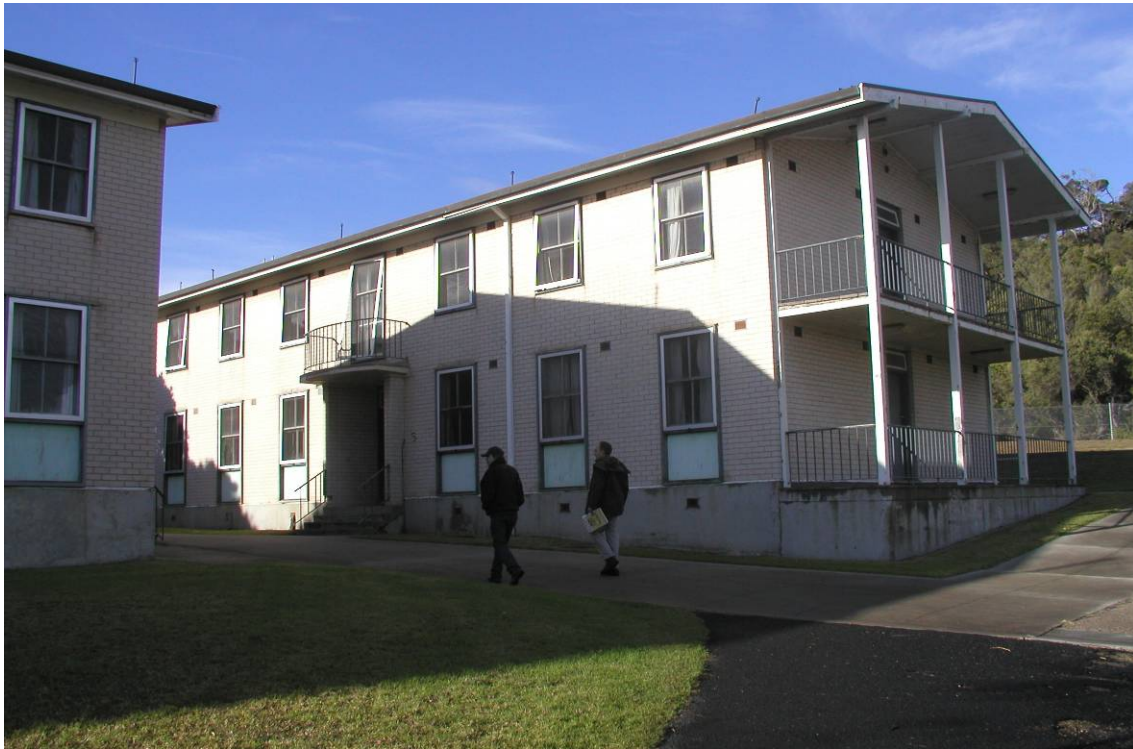
Figure 2 Building 5, west end.

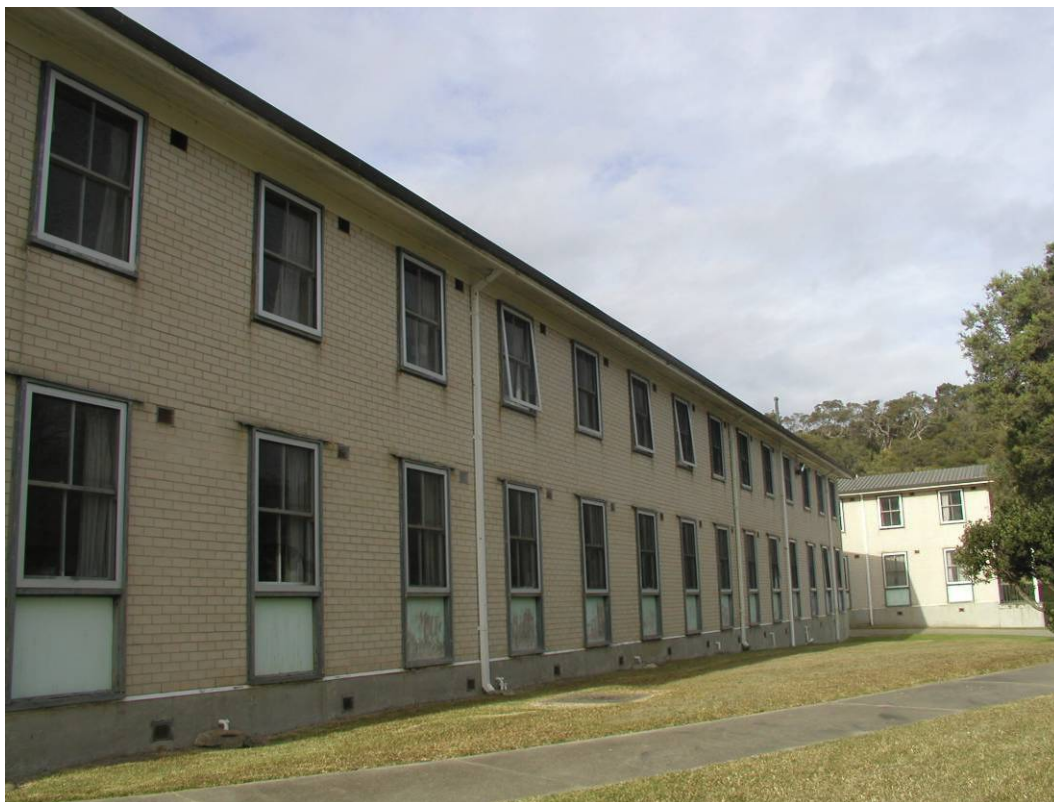
Figure 3 Building 6, west elevation.

As a building of secondary significance, including historical significance, the recommendation for Building 6, to be consistent with this Plan, would be to preferably retain and conserve as evidence of the OCS use. However, given its intrusive placement and disruptive siting within the former Quarantine Station, demolition of this particular building could be seen as a positive heritage outcome in terms of enhancing an understanding of the historical pattern of development. Demolition would also enhance views of, and the presentation of Hospital No. 2 to the east and help to reinstate the visual connection between this building and the other historic hospitals to the west.

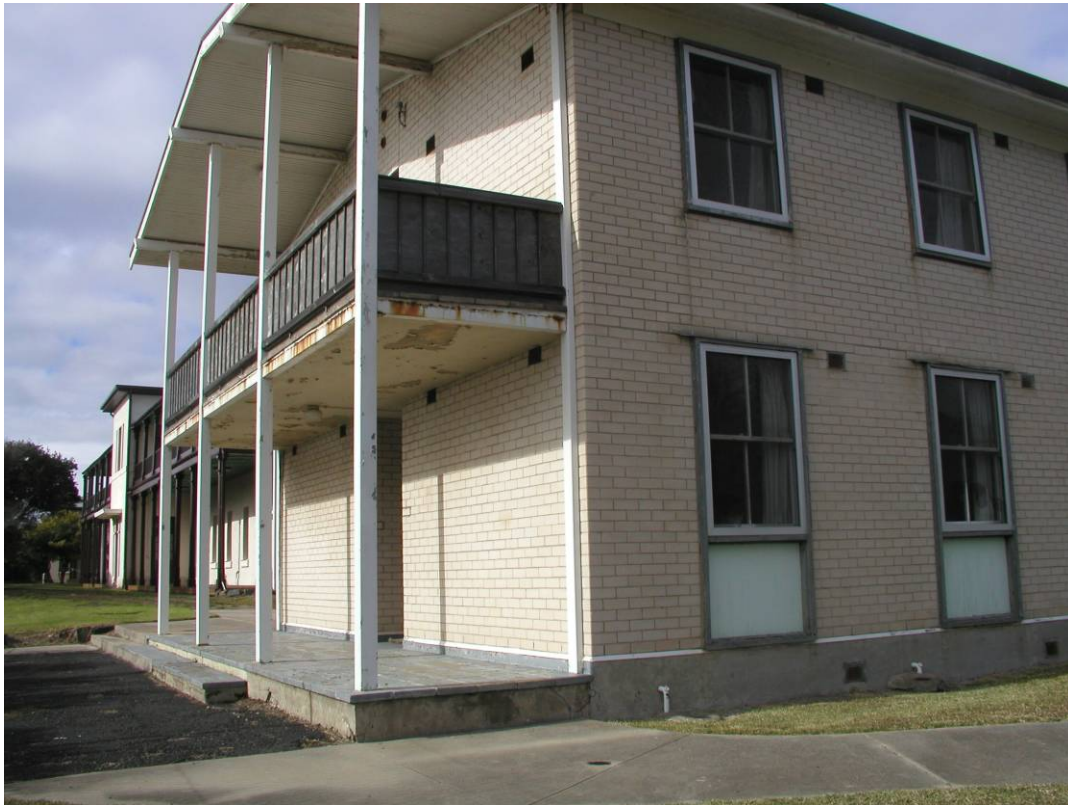
Figure 4 Building 6, north end. Hospital No. 2 (Building 4) is visible at background left.

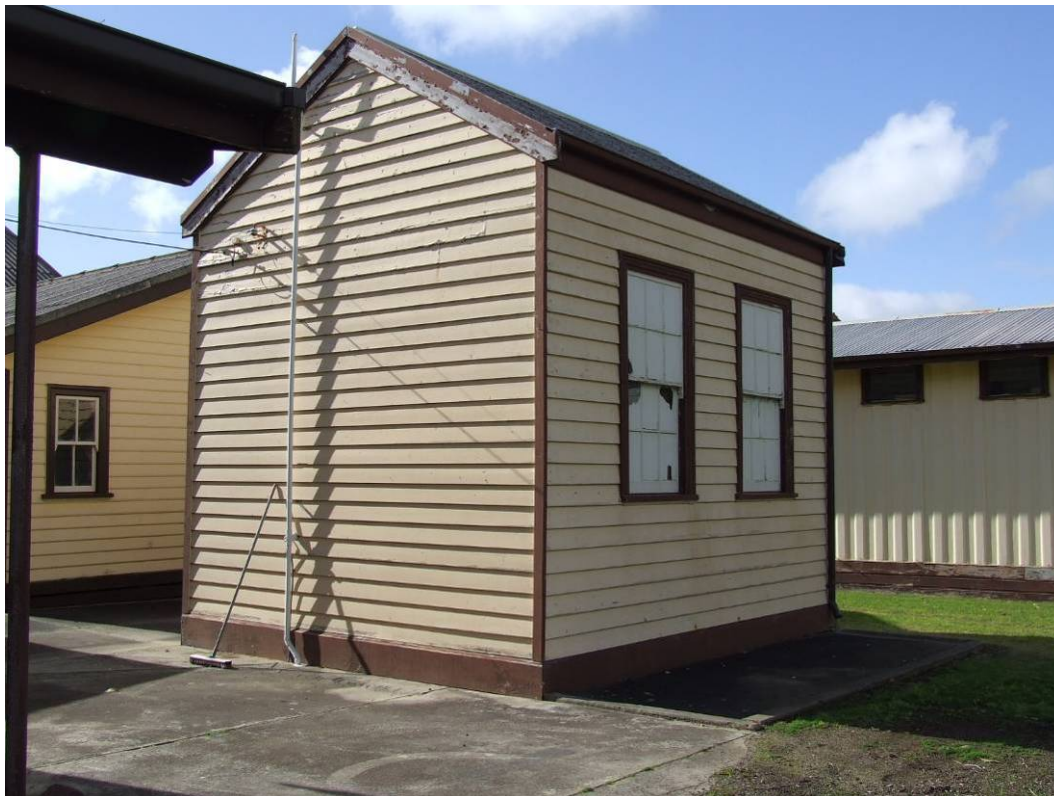
Figure 11 Building 19, northeast view.

This building preferably should be retained and conserved, as evidence of later Quarantine Station development and use. The physical and visual association with Buildings 18 and 20 should also be retained, to help demonstrate their former functional relationship.

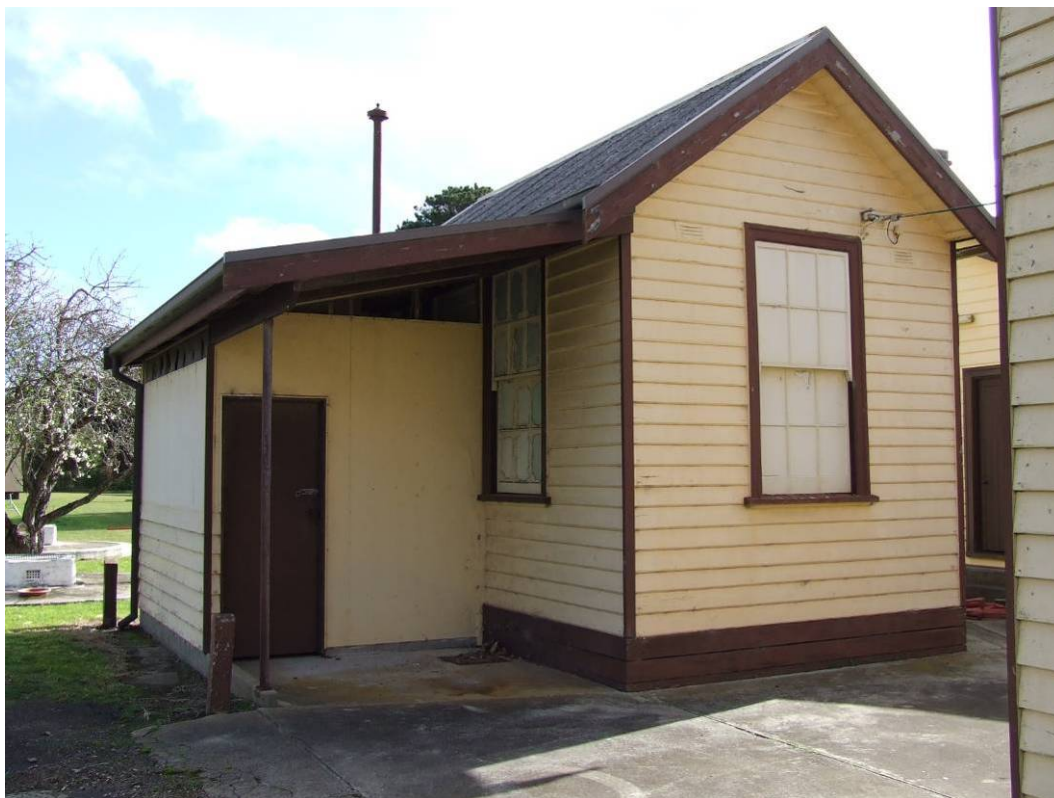
Figure 14 Building 20, northeast view.

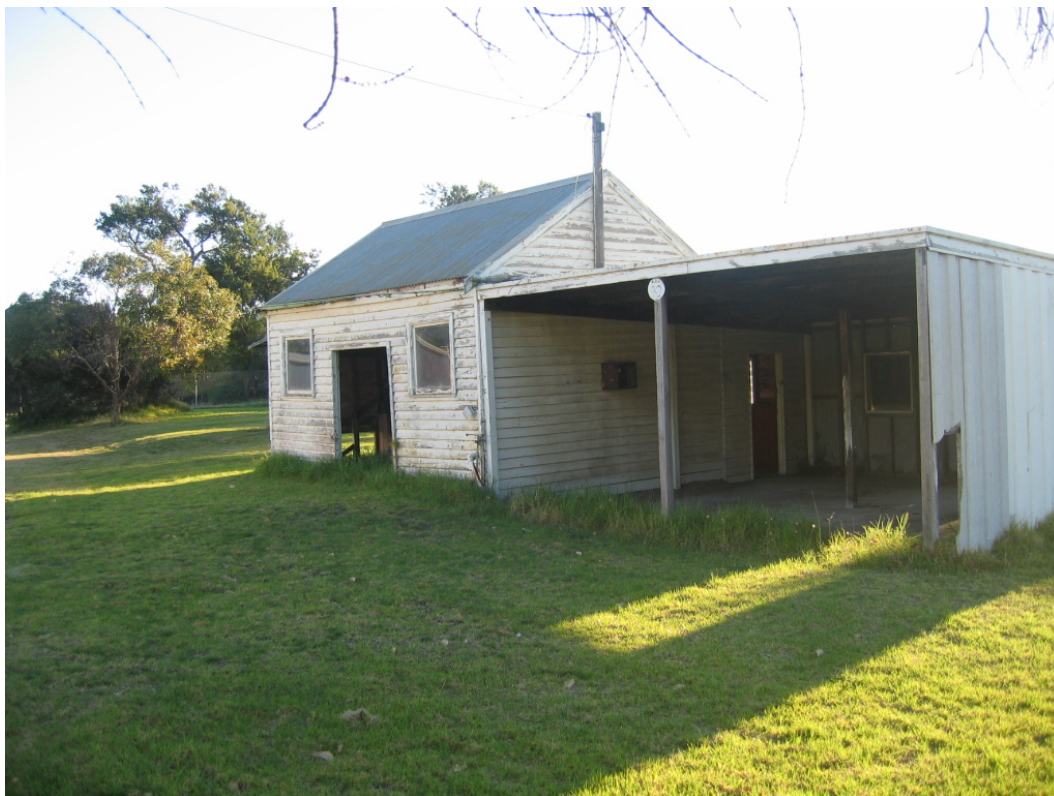
Figure 17 View of Building 32.

As a building of secondary significance the recommendation is generally to retain, but given the modest nature of this structure and its limited contribution to the historic character of the Station, the building offers flexibility with regard to retention and alteration. The timber-framed, asbestos clad shelter can be removed.

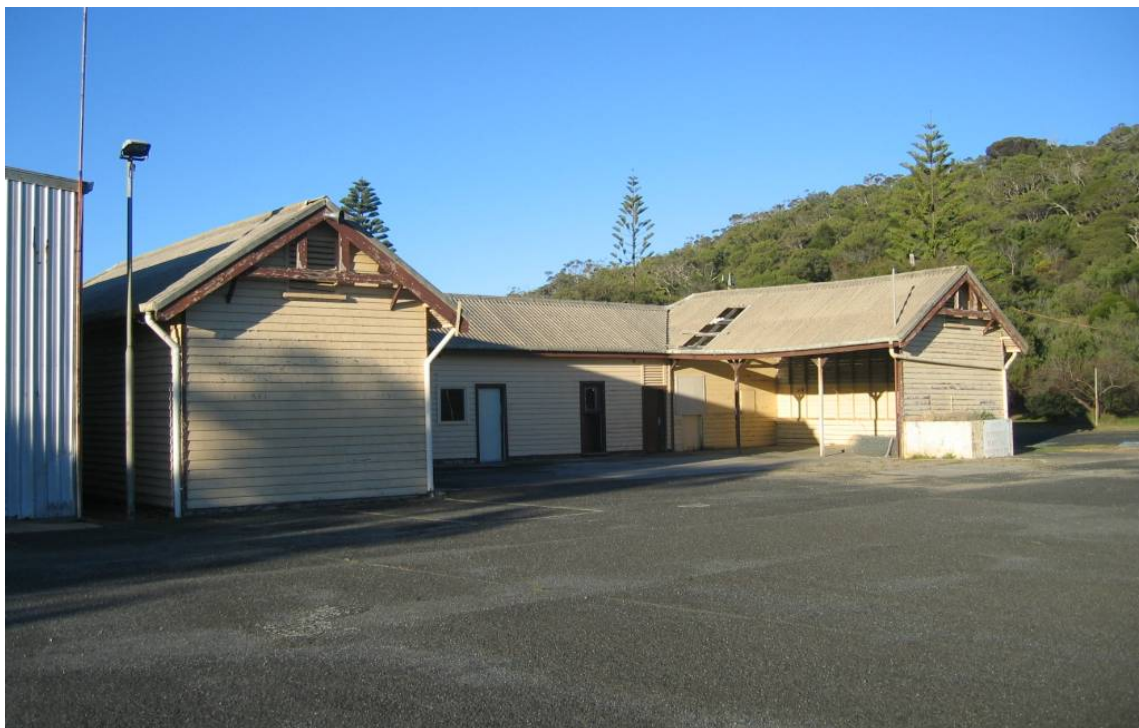
Figure 18 Building 33, southwest view.

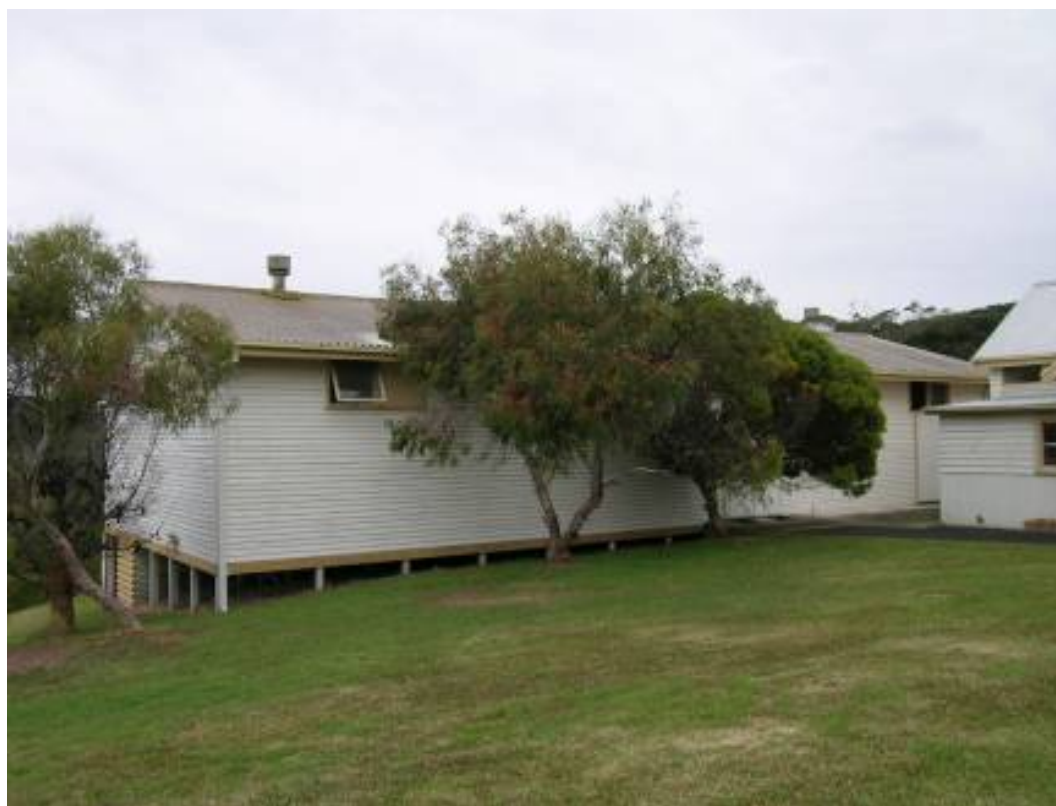
Figure 22 Building 72, viewed from north.

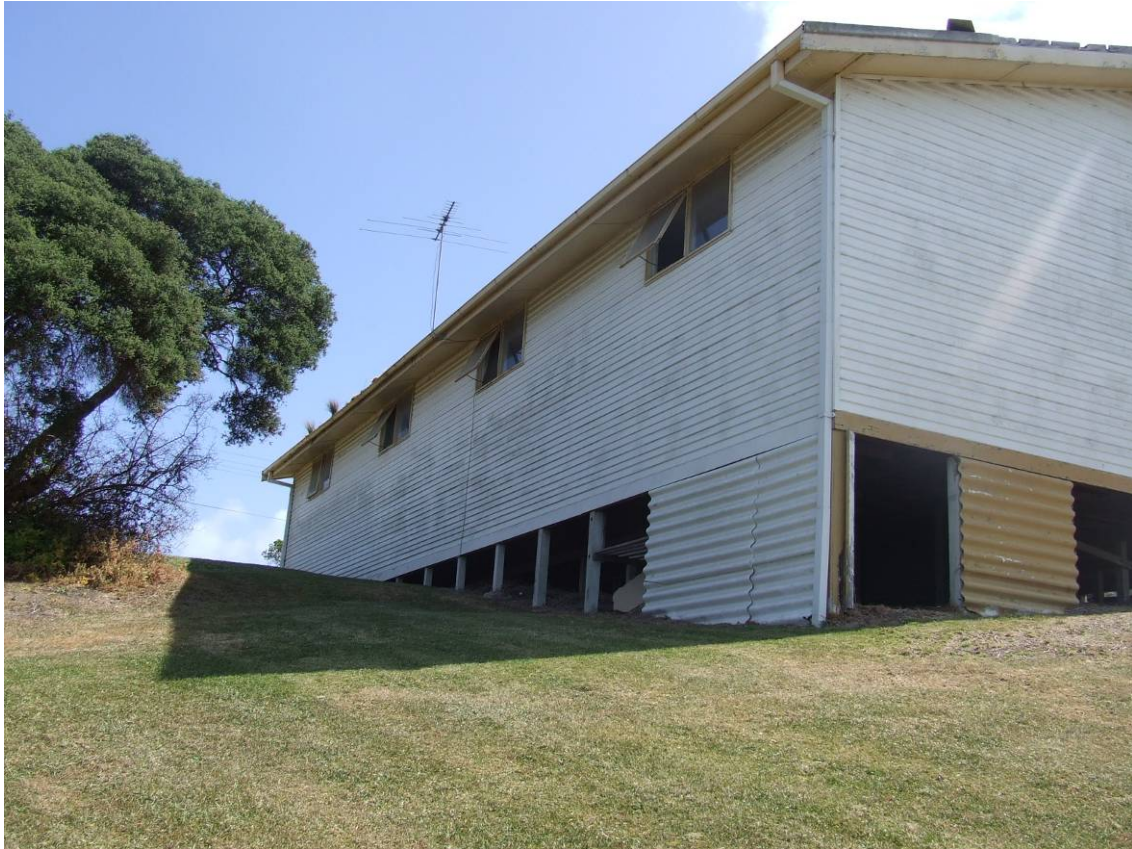
Figure 23 Building 72, east elevation.

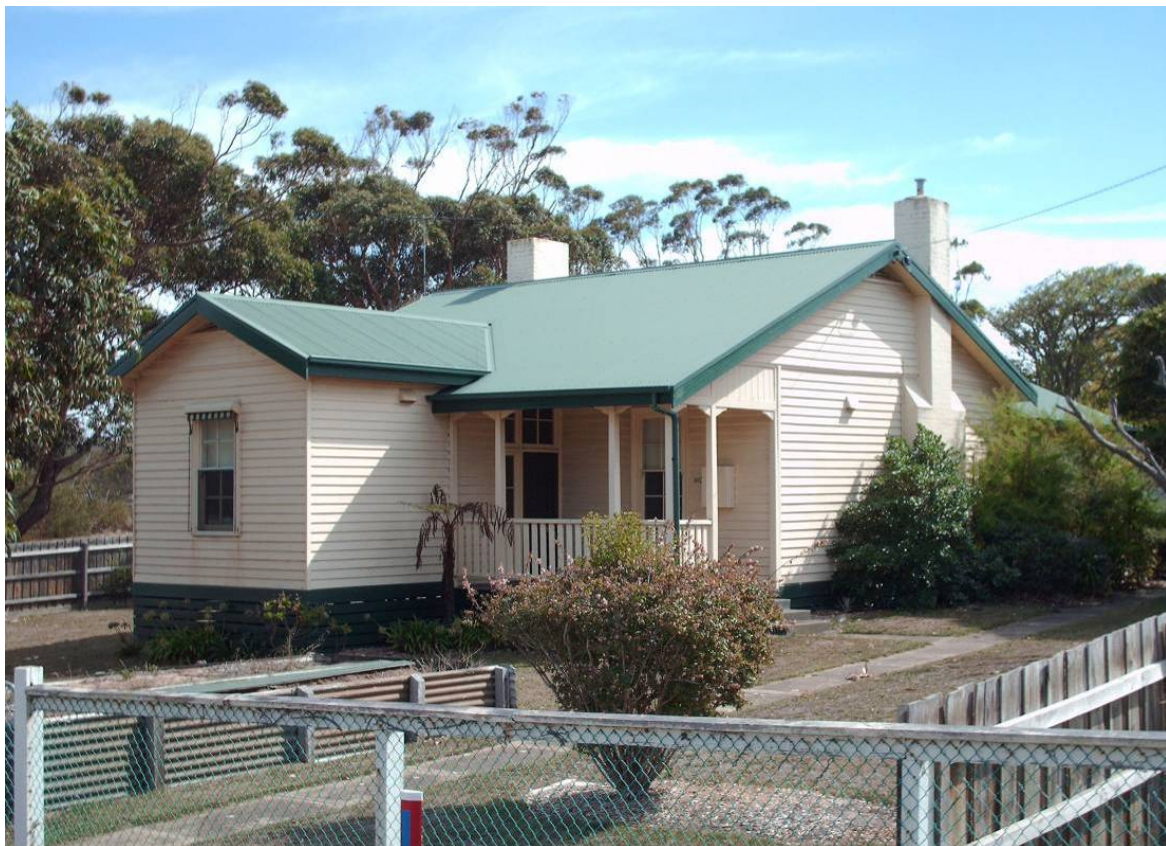
Figure 31 Building 1037, southeast view.

This building preferably should be retained and conserved, as evidence of the need for staff accommodation during a later phase of Quarantine Station development and use. The building offers opportunity for alteration and addition, including works to the rear (north) side of the building. The current fencing, pathways and vegetation of the garden area can be replaced and updated, although the informal garden character should be retained. The relationship between this building and the adjacent Attendant's Cottage No. 1 (Building 1041) to the east is also important, and this visual connection should be maintained.

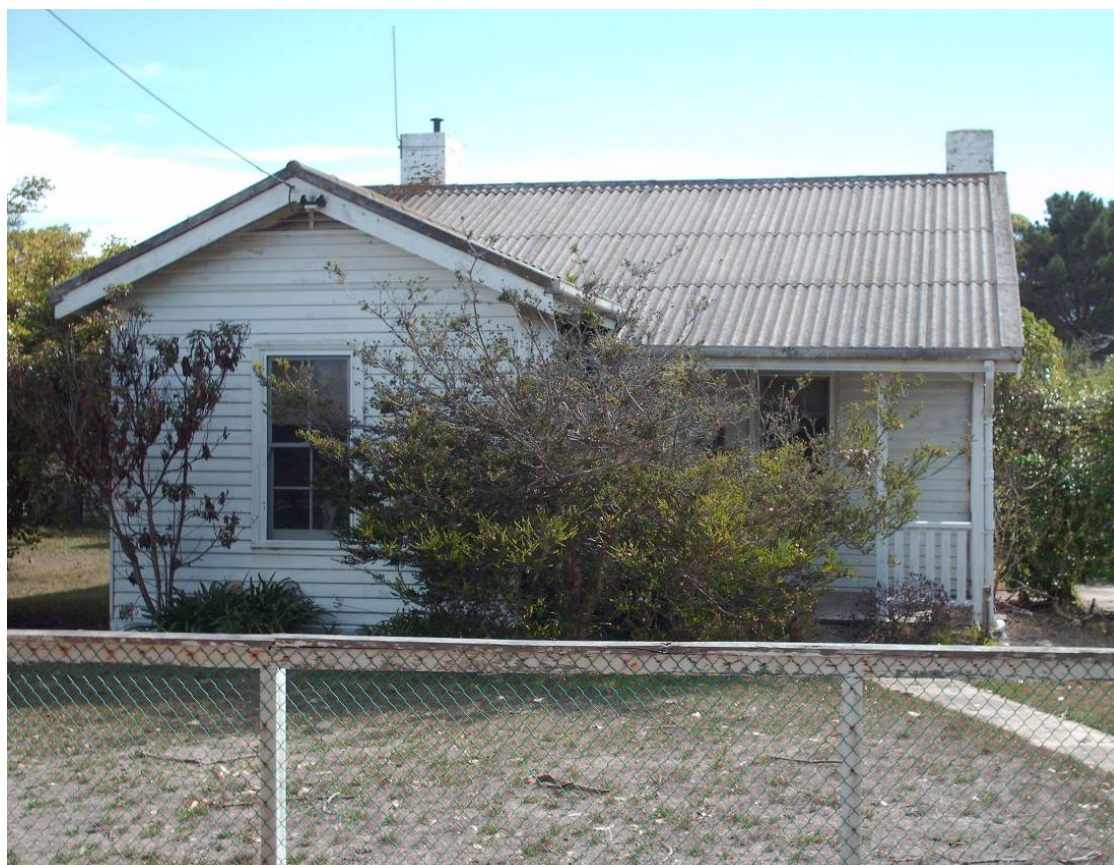
Figure 36 Building 1041, south view.

This building preferably should be retained and conserved, as evidence of the need for staff accommodation during a later phase of Quarantine Station development and use. The building offers opportunity for alteration and addition, including works to the rear (north) side of the building. The current fencing, pathways and vegetation of the garden area can be replaced and updated, although the informal garden character should be retained. The relationship between this building and the adjacent Attendant's Cottage No. 2 (Building 1037) to the west is also important, and this visual connection should be maintained.

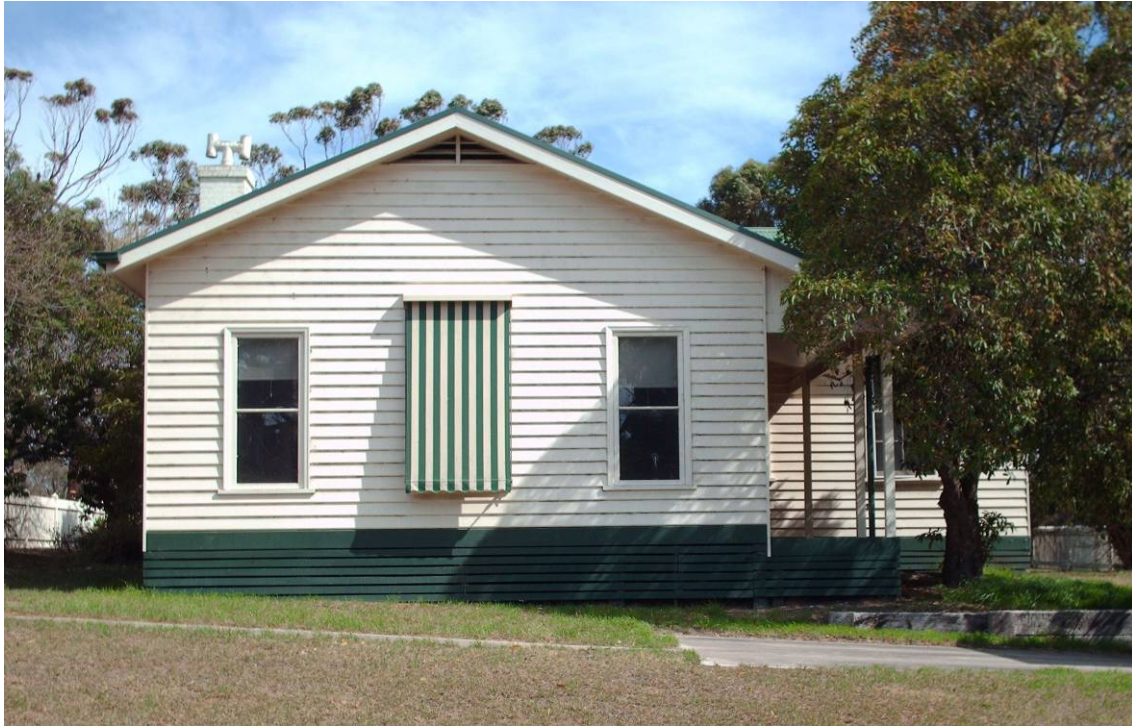
Figure 40 East elevation, showing gabled extension to rear.

building offers opportunity for alteration and addition, including works to the rear (east) side of the building. The current fencing, pathways and vegetation of the garden area can be replaced and updated, although the informal garden character should be retained. The relationship between this building and the adjacent Attendant's Cottage No. 4 (Building 1043) to the north is also important, and this visual connection should be maintained.

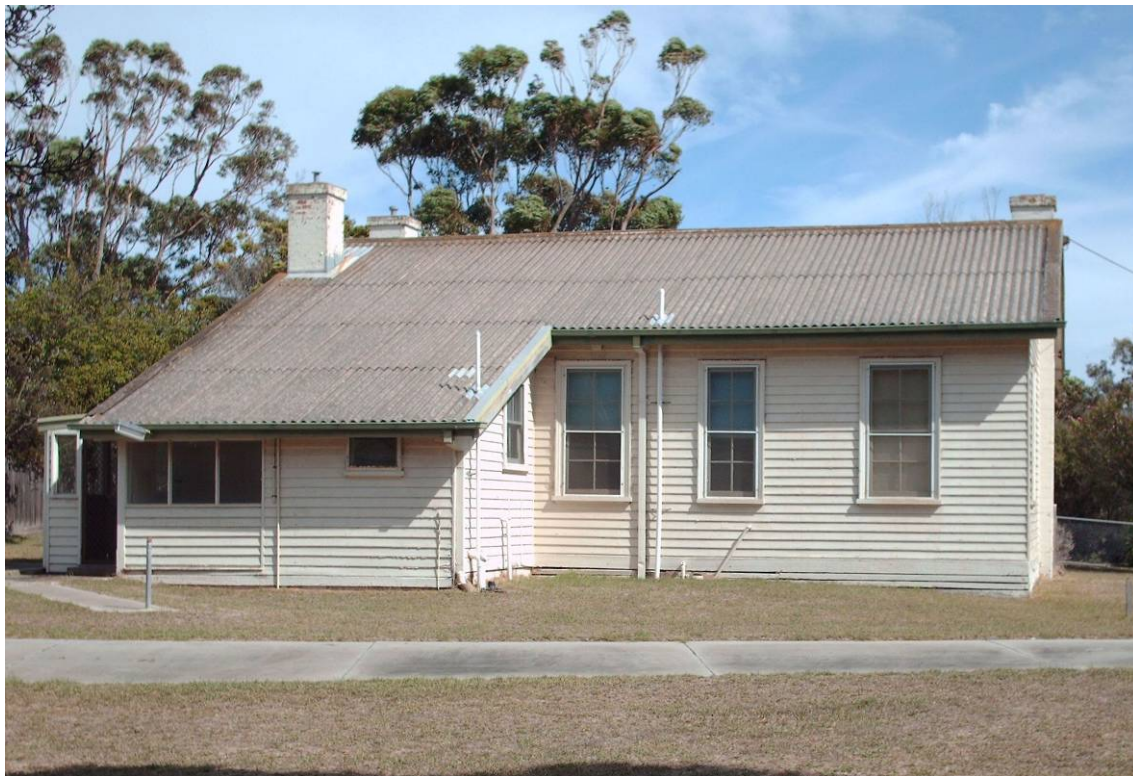
Figure 43 East elevation.

buildings of secondary importance typically offer opportunity for alteration and addition, this is most intact of the four residences in this Police Point Residential Group and accordingly works of this nature should have regard for this high degree of intactness and consider such works carefully so as to retain some evidence of the original rear building form in particular (the rears of the other cottages have all been altered). The current fencing, pathways and vegetation of the garden area can be replaced and updated, although the informal garden character should be retained. The relationship between this building and the adjacent Attendant's Cottage No. 3 (Building 1042) to the south is also important, and this visual connection should be maintained.

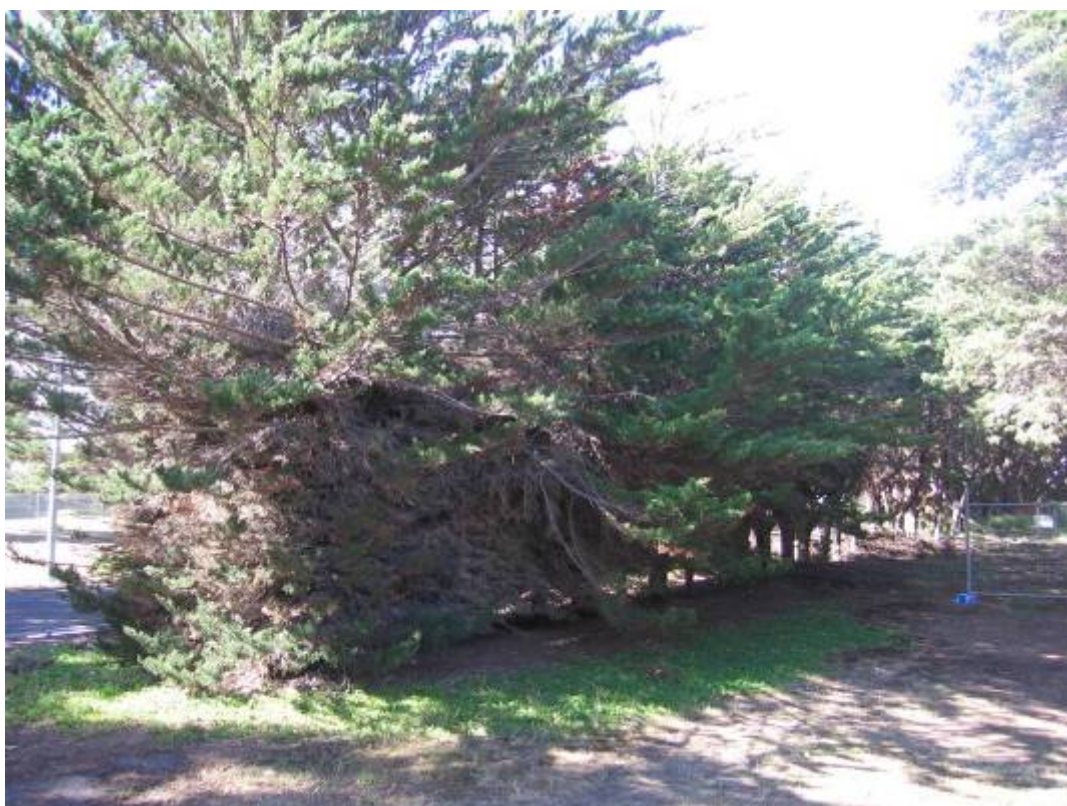
Figure 17 Overgrown section of clipped hedge, north east of Building 25.

The Cypress planted as part of the former clipped hedge, are generally in poor condition. They have lost their clipped form and are overshadowed by larger trees in the adjacent double row.

Manage the Cypress double row and trees from the former Isolation area as part of a broader Arboricultural Management Plan for the site. The retention and long term replacement strategy for the double row should be considered in conjunction with the other Cypress rows within the site to ensure:

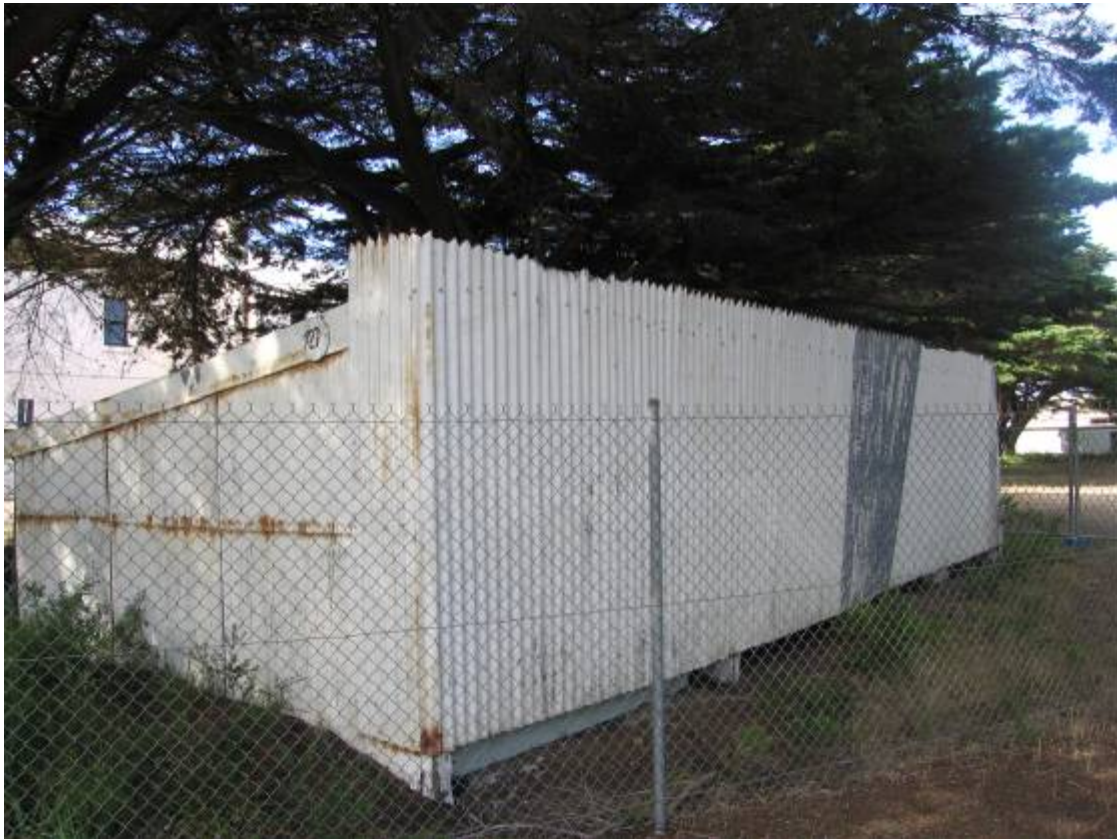
Figure 18 Remnant section of Isolation Building fencing (known as Building 27). Note the jagged top.

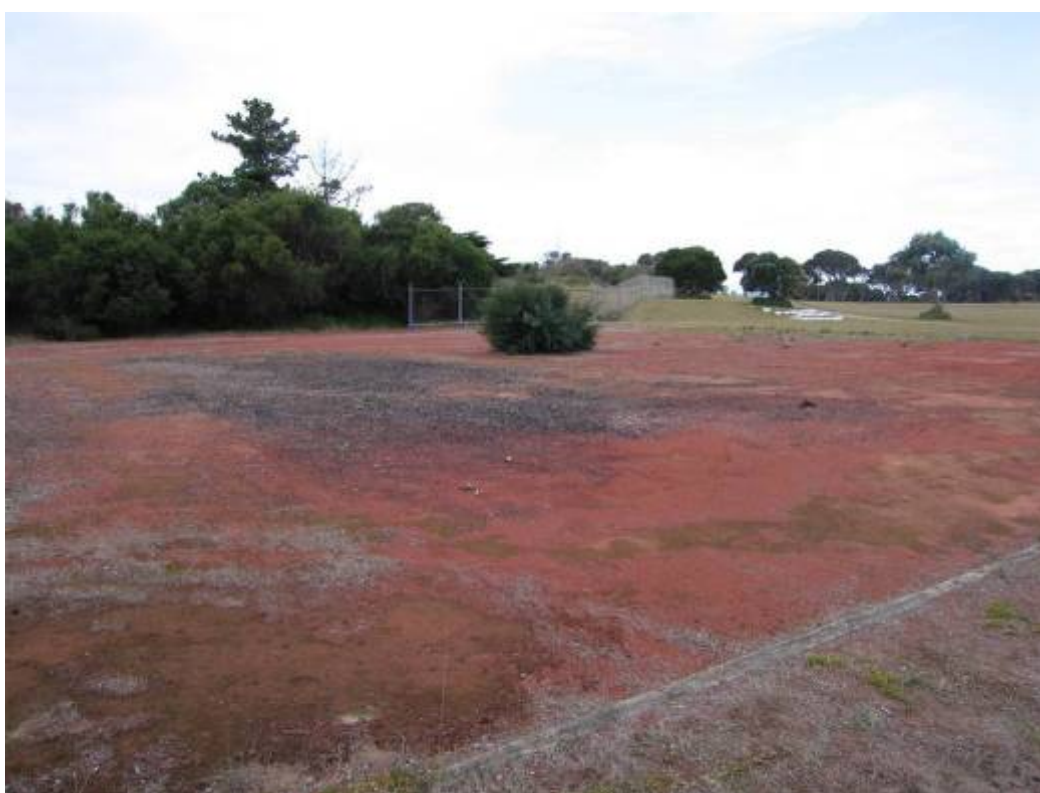
Figure 42 Derelict tennis courts on the west side of Jarman Oval. Note the self-sown Pine (emergent tree) in the background.
