**APPENDIX C      DATASHEETS - BUILDINGS OF PRIMARY SIGNIFICANCE**

QUARANTINE STATION, POINT NEPEAN

**BUILDING 1**

**PRIMARY NAME:** First Class Accommodation

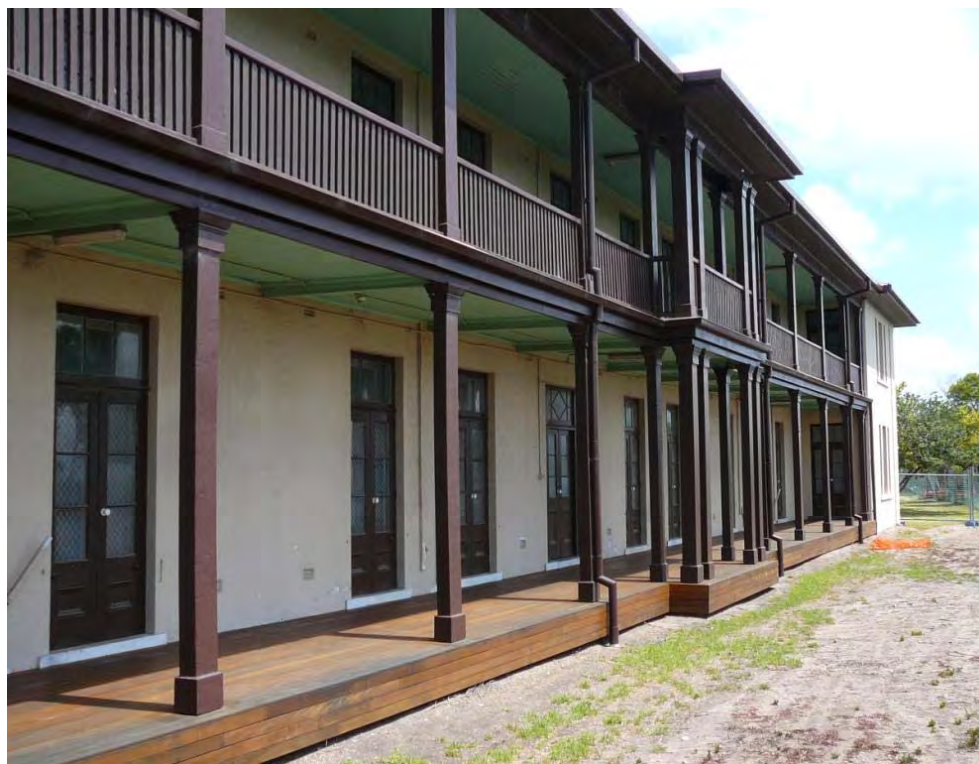
Figure 1 Building 1, partial view of north façade.

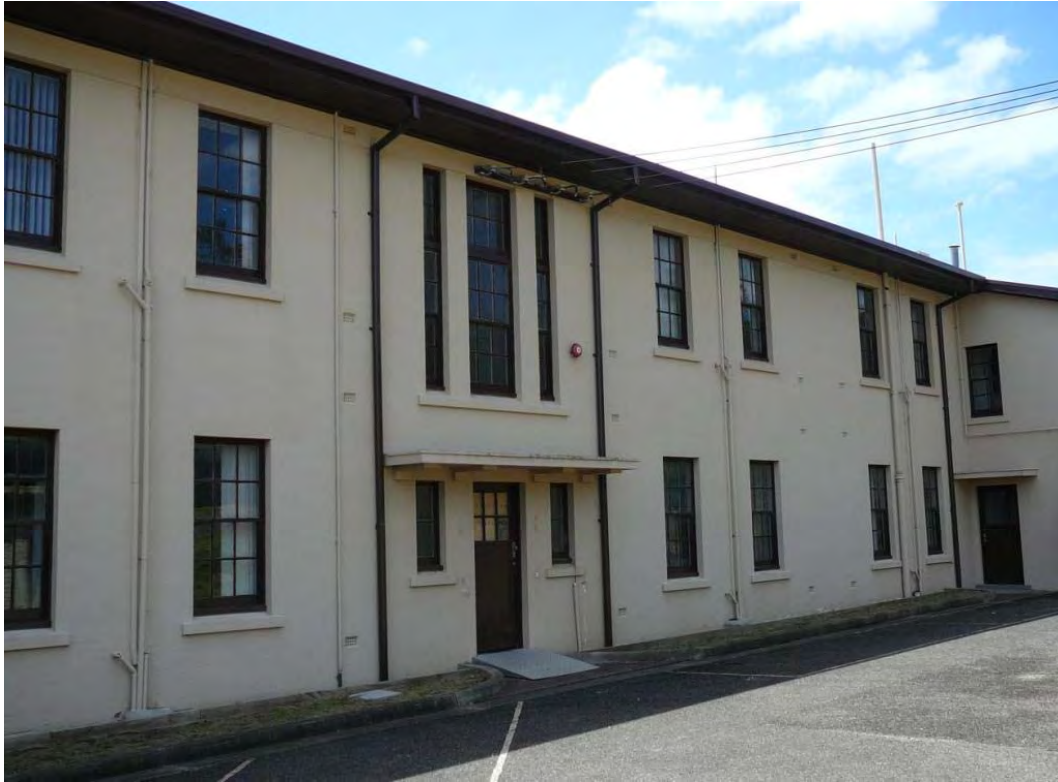
Figure 2 Building 1, partial view of south façade.

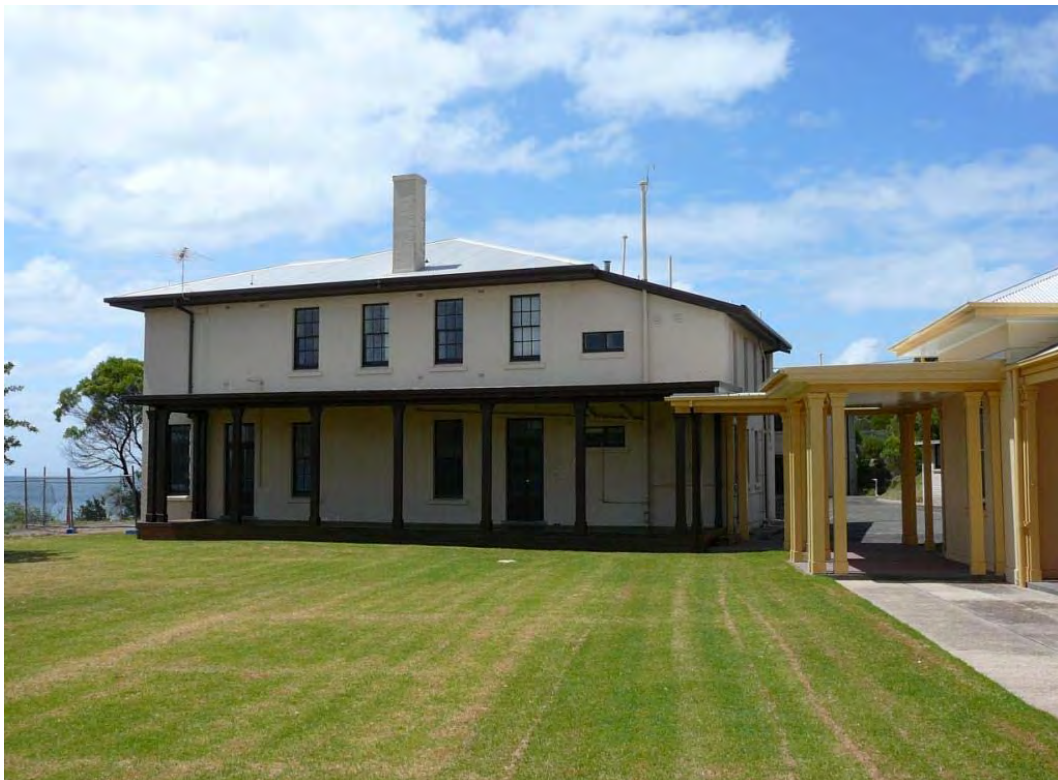
Figure 3 Building 1, west façade (the east façade is similar) – part of Building 3 can be seen at right.

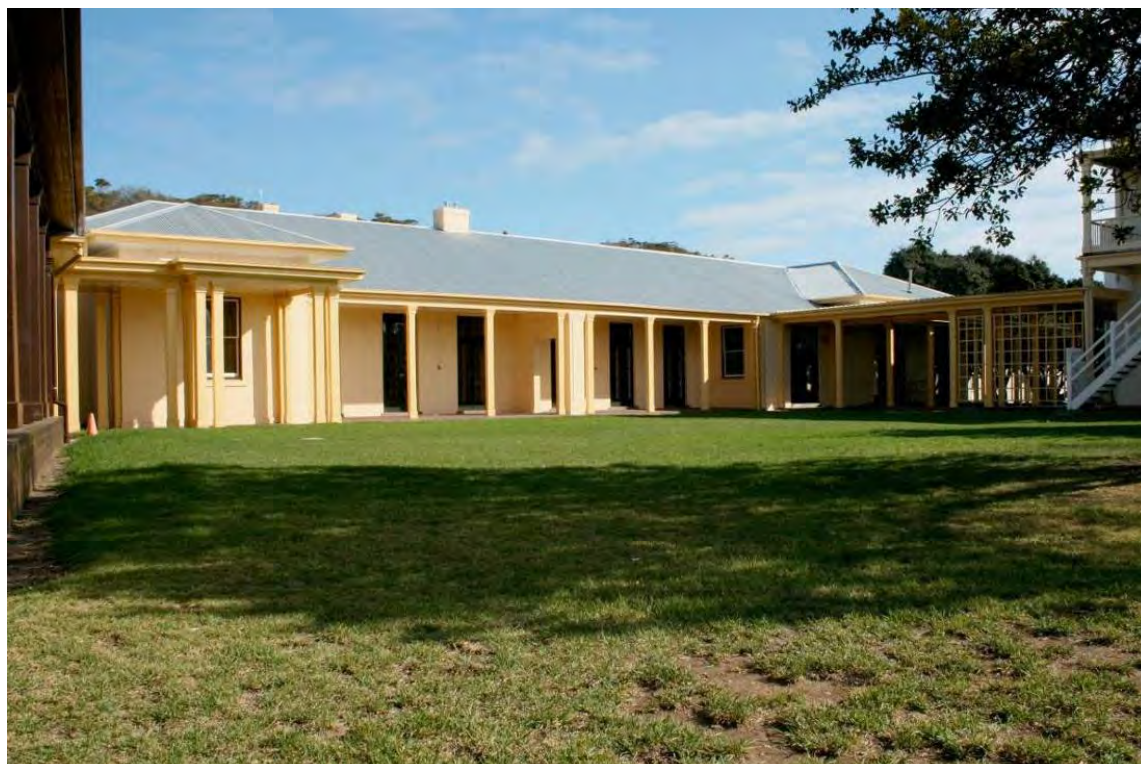
Figure 10 Building 3, north façade.

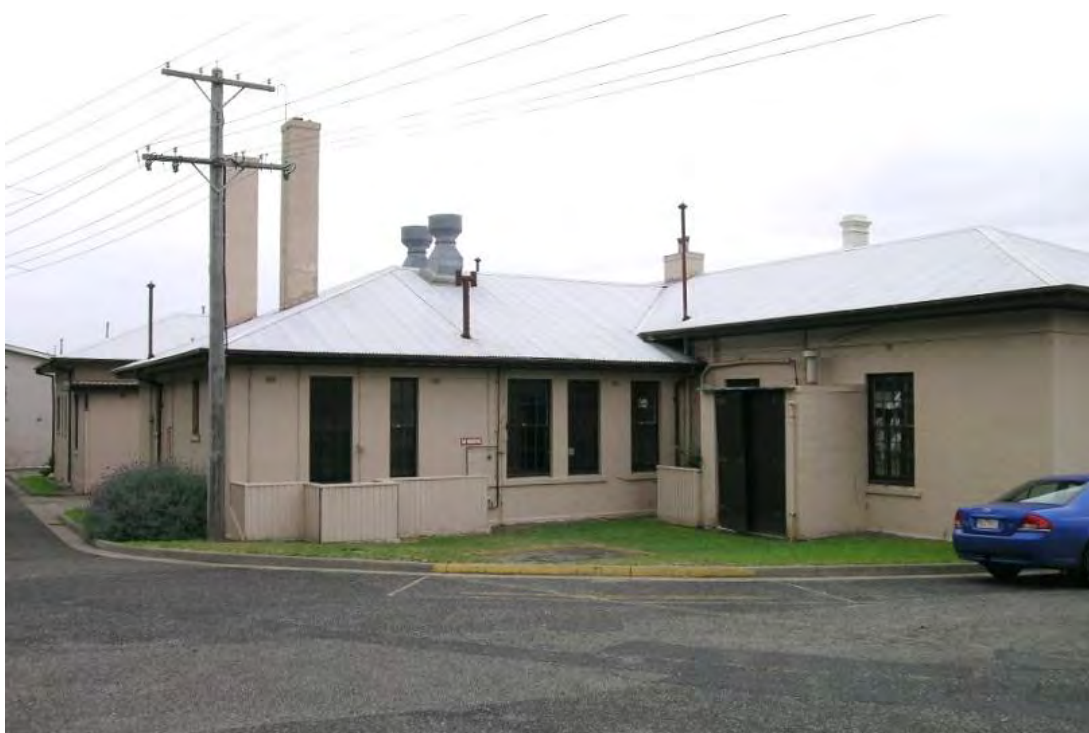
Figure 11 Building 3, southeast view, prior to completion of restoration works.

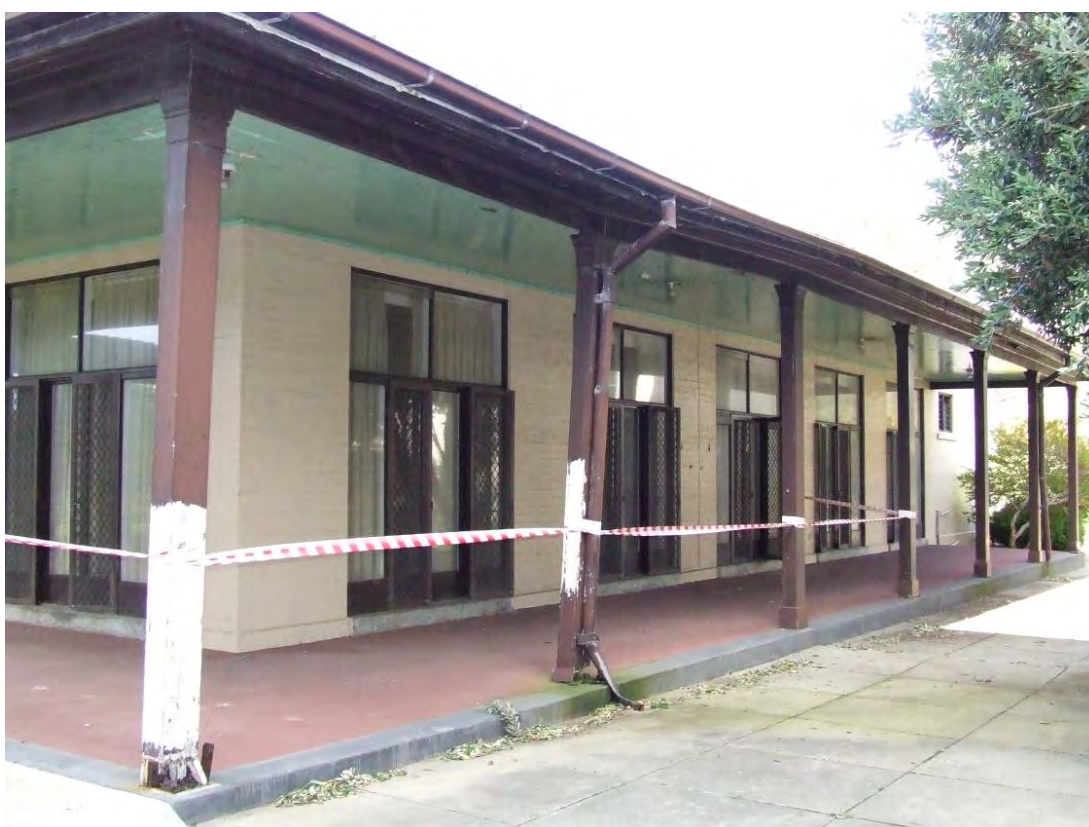
Figure 12 Building 3, showing the mid-1960s west extension. The photograph shows the building prior to the programme of recently completed restoration works.

In the early to mid-1960s Building 3 was quite substantially altered by the Army for use as a mess (dining room) and bar. An extension comprising a large open room, bar area, and male and female toilets was added on the west side, and the existing covered walkway from Building 4 was extended across the north facade of the extension, and returned down the west facade. There were also changes made to the internal layout and external appearance of the original building - the wall between the two dining rooms was substantially removed with only the fireplace section remaining; the glazed double doors to the east lobby have been removed and replaced by a window and other windows and doors have been altered or replaced. The west end wall of the '2<sup>nd</sup> class' dining room was also removed where it sits adjacent to the 1960s addition.

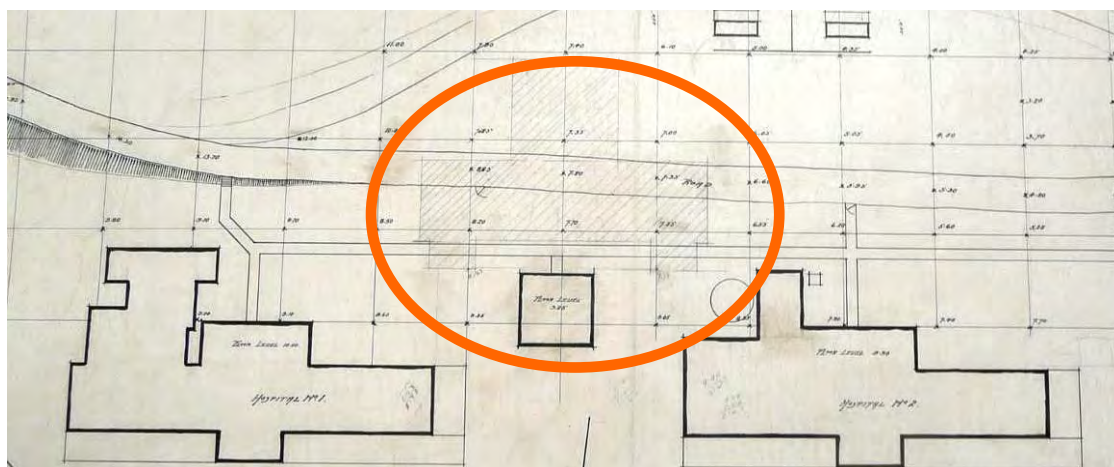
Figure 13 Quarantine Station Point Nepean. Block Plan showing Levels of Site (detail). Dated 26 October 1914. The circle indicates the outline of the subject building. Source: National Archives of Australia.

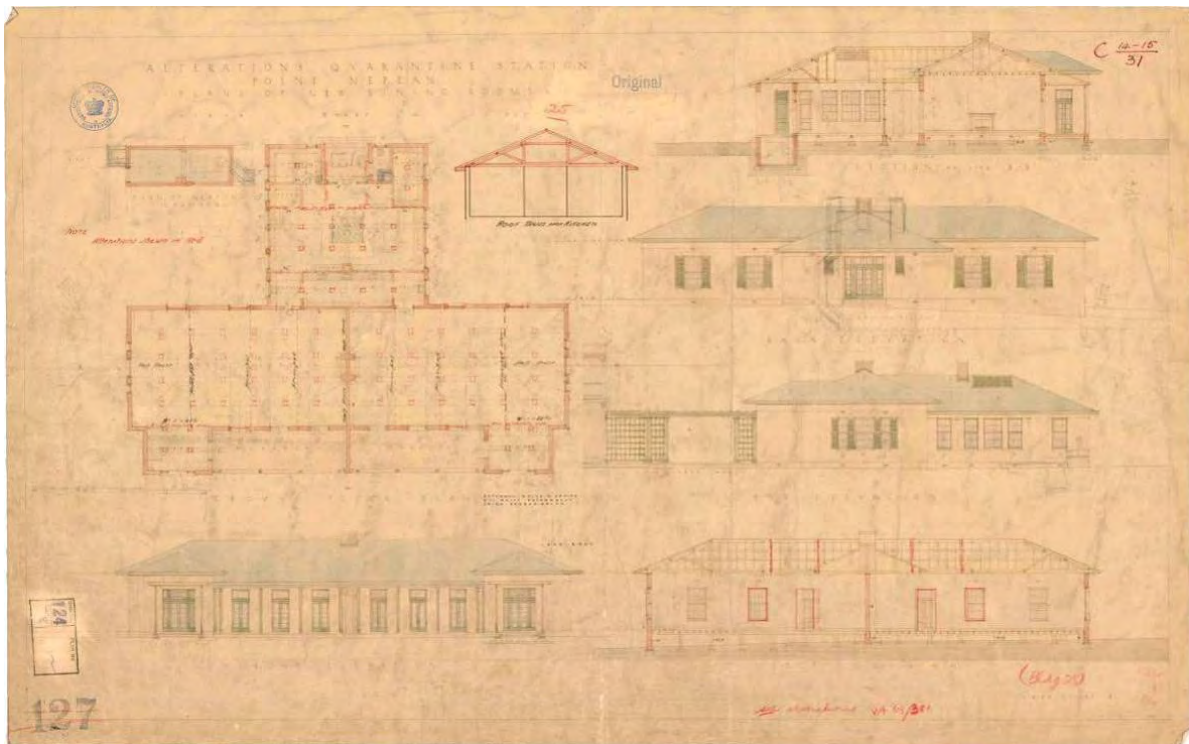
Figure 16 Alterations Quarantine Station Point Nepean. Plans of New Dining Rooms. Drawing No. 1.  
Source: National Archives of Australia.

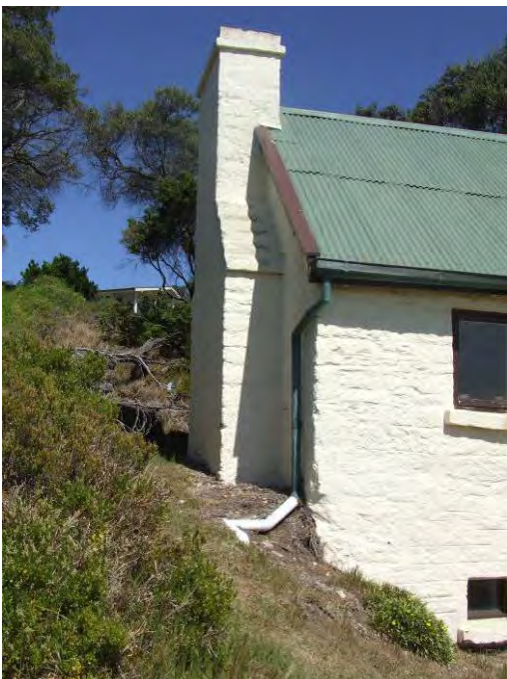
Figure 30 Chimney detail to east facade

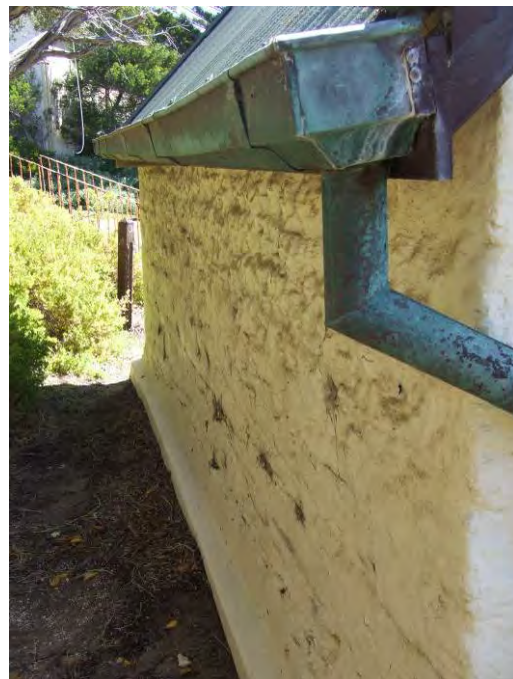
Figure 31 South façade and gutter detail

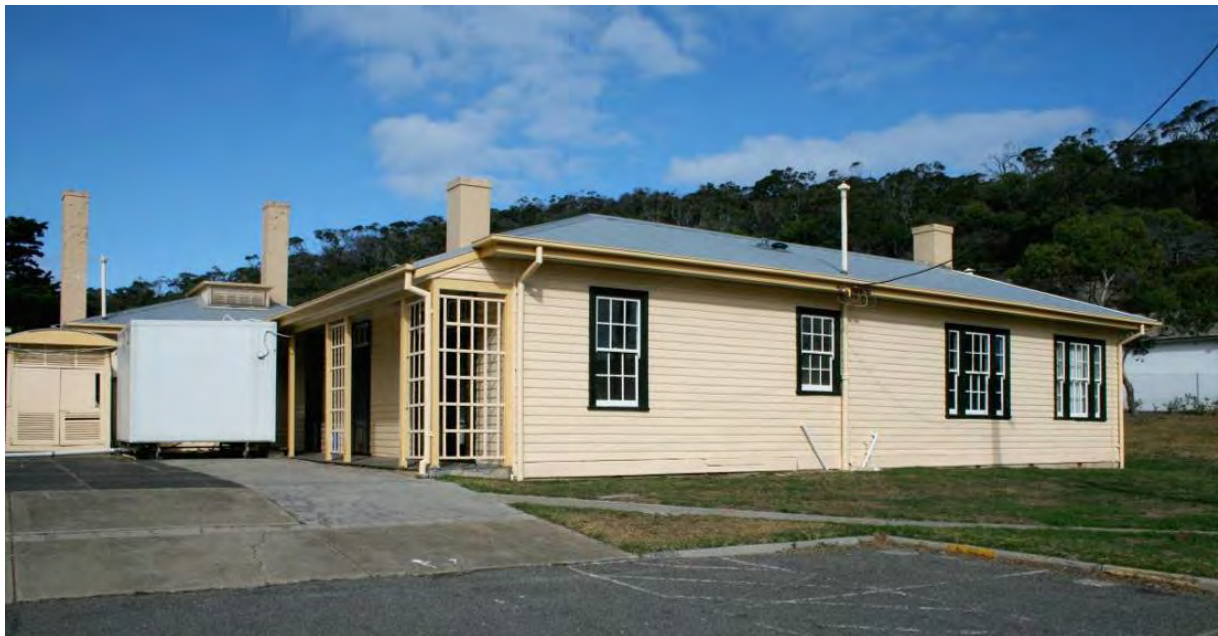
Figure 37 Building 9, northwest view. Note the early cool room structure to the extreme left of the image.

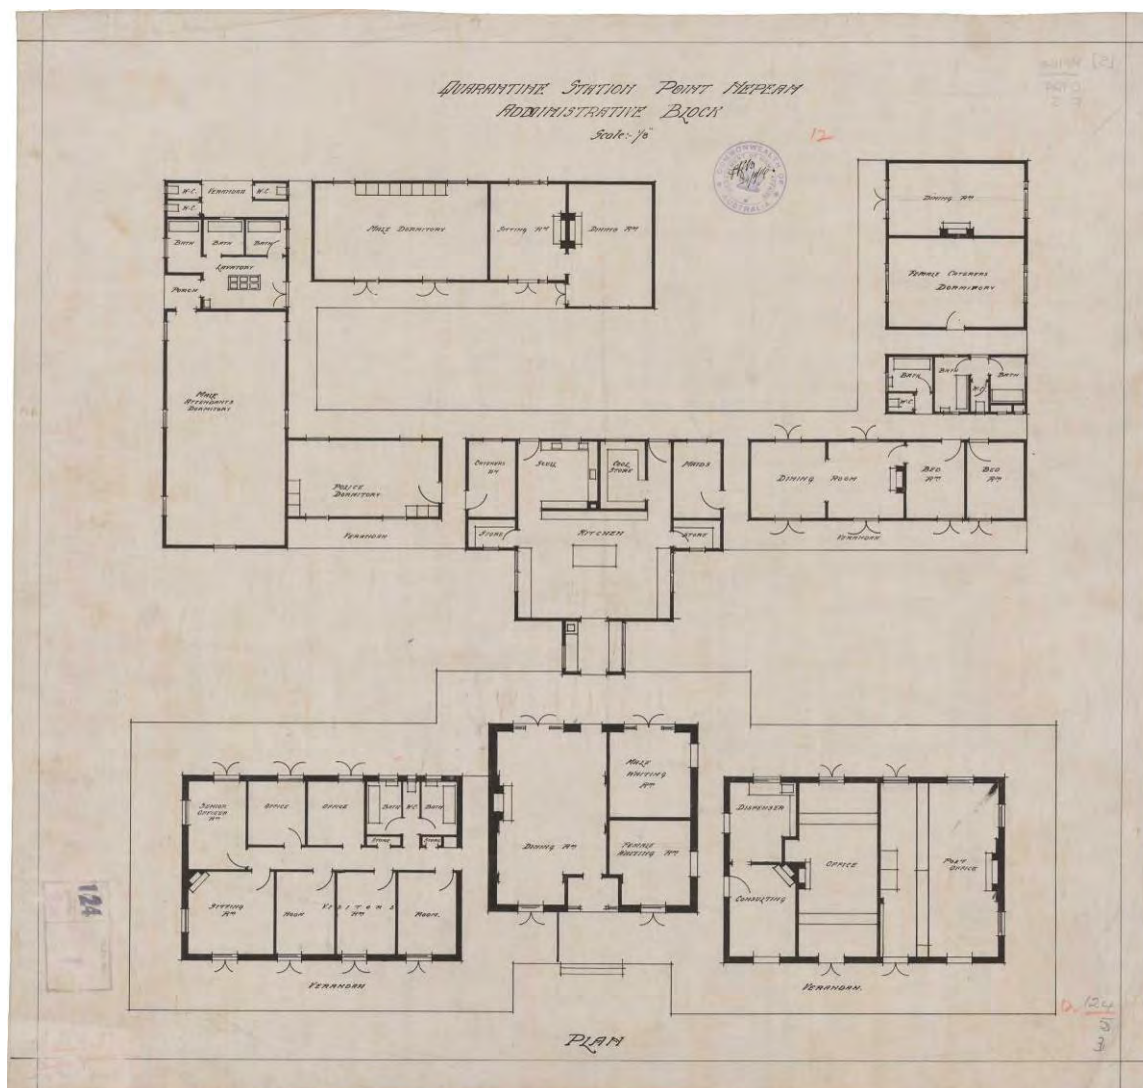
Figure 45 Quarantine Station Point Nepean. Administrative Block. Drawing dated 24 November 1916. Building 9 is at the top of plan.  
Source: National Archives of Australia.

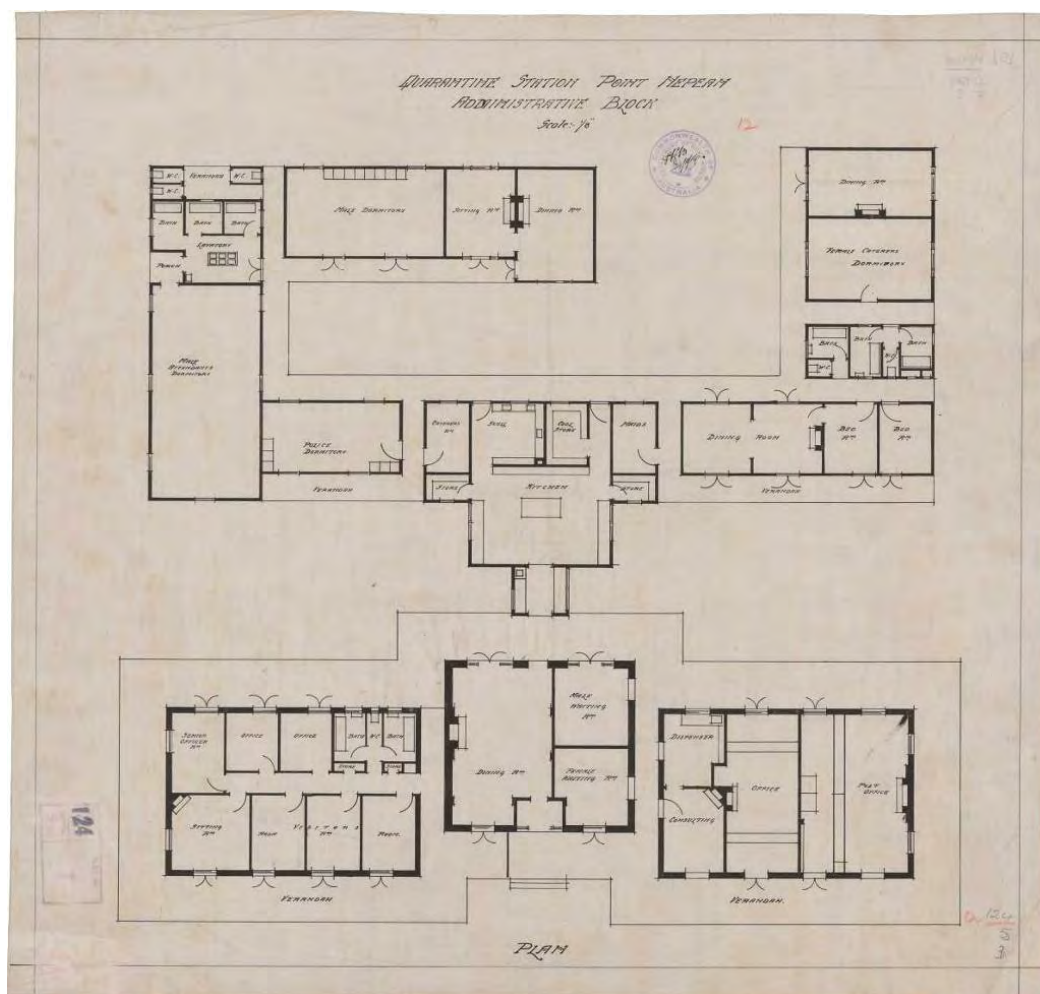
Figure 54 Quarantine Station Point Nepean. Administrative Block. Drawing dated 24 November 1916. Building 10 is at bottom of plan.  
Source: National Archives of Australia.

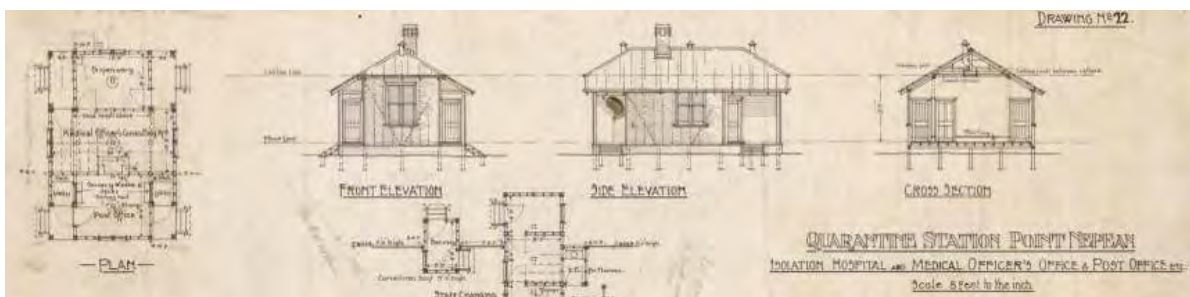
Figure 62 Isolation Hospital and Medical Officer's Office & Post Office etc. Block Plan No. 21, Drawing No. 22. Note that the remainder of the drawing shows Building 66. The drawing is reproduced in full at Figure 174.  
Source: National Archives of Australia.

This building was originally constructed in c.1913 in front of the Administration Building (Building 10), in the Parade Ground area (Figure 62). It was one of a significant number of structures built during an intense phase of development between 1900 and 1925. The building adopts a modest cruciform plan initially divided into sections, with four entrance doors, one to each of the four corner porches. The front room operated as the Post Office with the remainder used as the Doctor's consulting room and dispensary (Figure 62).

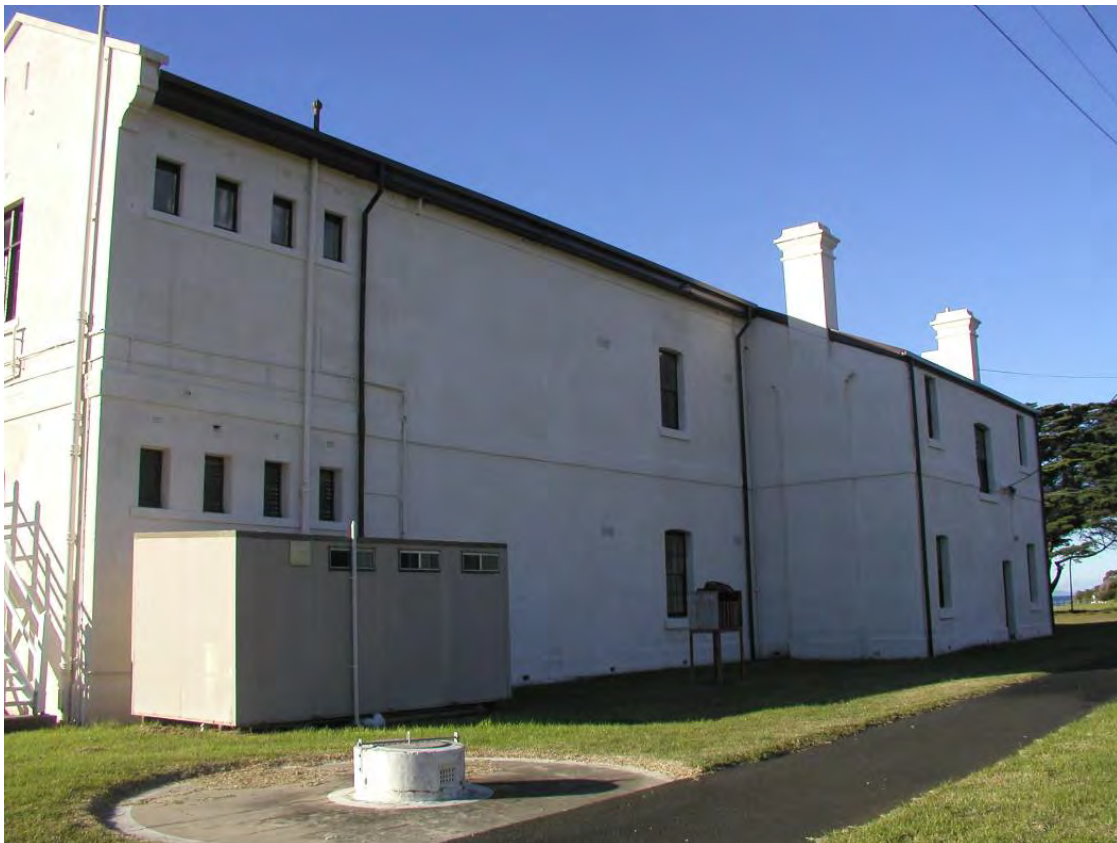
Figure 71 Building 16, showing the south façade – the c.1916 addition to the west end of the original hospital building is clearly identified by the rows of small windows on the left of the image.

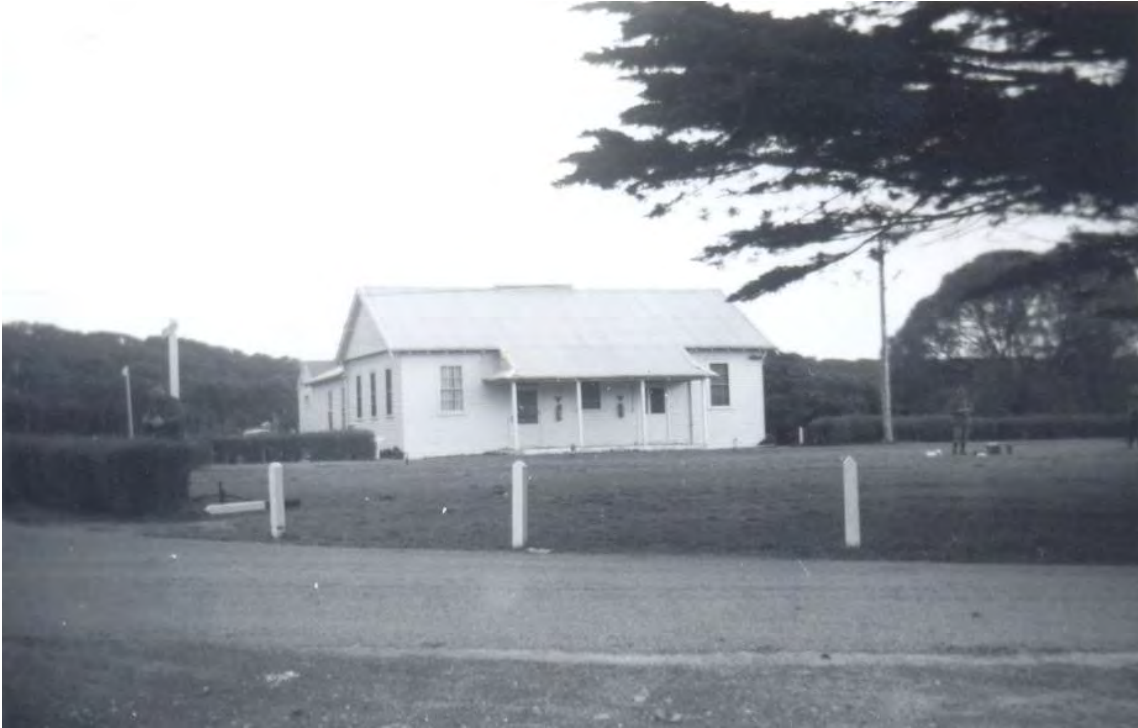
Figure 83 Undated photograph of Building 18.

infilled and the original pair of doors replaced with a single four panel door. A later insertion of sheet lining to the west side of the porch is presumably for weather protection. This is not shown in the photograph at Figure 83, indicating it has been added within the last thirty or forty years.

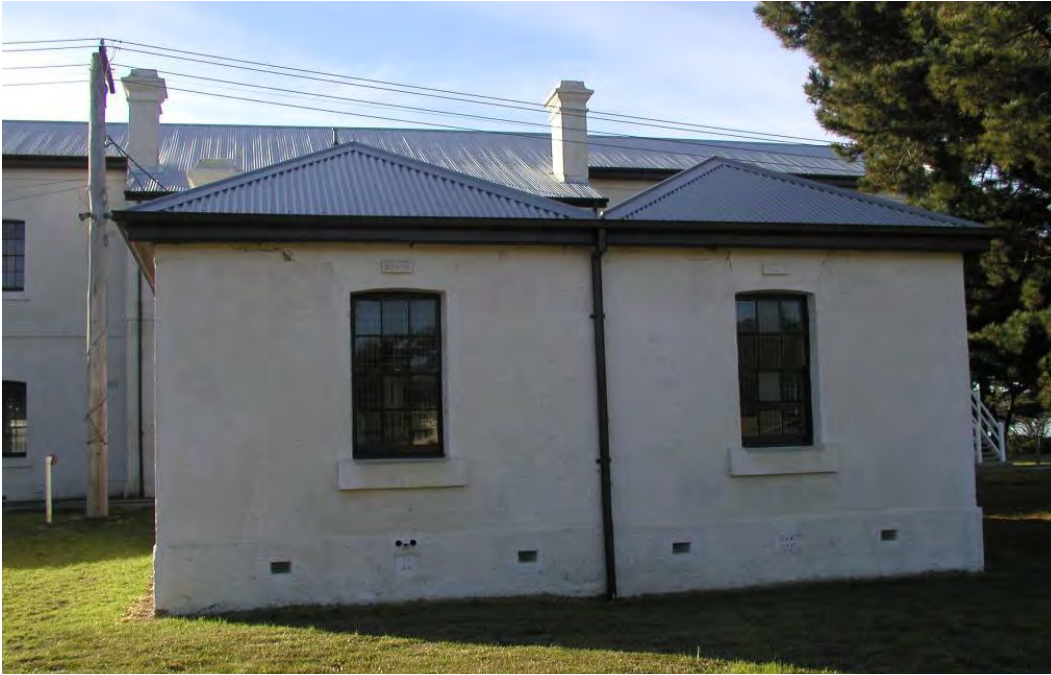
Figure 85 Building 21, rear (south) elevation. Building 22 (Hospital No. 4) can be seen behind.

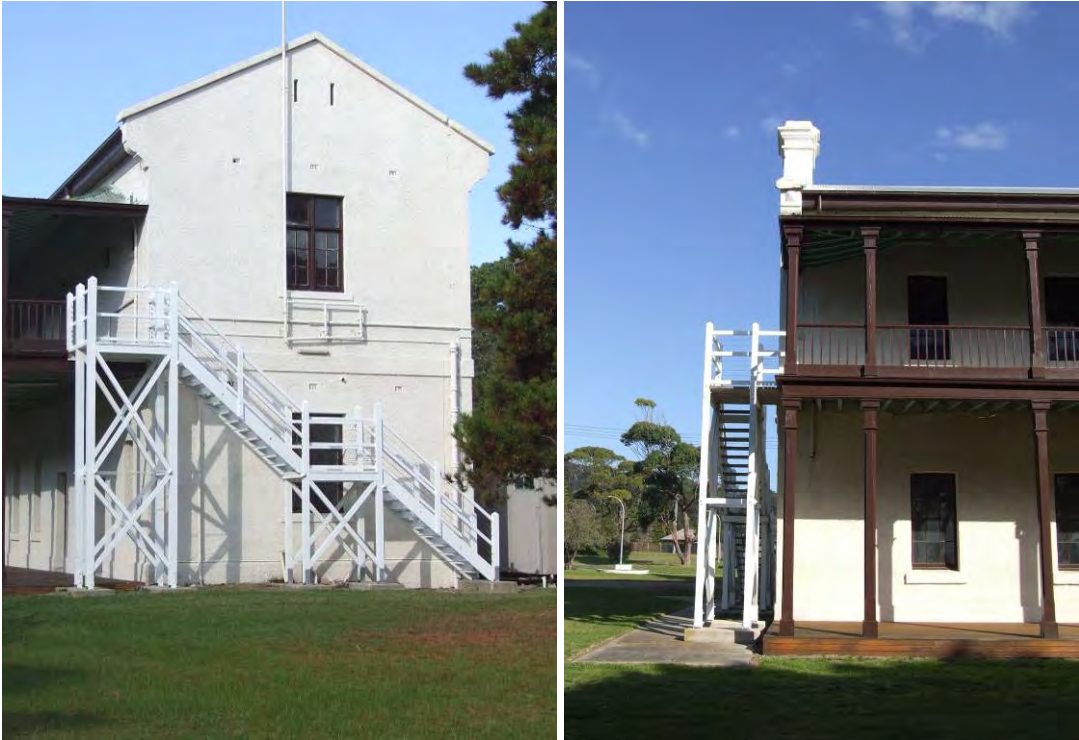
Figure 88 Building 22, from left: west elevation; eastern end of the north elevation.

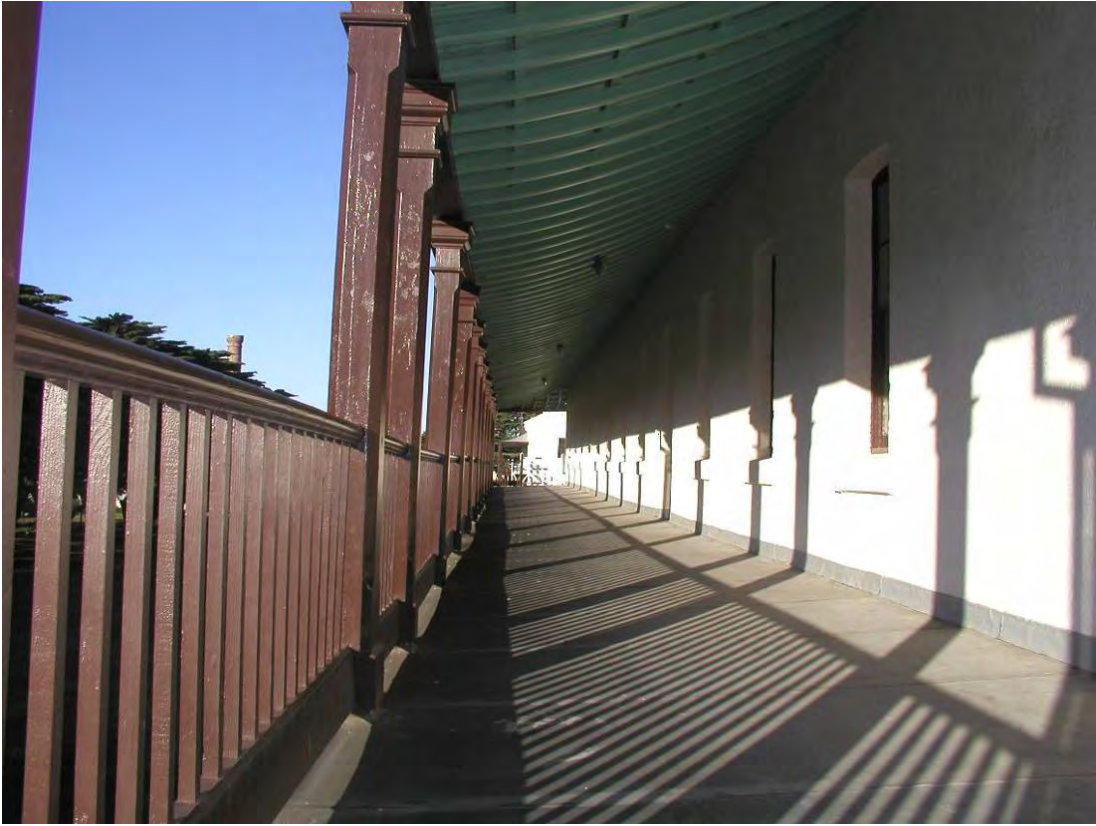
Figure 89 Building 22, looking east along the first floor verandah.

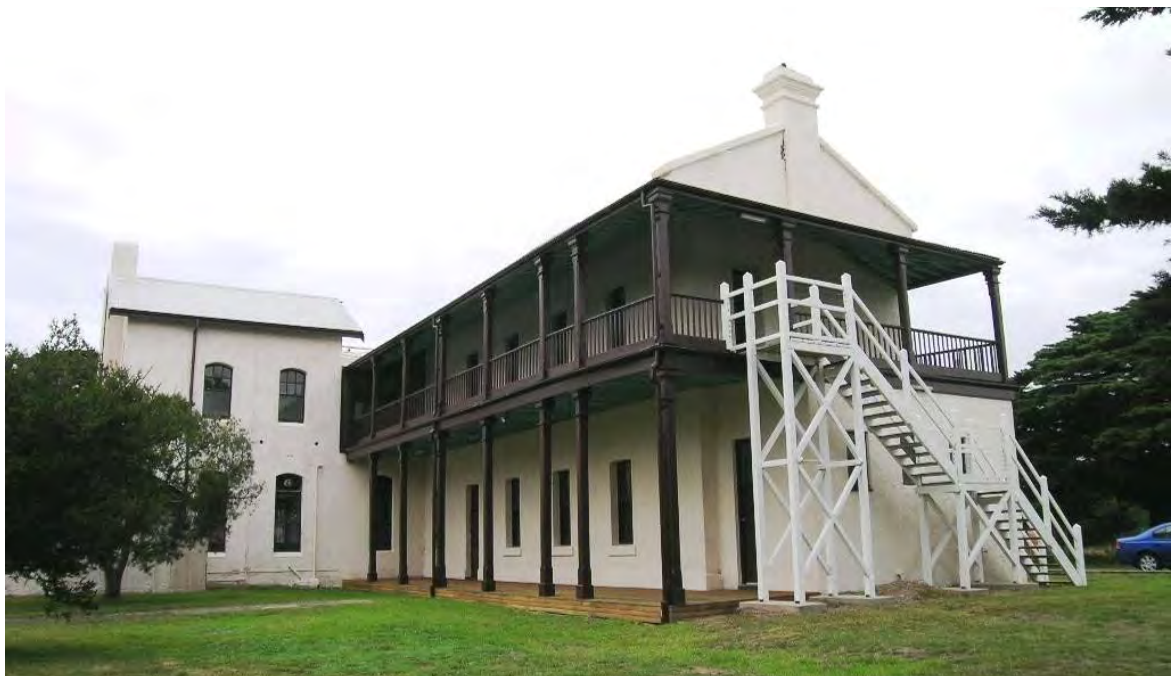
Figure 97 Building 25, northwest view showing the annexe appended to the centre of the building's north façade.

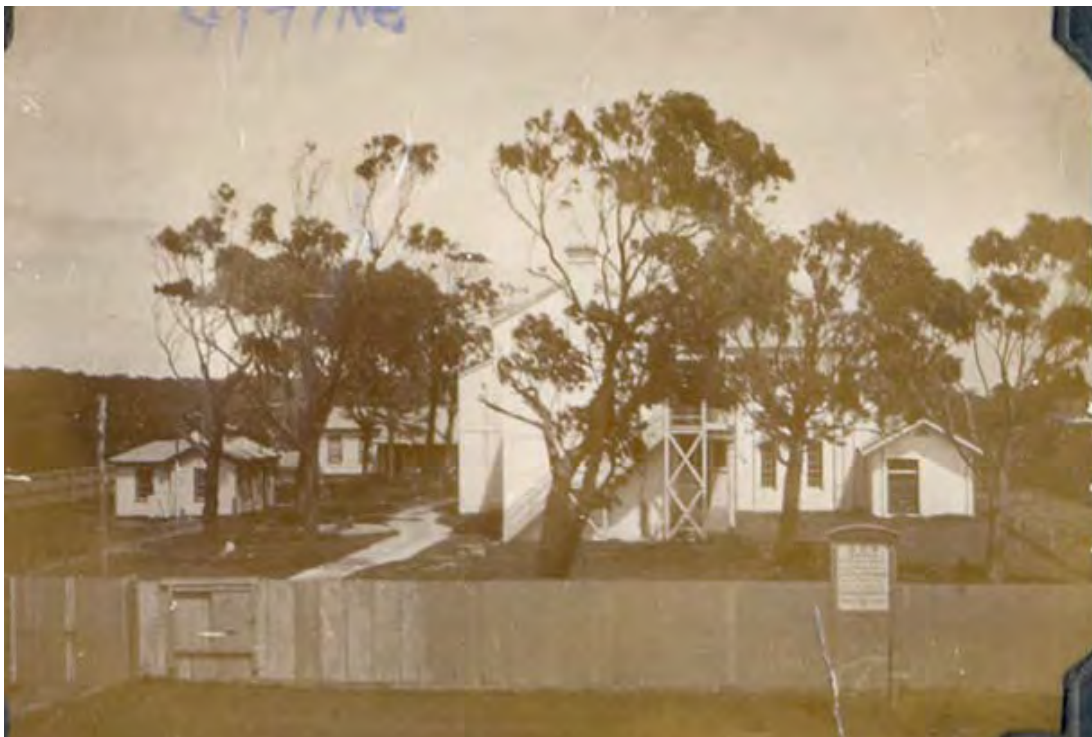
Figure 104 View of Building 25, from the same viewpoint, c.1920s, after the construction of the two-storey annexe (at right) and external stairs to building ends.

The builder for these works was a G. Waterman who signed contract no 92.3/163 for the sum of £1114.7.10 in January 1893. The annexe was completed a few months later at the end of April.<sup>54</sup> The works also included the provision of two underground water tanks some 9' deep and 14' in diameter. Figure 102 shows the original architectural drawing for these works and Figure 104 shows the considerable change in the building's original appearance.

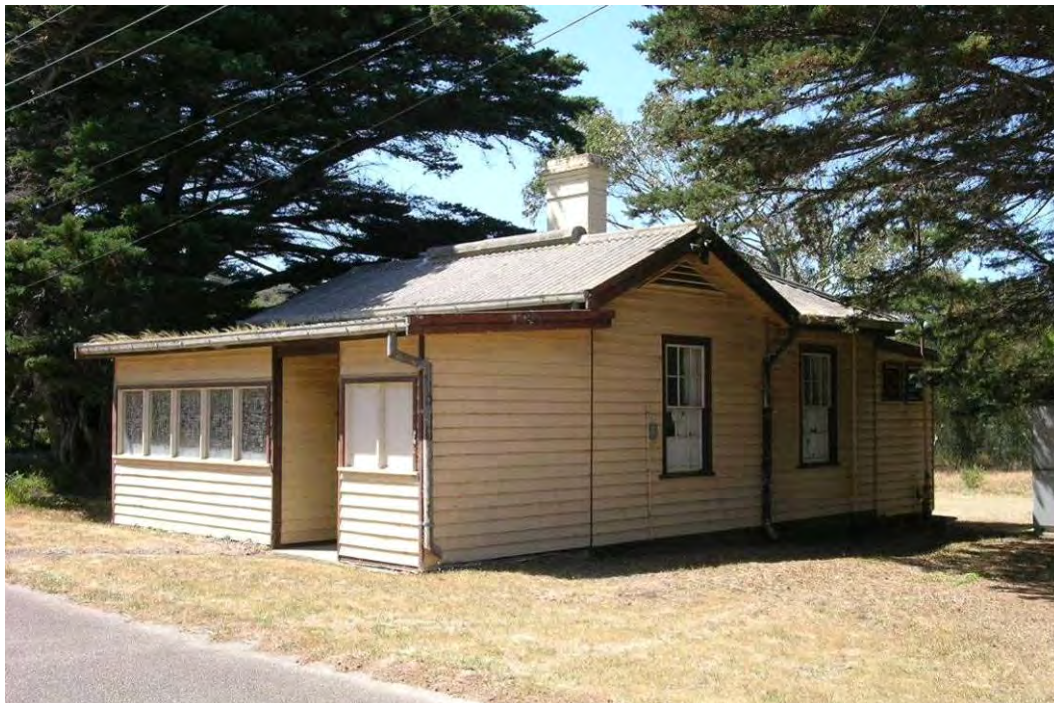
Figure 106 Building 26, showing the north and west elevations, from Bates Road. Note the later skillion roofed addition to the façade.

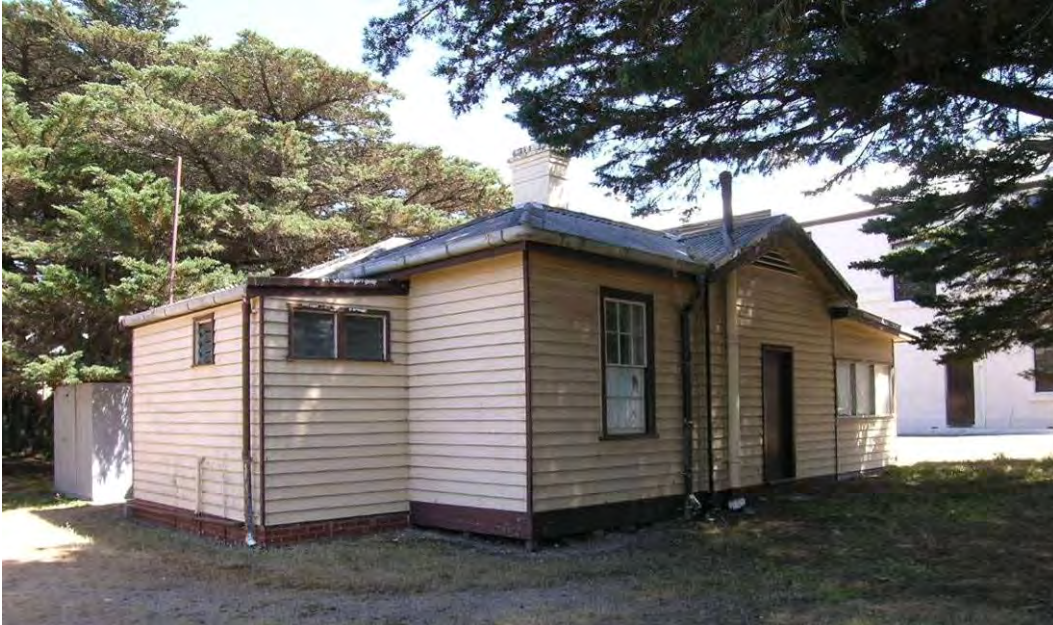
Figure 107 Building 26, showing the south and east elevations. Note the later skillion-roofed addition to the south elevation.

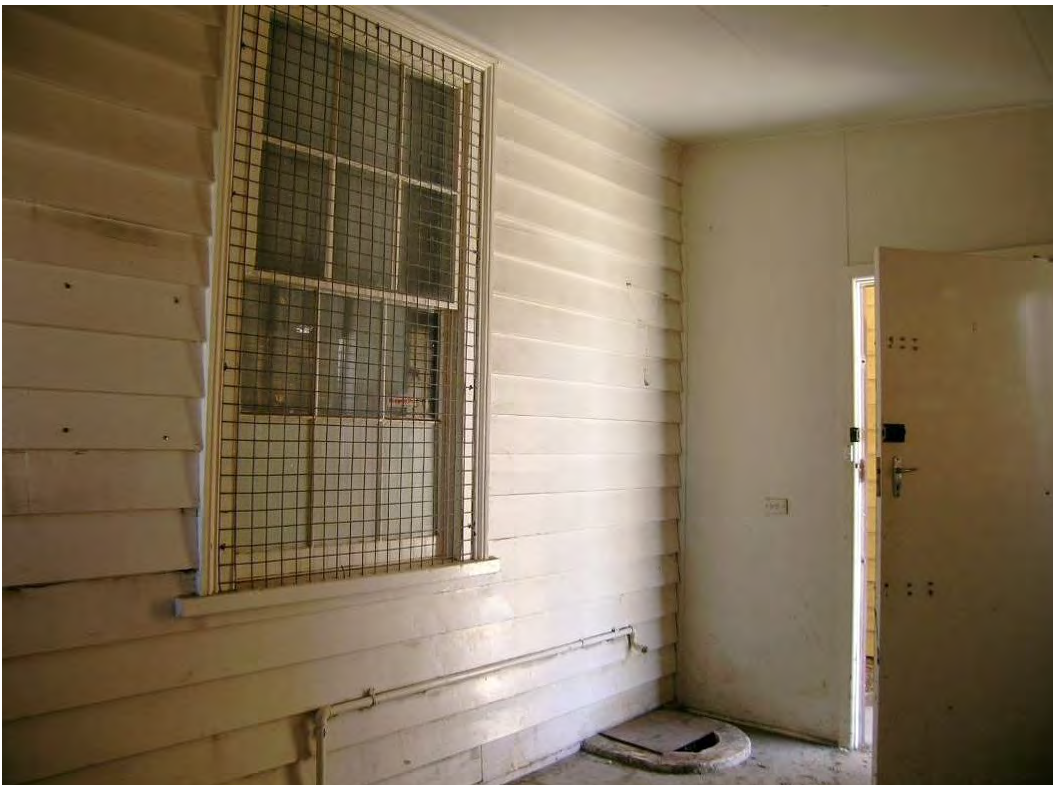
Figure 108 Building 26, showing the original façade now contained within the skillion-roofed addition. Compare with the photograph at Figure 111.

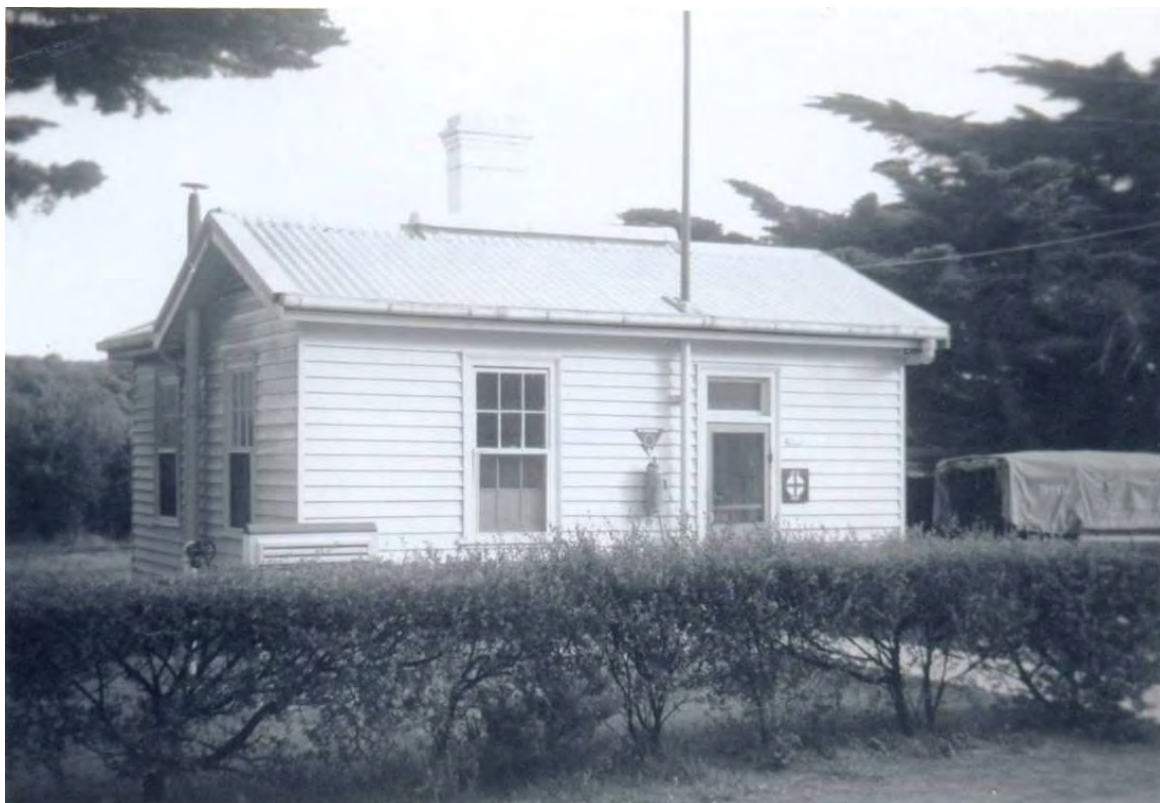
Figure 111 Building 26, photographed in May 1966.

When the Army moved onto the site this building was used as the kitchen for Other Ranks and is also identified as the Sergeant's Mess annexe (see Figure 111).

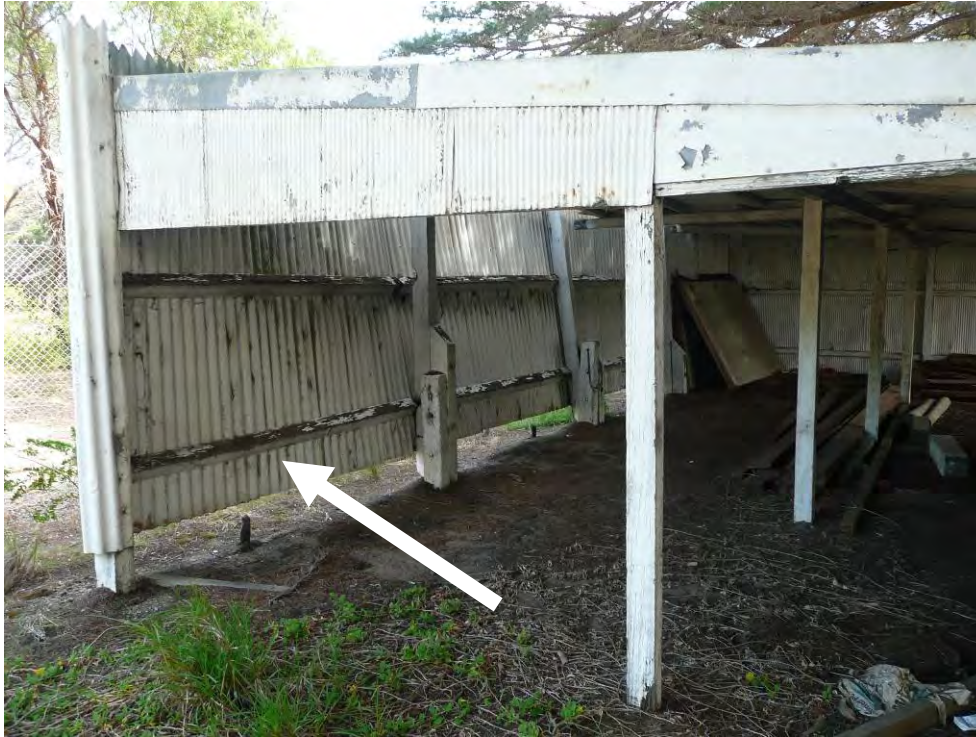
Figure 113 Building 27, showing the interior of the structure. The south elevation - indicated by the arrow - is thought to incorporate a portion of the original fencing to the Isolation Hospital compound.

Building 27 is a timber-framed skillion-roofed open shed form clad with corrugated iron, currently used as a carport. The southern wall of this structure is believed to contain a portion of the original fence to the Isolation Hospital compound, which was located in this position (Figure 113).

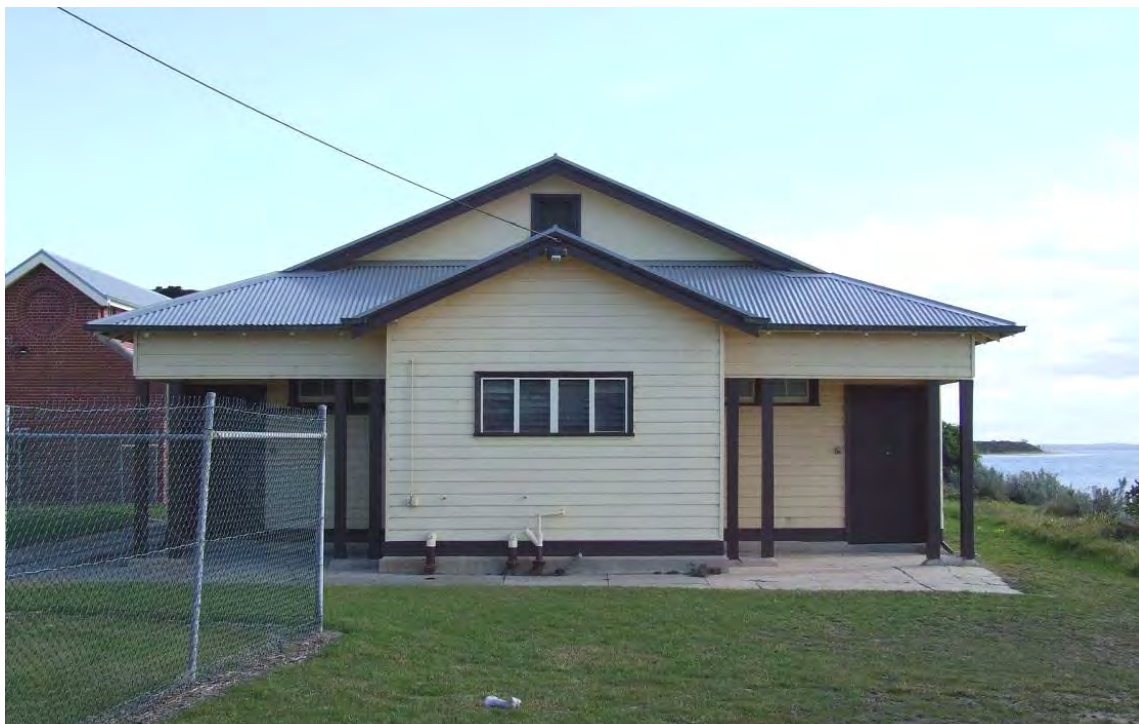
Figure 133 Building 60, showing the east (front) elevation. The toilet facilities are centrally located with flanking entrances to the segregated bathing facilities.
