**APPENDIX C      DATASHEETS - BUILDINGS OF PRIMARY SIGNIFICANCE**

QUARANTINE STATION, POINT NEPEAN

**BUILDING 1**

**PRIMARY NAME:** First Class Accommodation

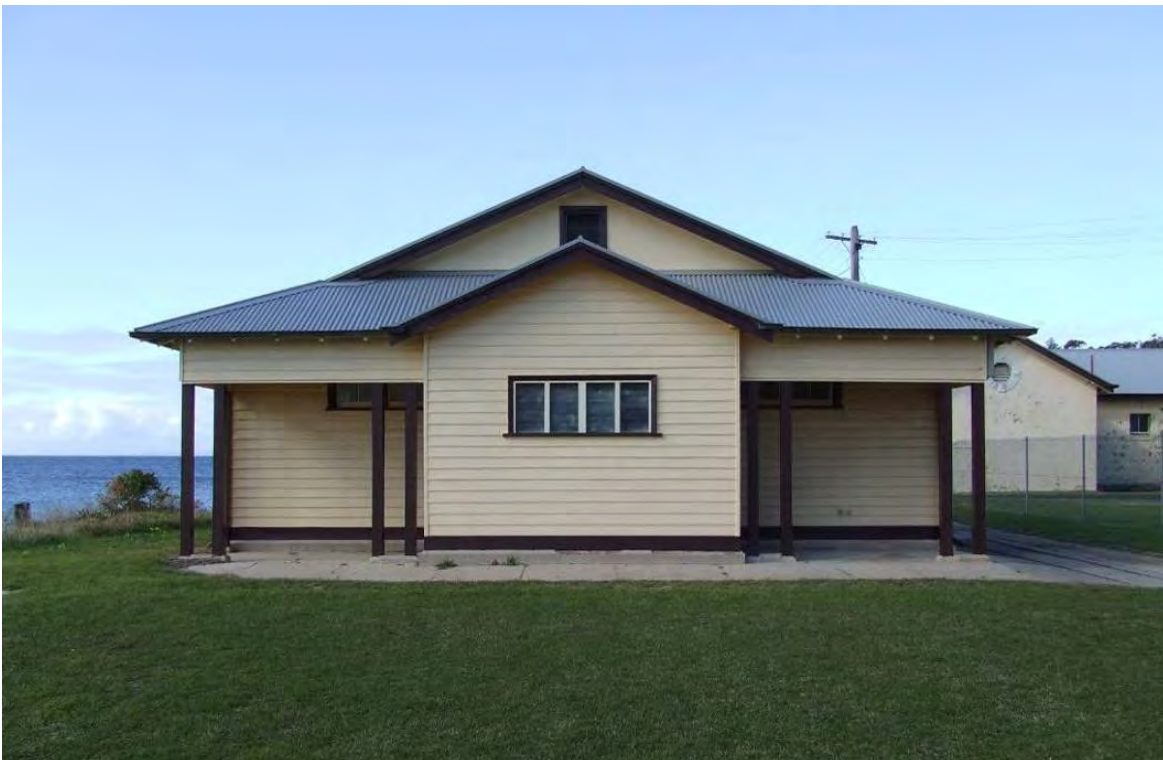
Figure 135 Building 60, showing the west (rear) elevation. The exit doors are located in the north and south walls of the central projecting bay.

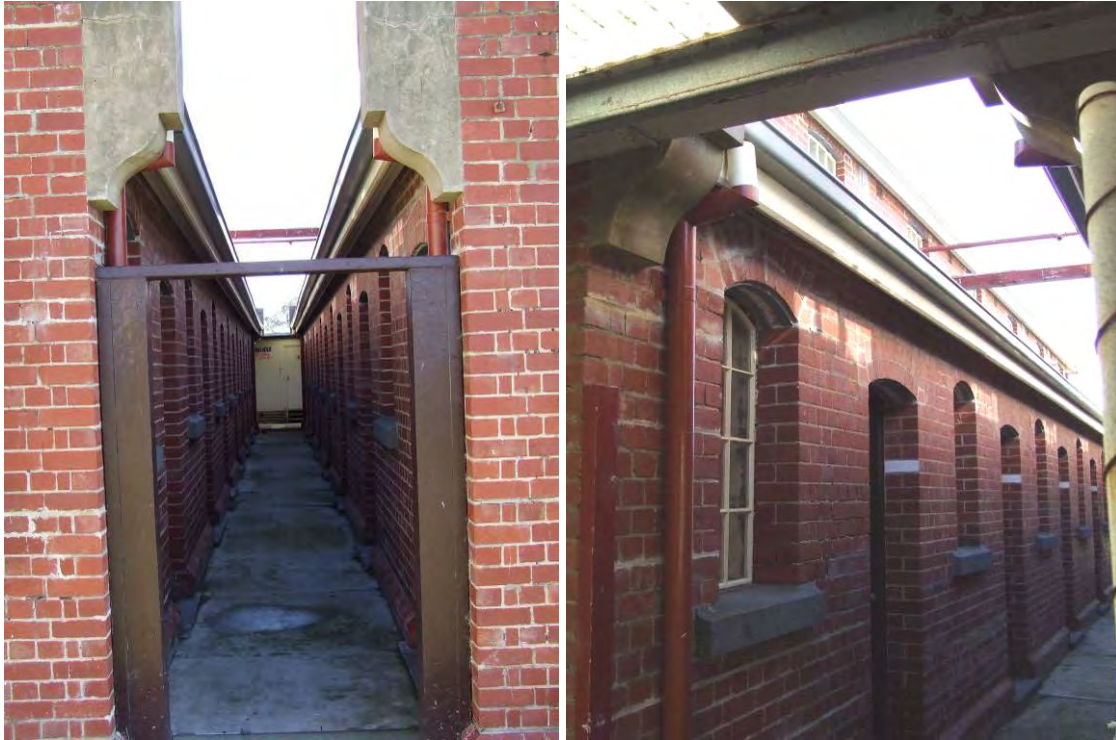
Figure 153 Buildings 63 and 64, from left: looking west down the central access way or 'alley' between the two bath houses; the steel-framed window forms and doorway detailing of Building 63. Note the recent repairs and strengthening works to the segmental brick window heads.

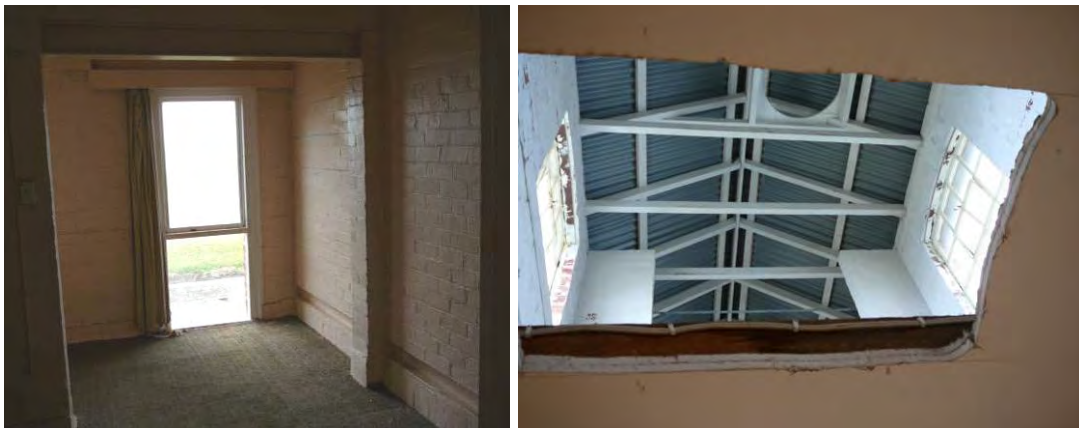
Figure 154 Building 63, from left: interior of one of the bathroom suites, later converted to accommodation; the lantern roof form above the bath chamber visible because of the removal of a section of the false ceiling.

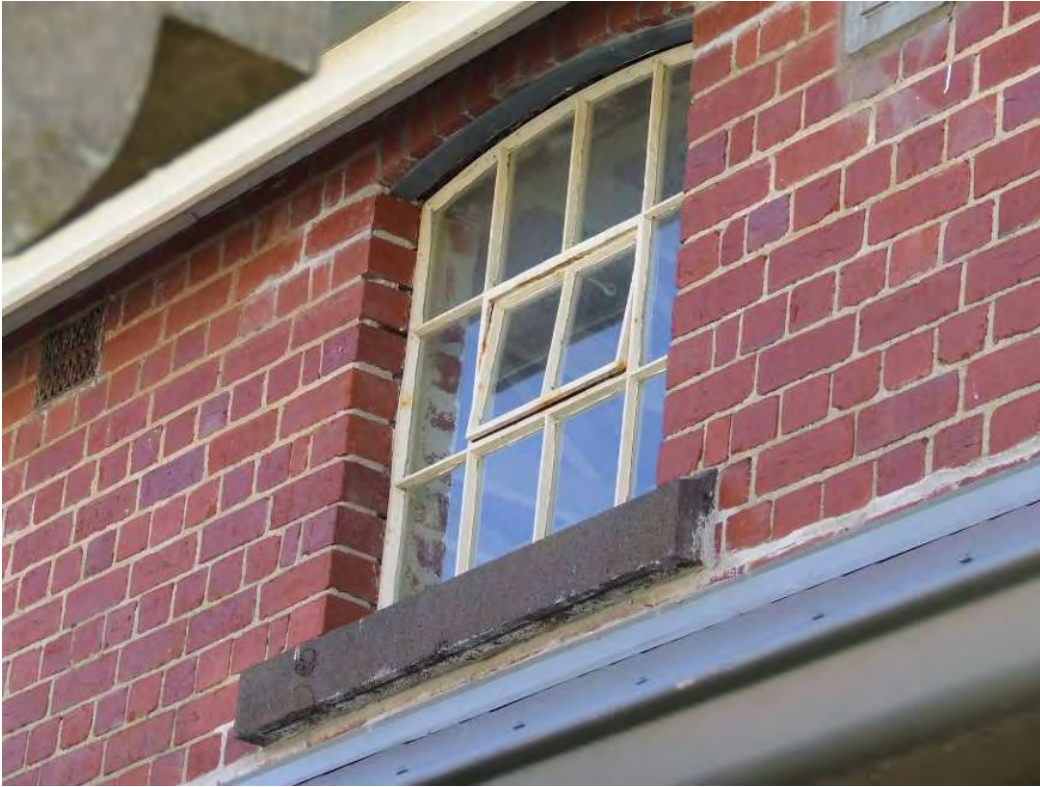
Figure 155 Building 63, showing one of the steel-framed clerestory windows with openable central element.

The building has recently been re-roofed in Colorbond sheet metal. Windows are steel-framed and multi-paned. Those to the lantern contain an openable element which operates on a central pivot (Figure 155). The external north entry doors were removed and infilled with a fully glazed awning sash window, during the period of Army use for accommodation purposes. The latter period also involved internal works including the removal of the bath fittings and alteration of the bath spaces to form small accommodation suites. Carpeting and lowered plaster ceilings were also installed throughout the building (Figure 154). The internal transverse walls retain the steel lintels at low level, although the former openings between bath cubicles have been bricked up.

The building has recently been reroofed in Colorbond sheet metal. Windows are steel framed and multi-paned. Those to the lantern contain an openable element which operates on a central pivot (Figure 155).

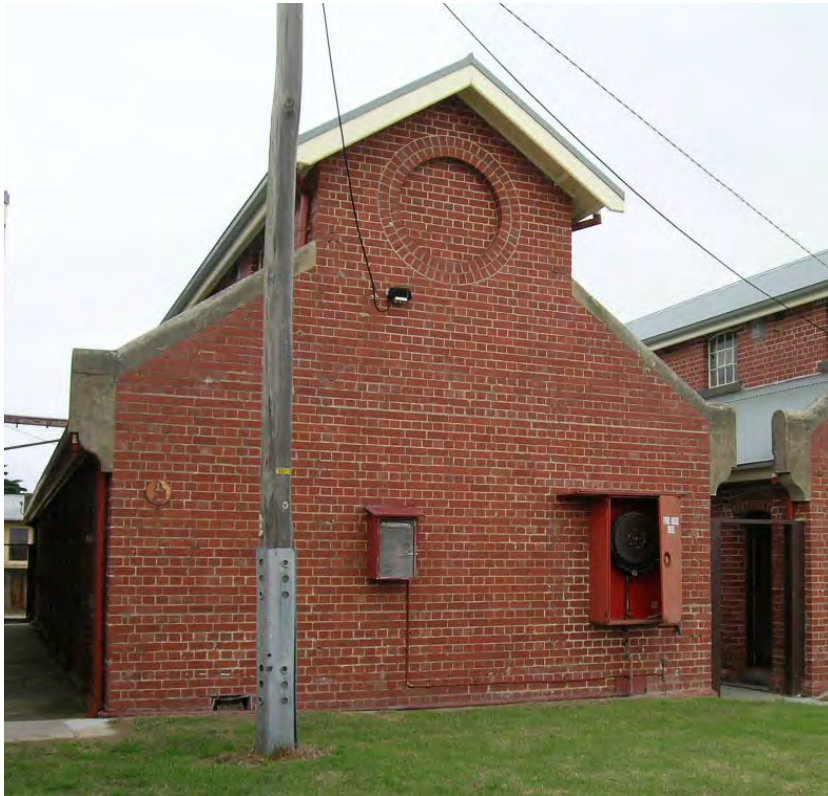
Figure 159 Building 64, detail of east elevation.

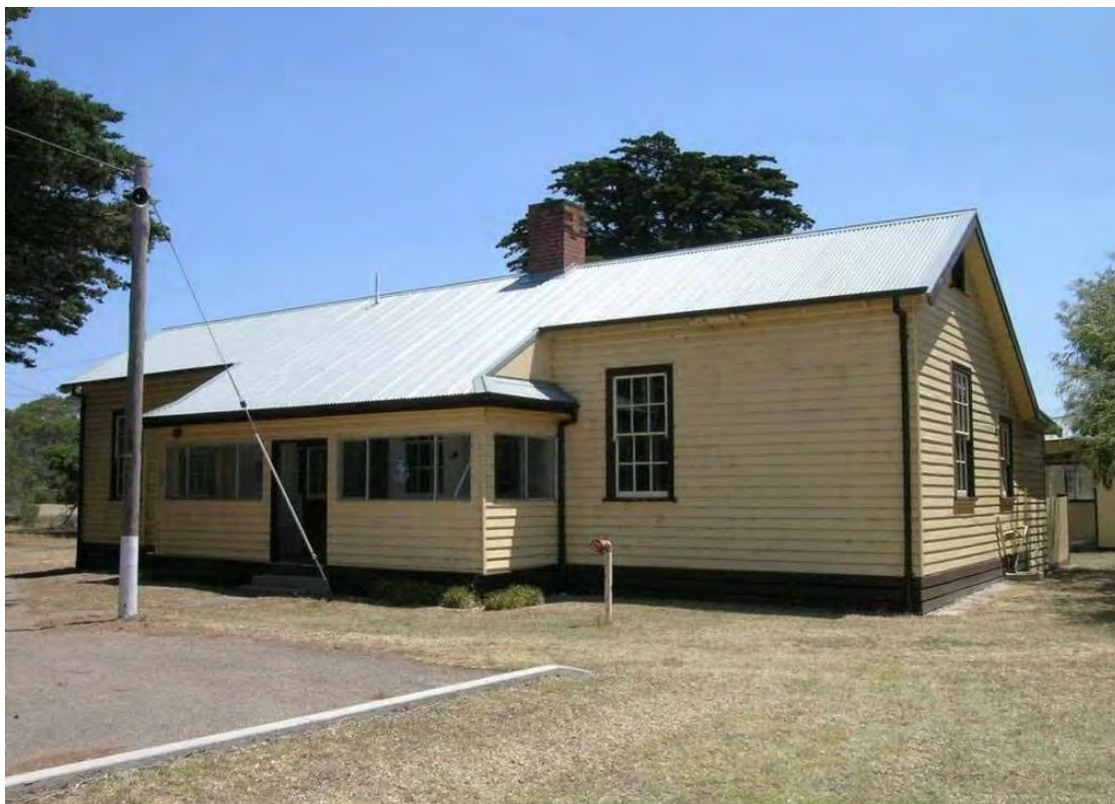
Figure 162 Building 65, showing the east (façade) and north elevation.

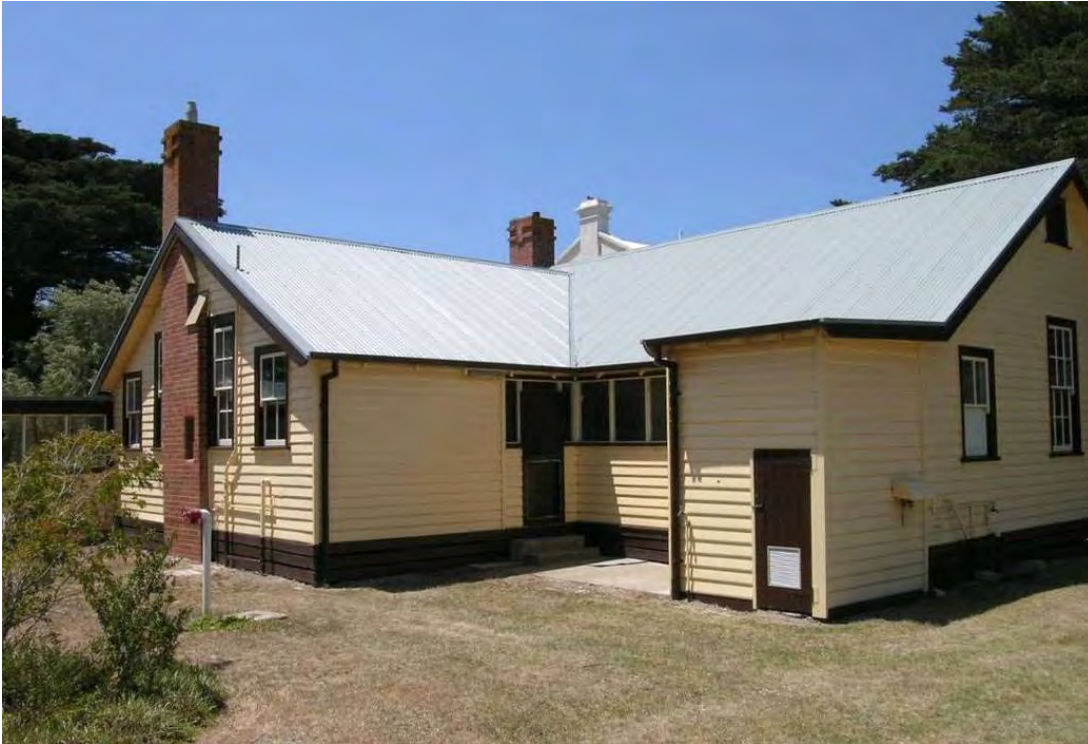
Figure 163 Building 65, showing the west elevation and part of the south elevation.

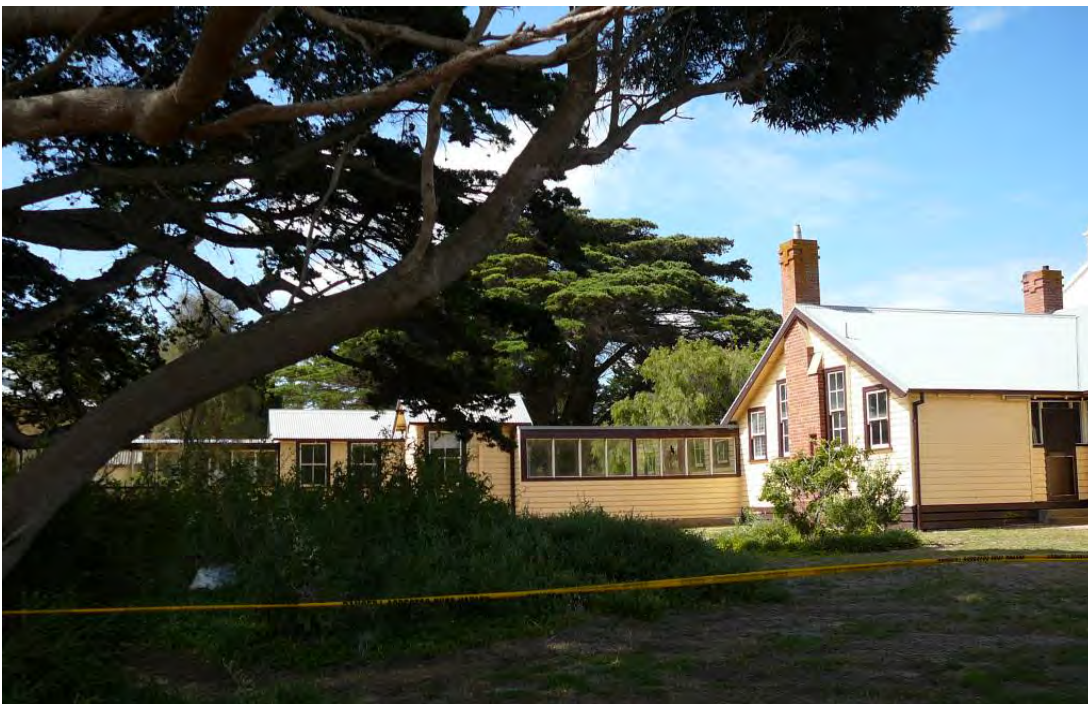
Figure 164 Building 65, showing its connection with Building 66. Note the covered way and the small servery – sited forward of the staff changing room. The covered way continued further west, connecting with Building 66. A high fence flanked the servery and changing room, dividing the administrative block from the hospital.

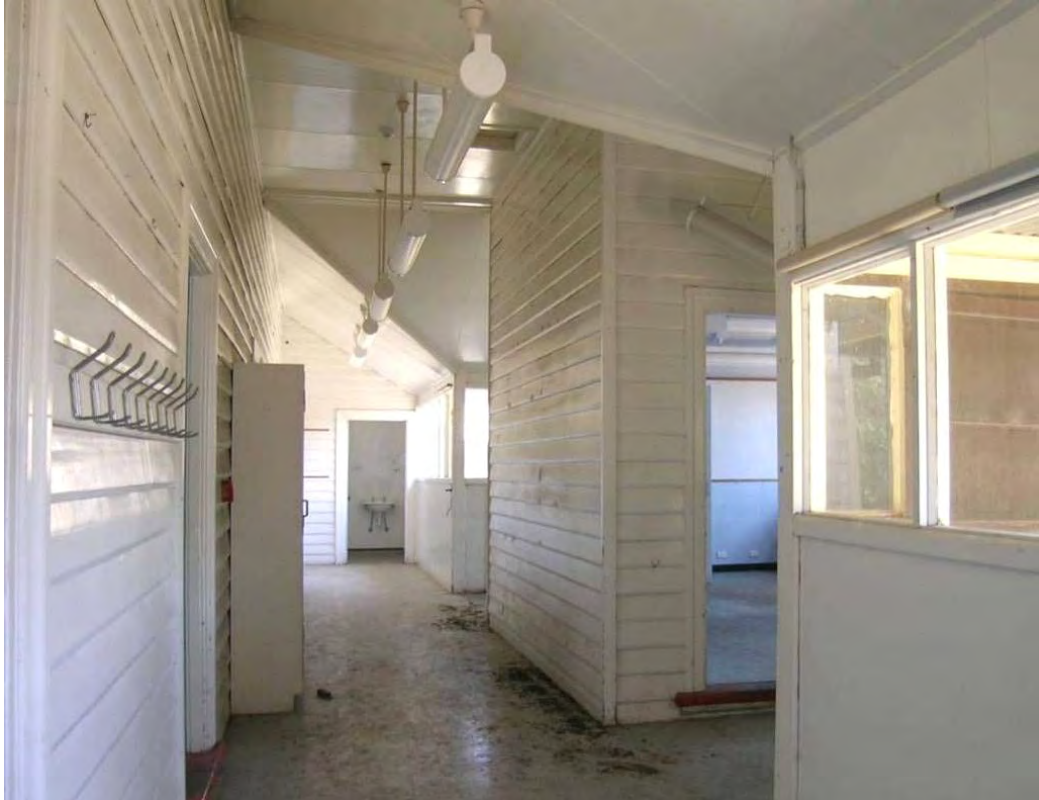
Figure 165 Building 65, looking south along the axis of the former open corridor. The kitchen is to the right.

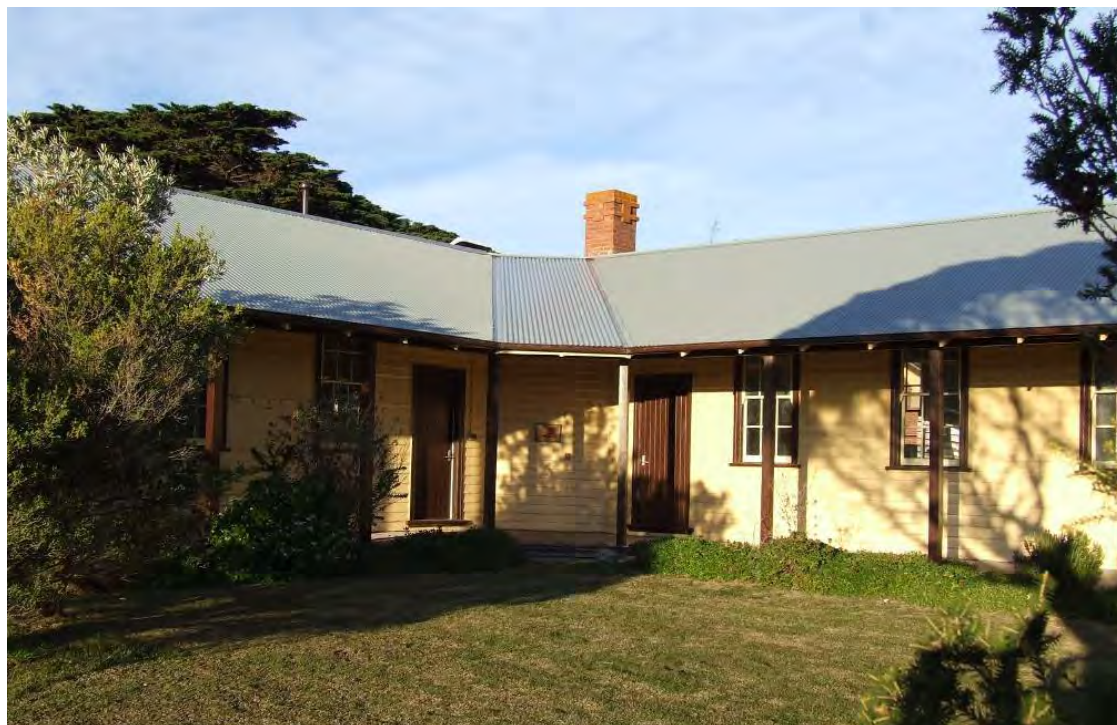
Figure 170 Building 66, looking east and showing the central garden area between the two ward blocks/wings. At the centre of the image is the wall of the Duty Room.

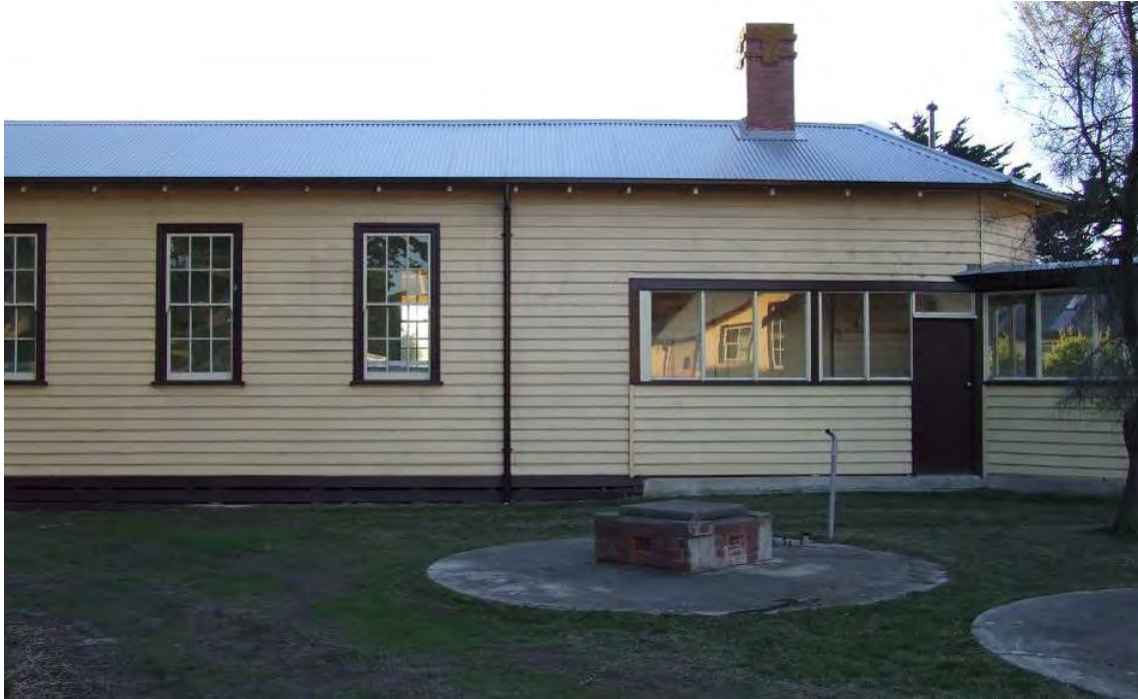
Figure 171 Building 66, showing one of the two isolation wards. The covered walkway – at right – originally joined an open verandah, later enclosed.

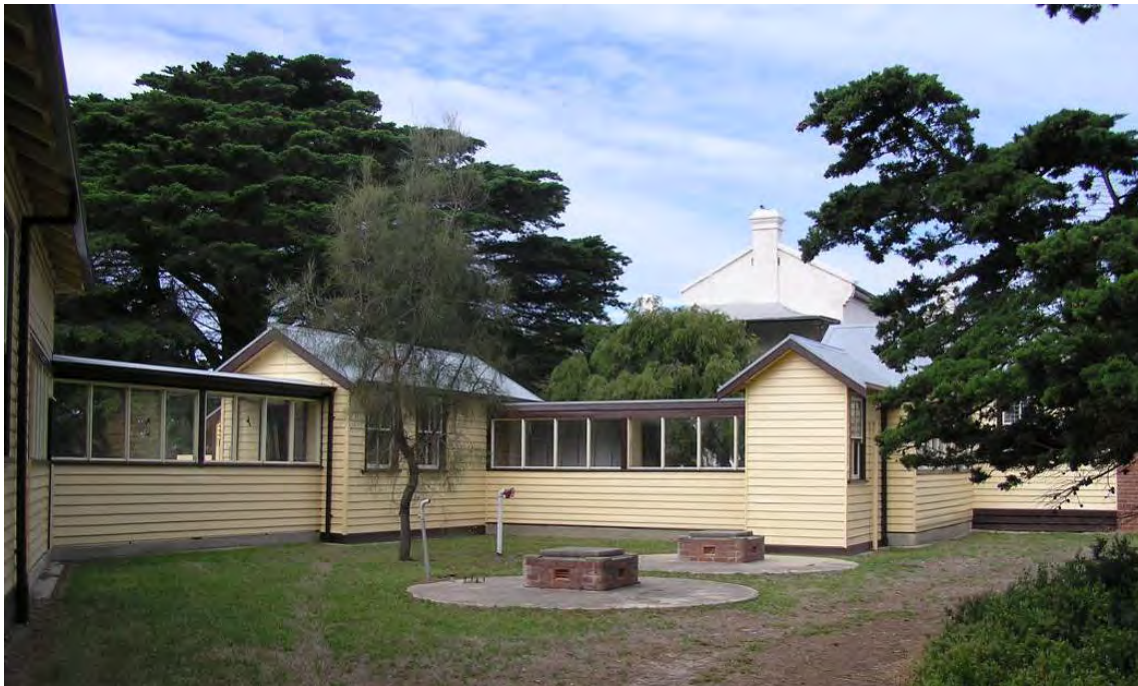
Figure 172 Building 66, looking east towards Building 65. The gable west end of Building 25 (Hospital No. 5) is in the background. The staff changing room and servery are the two interlinked structures. Note the two capped wells in the centre of the image.

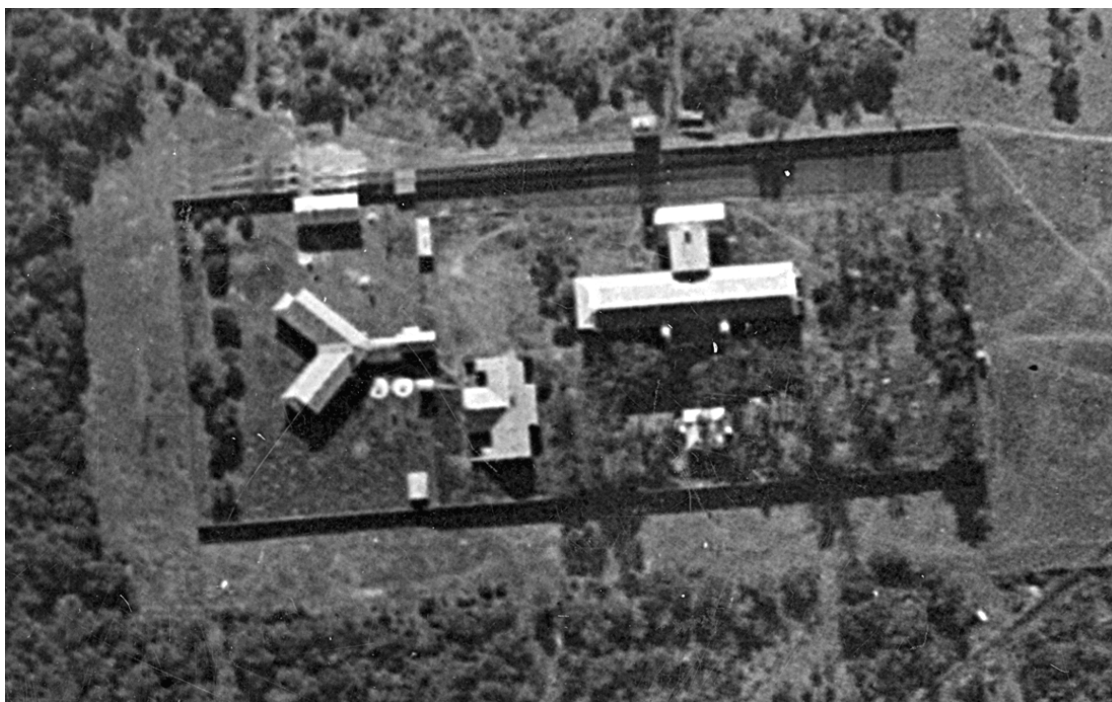
Figure 173 Detail from the c.1922 aerial showing the Isolation Compound, enclosed by a high corrugated iron fence. Building 66 is at left.

This building is also the last to have been constructed within the Isolation compound (see Figure 173). This compound had first been established around the mid-1880s with the conversion of Hospital No. 5 to these very specific purposes, and was substantially augmented by the construction of an Isolation Hospital and associated Administration building in c.1912. The Mortuary was located within the 'inner' fenced part of this compound, a short distance to the north of the Isolation Hospital building (Building 66).

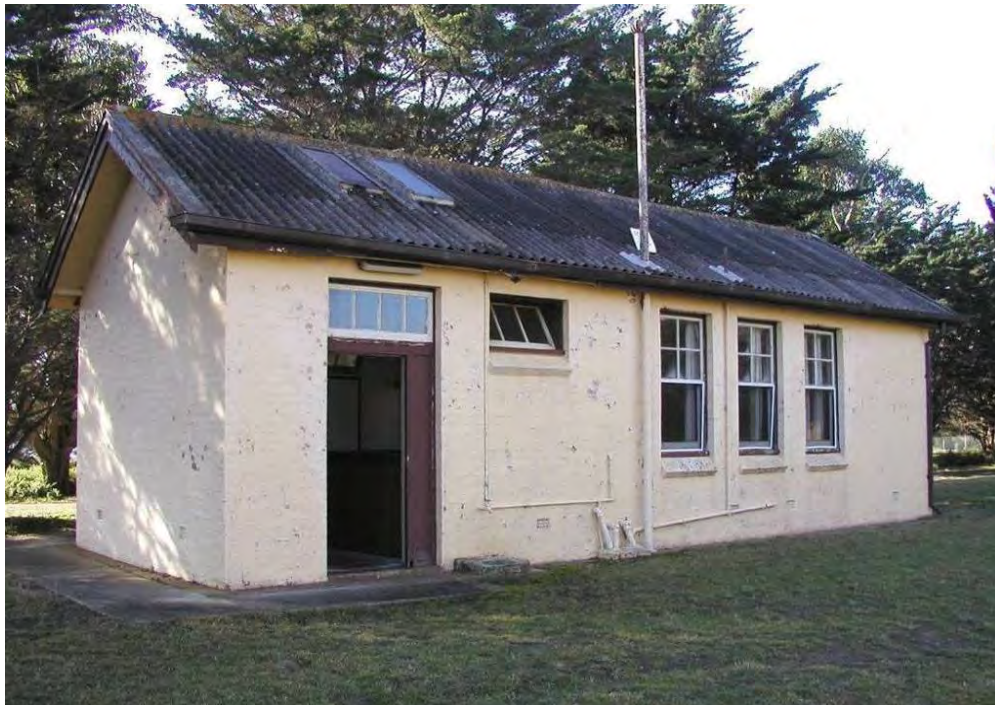
Figure 176 Building 67, south elevation. The open door leads into the former mortuary room.

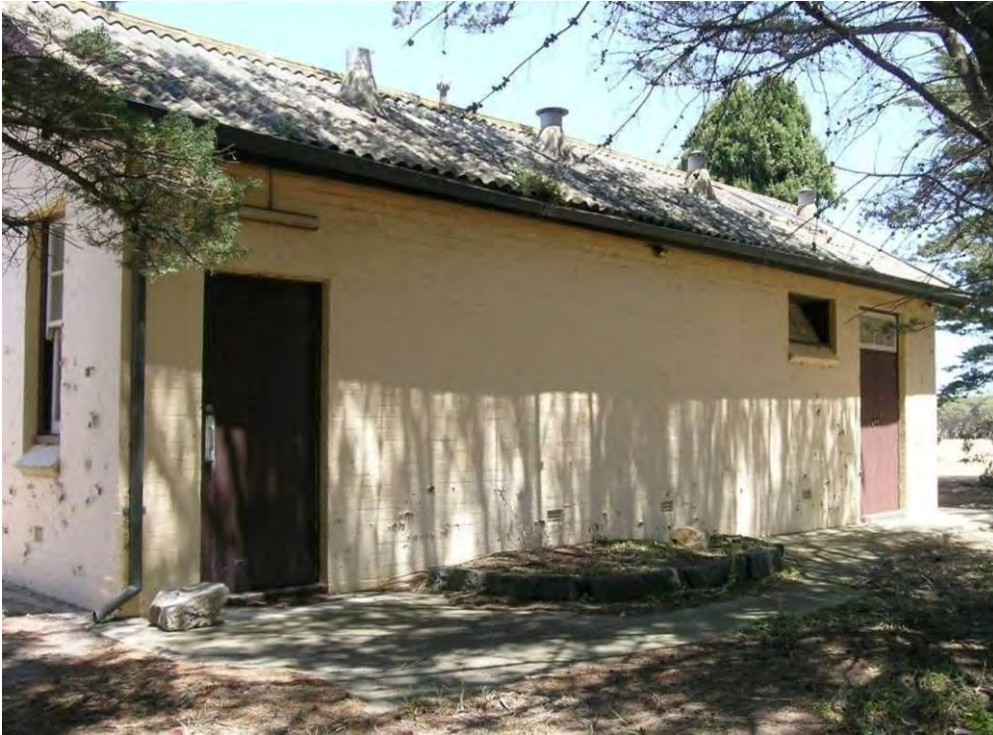
Figure 177 Building 67, north elevation. The door at left provides access to a small lobby to the former laboratory and the door at right provides access to the former mortuary room.

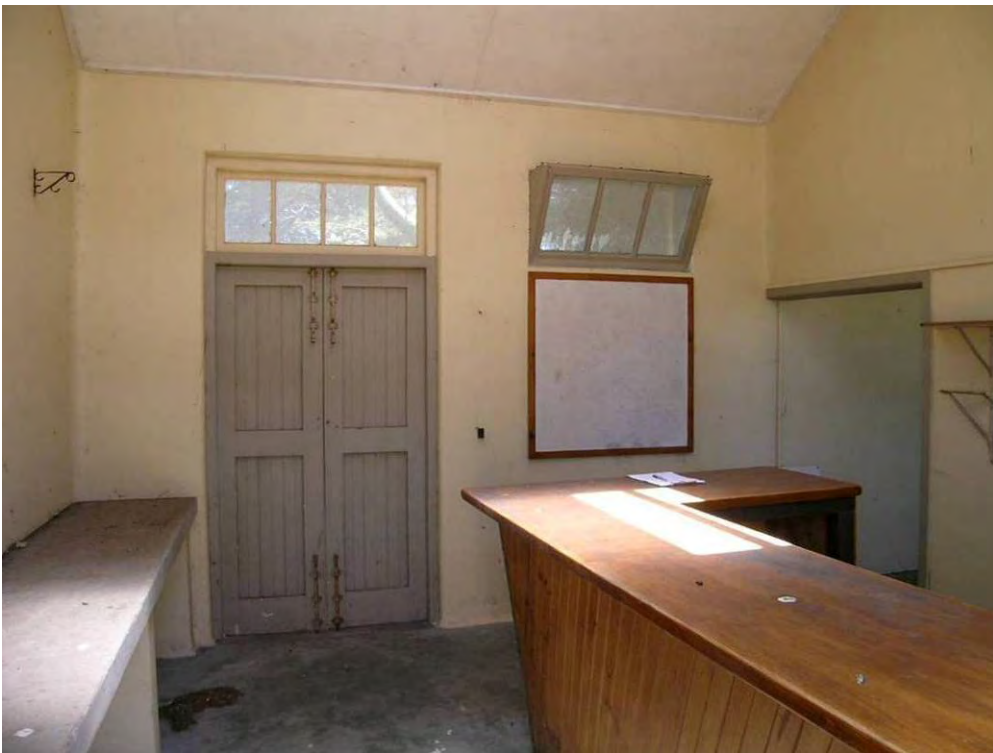
Figure 178 Building 67, interior of the former mortuary. The mortuary slab to the west wall has been retained in-situ.

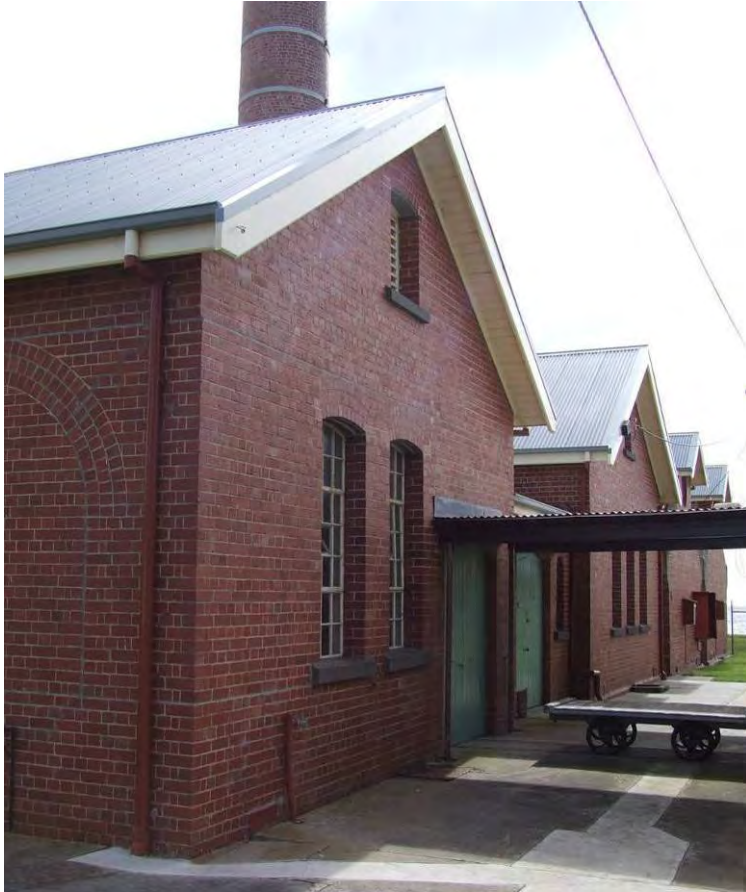
Figure 181 Building 84, east elevation. Note the tram trolley used for the transfer of infected luggage from Building 61 (to right side of picture) to the subject building. The bath houses (Buildings 63 and 64) are in the background.

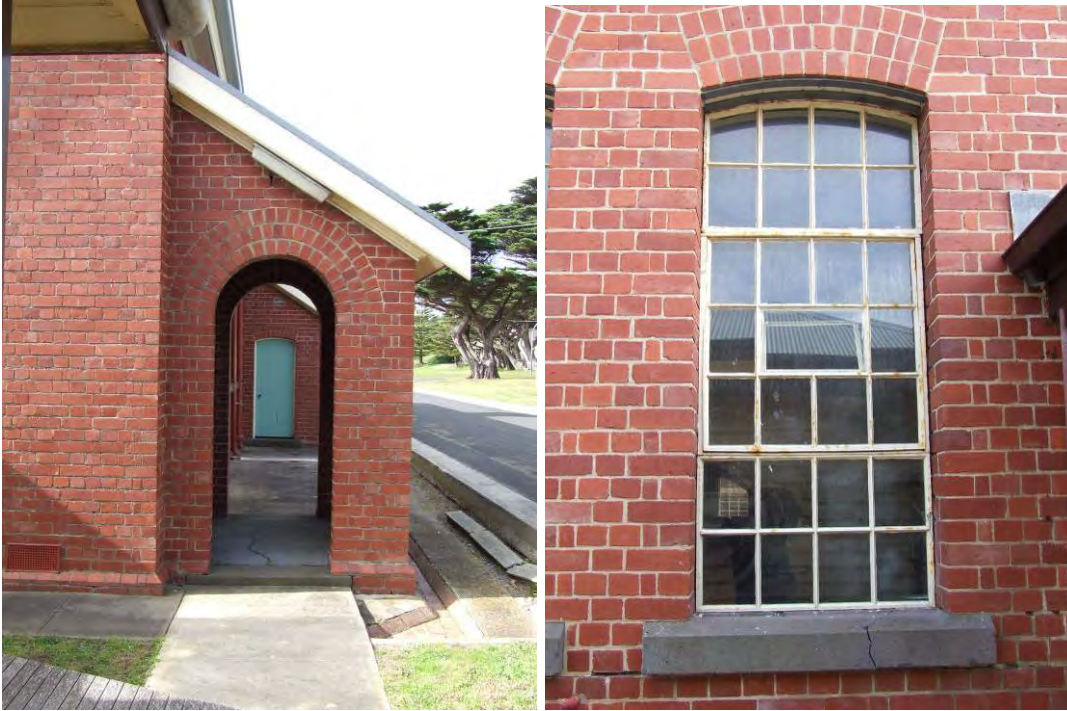
Figure 183 Building 84, from left: detail of brick semi-circular arch to west elevation; segmental arch window head over iron-framed multi-paned window to the east elevation.

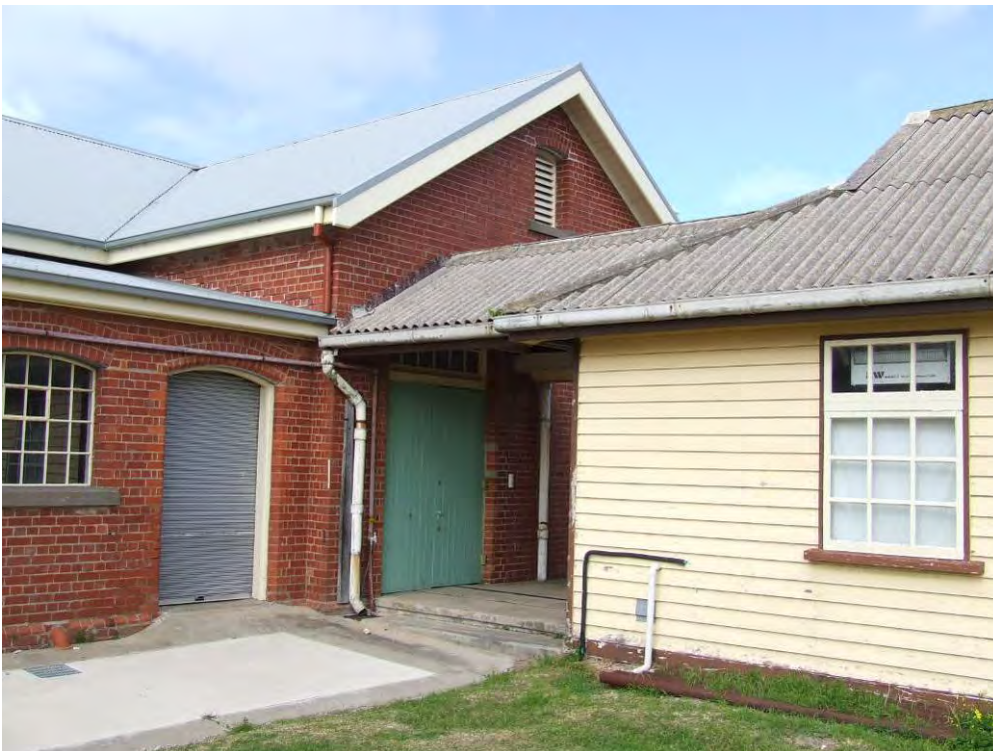
Figure 184 Building 84, west elevation showing the interconnection with Building 62, to where the clean luggage would be transferred by tram tray after the disinfection process.

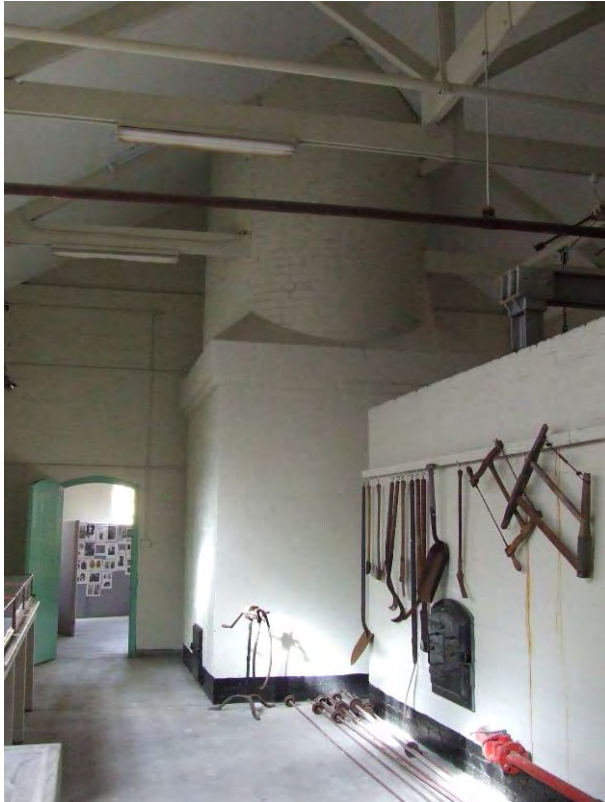
Figure 185 Building 84, interior showing the base of the chimney and part of the museum display.

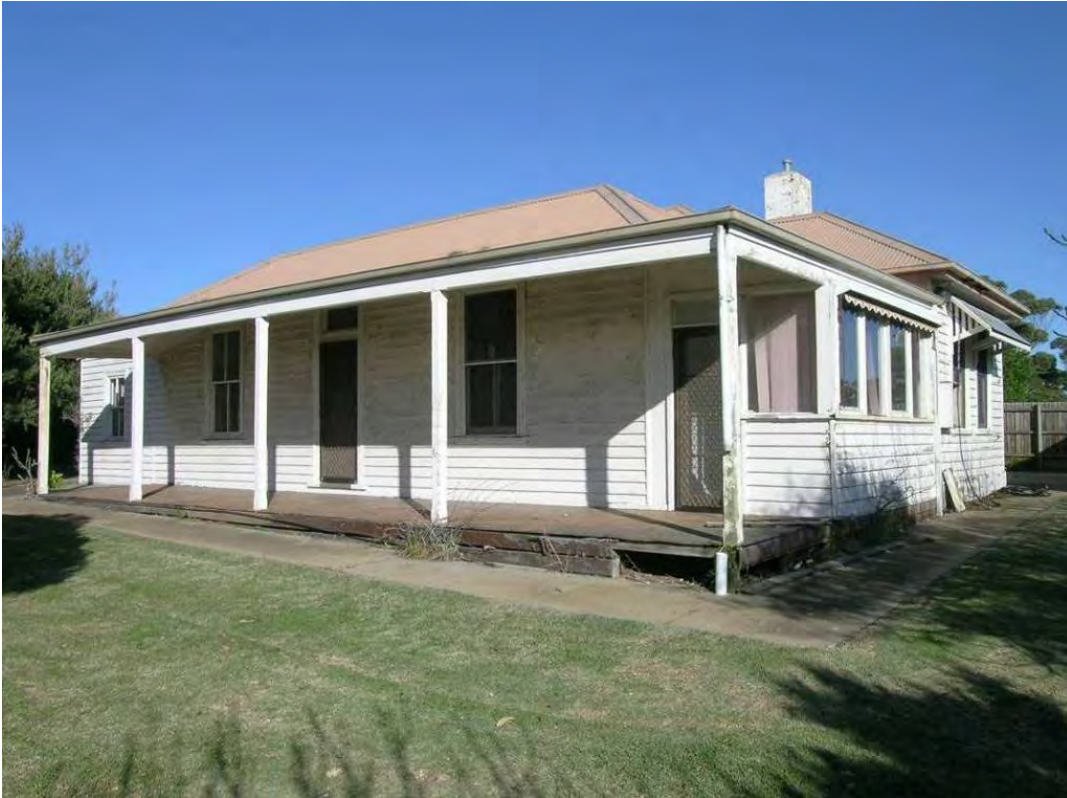
Figure 192 Building 966, showing the main north façade and part of the west elevation.  
Source: Courtesy Point Nepean Community Trust.

Formerly there was a bathroom sited in a skillion roofed structure appended to the west elevation. This was subsequently removed, and by 1917, as shown in Figure 196, the verandah was extended to return to adjoin the western extension – of the dining room in the former location of the kitchen. As contemporary photographs show, this section of the verandah has subsequently been infilled (Figure 192).

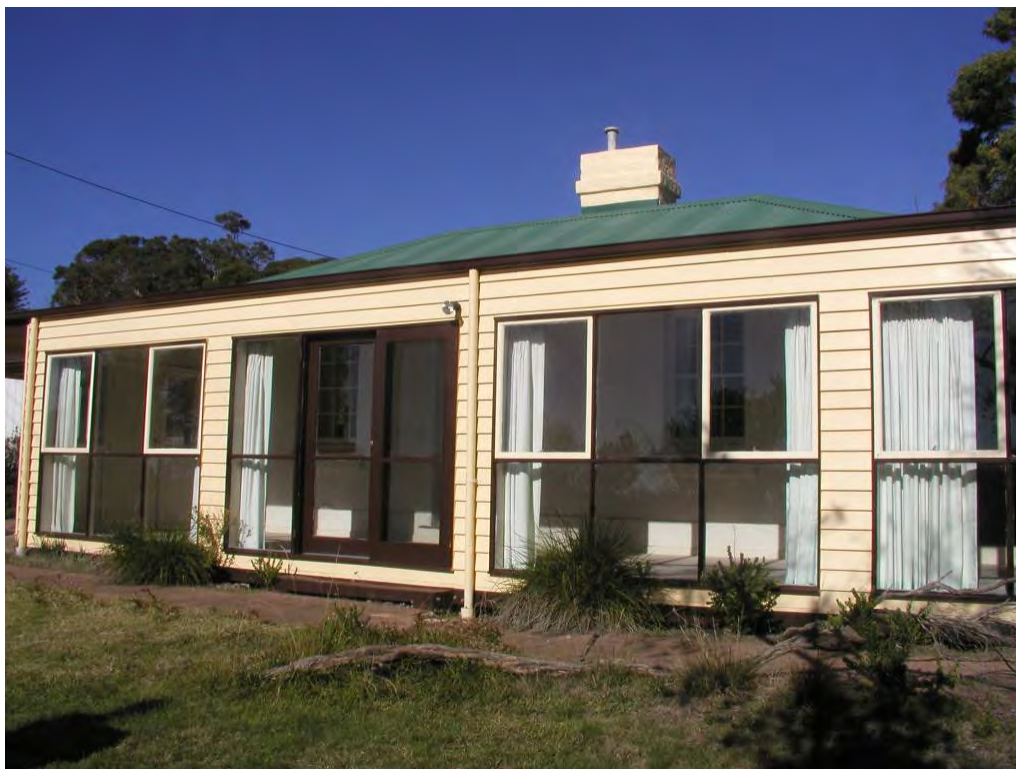
Figure 198 Building 1035, façade. Note the earlier cottage façade, visible behind.

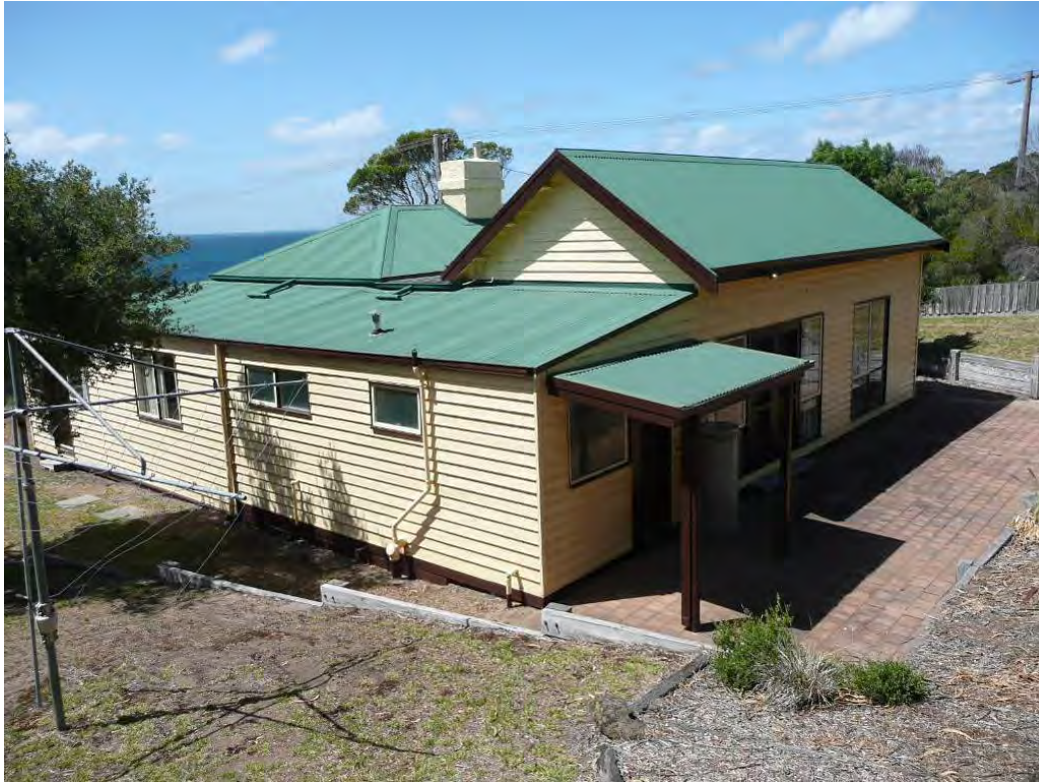
Figure 199 Building 1035, west and south elevations. The photograph clearly shows the phases of development, evident in the different roof forms.

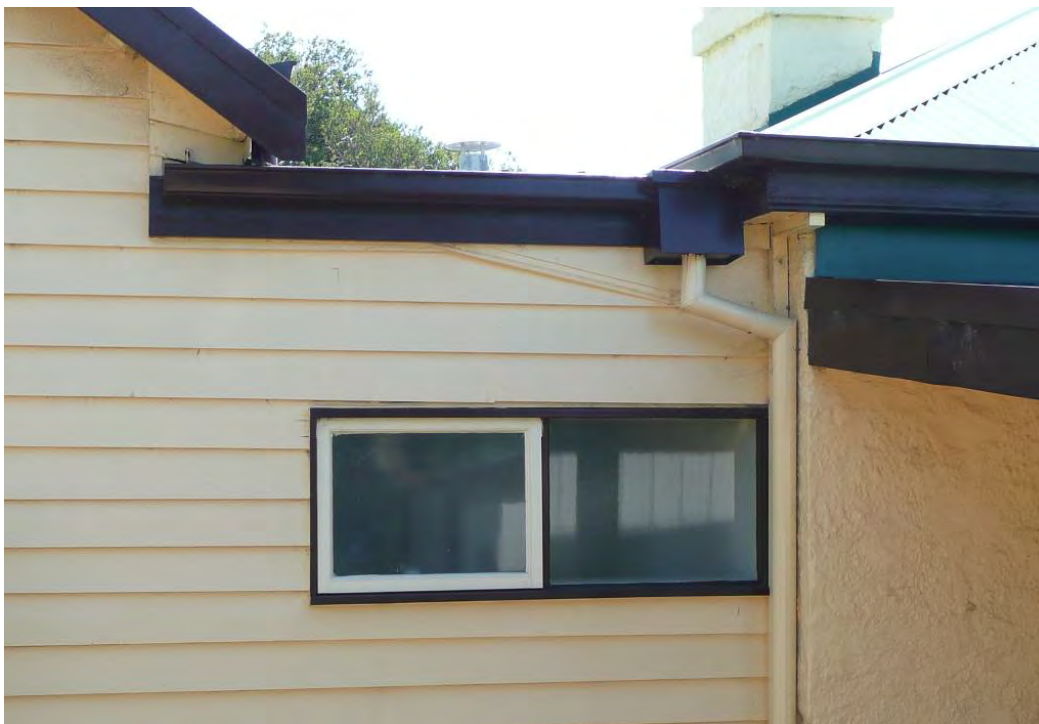
Figure 200 Building 1035, detail of the east elevation, showing the junction between the two phases of building with the verandah form of the timber addition expressed.

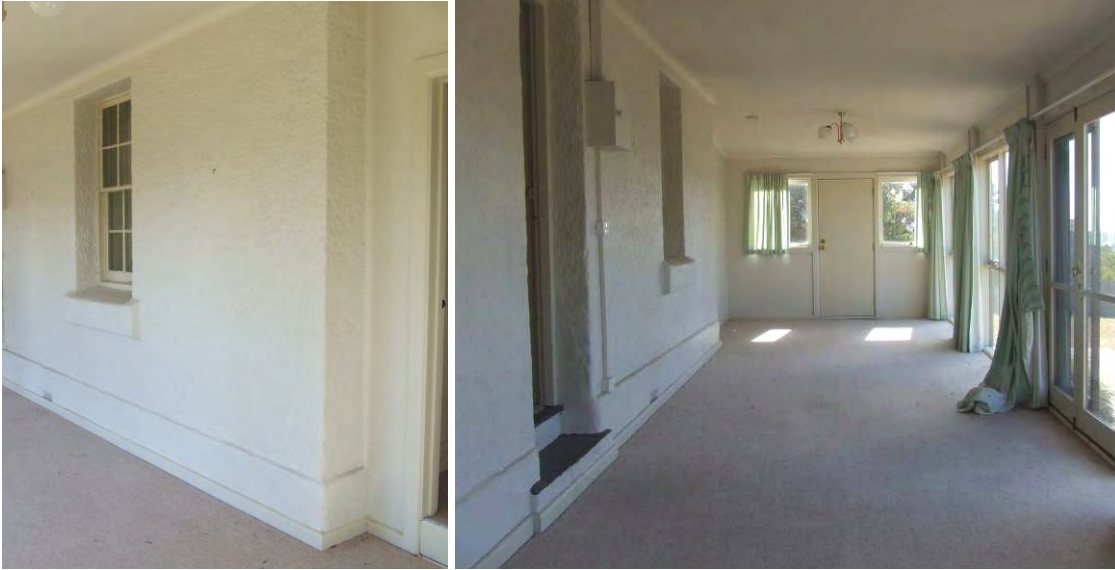
Figure 201 Building 1035, from left: original window of the 1857-58 cottage, now enclosed within the verandah; the enclosed verandah looking west. The original front door opening is at left.

Building 1035 is a composite structure. Originally it comprised a two room rendered stone cottage with a central double-sided chimney (Figure 202) and hipped roof. There were only two windows, one to either side of the door in the (north) façade (Figure 201). A modern window has subsequently been inserted into the east elevation. The windows are timber-framed and double hung windows with multi-paned sashes. The cottage has subsequently been enclosed by timber additions.

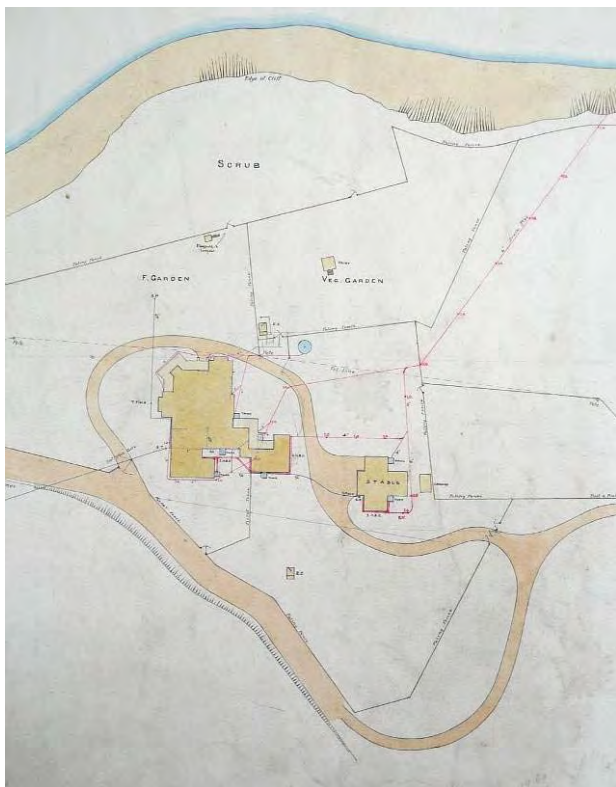
Figure 210 [Quarantine Station Point Nepean]. Detail of Block Plan, June 1901. Note also that the stables (Building 73) had been constructed by that time and the roadway from the main entry had a more circuitous route than at present. Source: National Archives of Australia.

In turn this building was replaced by a single-storey timber residence in 1899, the present Building 1038. It has not been established how much of either of the two earlier structures were incorporated into this third building on the site but the contract drawings appear to show the re-use of a two-roomed section of an earlier building - Kitchen and Bedroom 5 on the plan drawing - and the filling-in of an existing cellar, the extensive outline of which is dotted on the plan (Figure 208 and Figure 209). The provenance of what is known as Building 71 (the oddly placed structure on the south-east corner of the main Building 1038) is less clear. A Block Plan dating to June 1901 clearly shows this structure in its present position, although the contract drawing plan only shows a rough penciled outline along with the penciled words 'DEMOLISH'. This evidently did not occur (Figure 210).
