# **PARKS VICTORIA TECHNICAL SERIES**

**NUMBER 36**

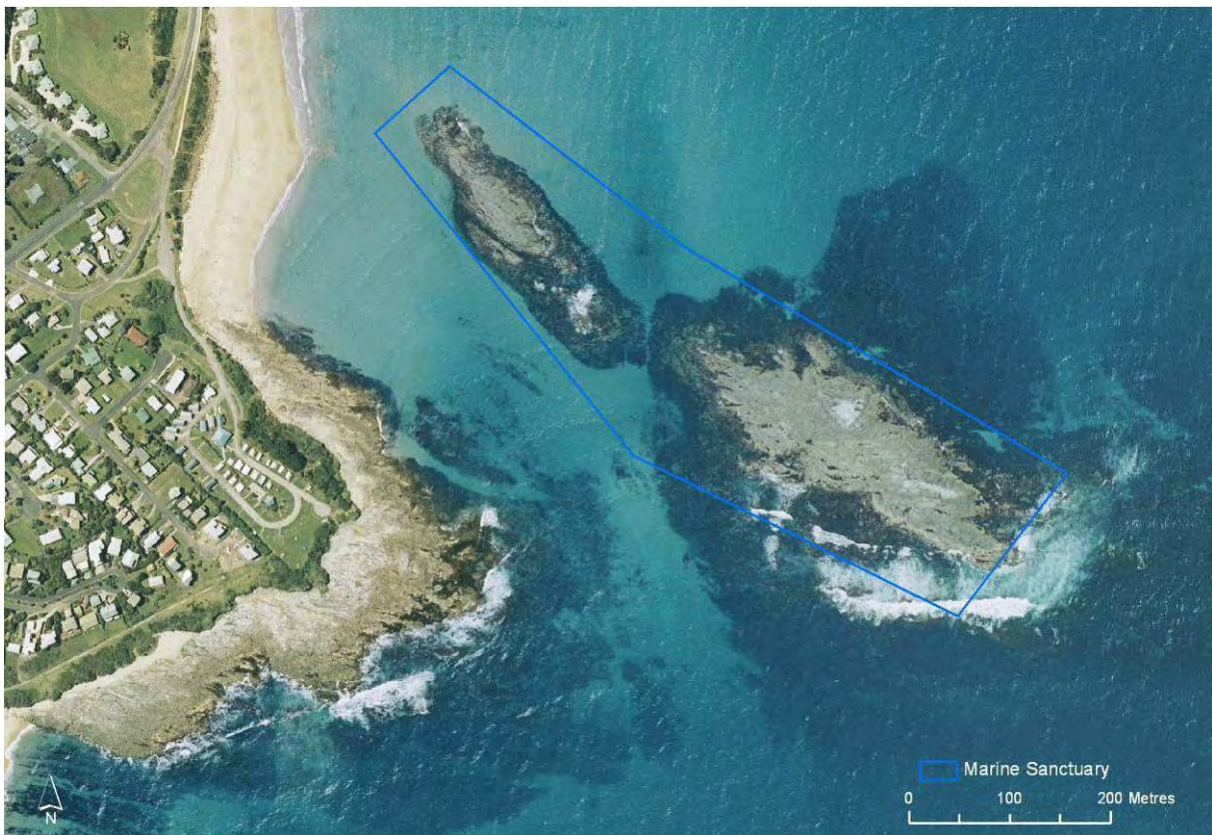
**Figure 16.** Marengo Reefs MS 2004 aerial photography (The State of Victoria through the Department of Sustainability and Environment, 1/11/04).

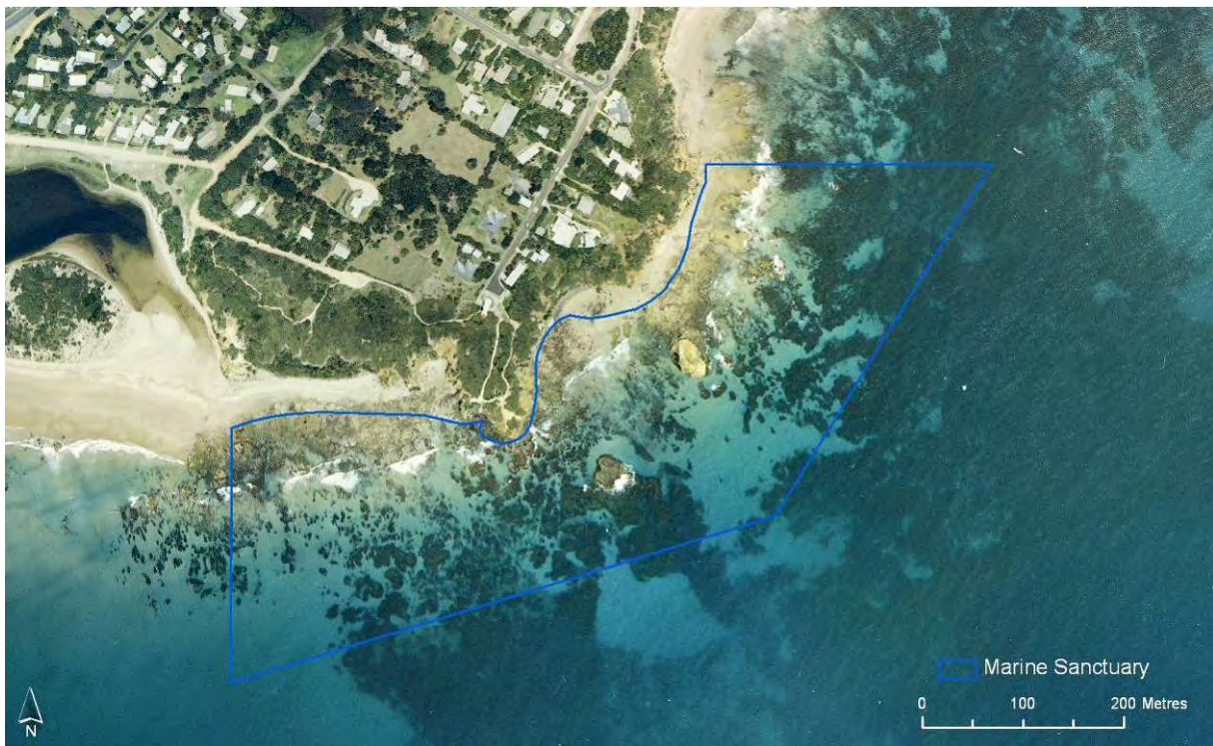
**Figure 19.** Eagle Rock MS 2003 aerial photography (Geomatic Technology 13/12/2003).

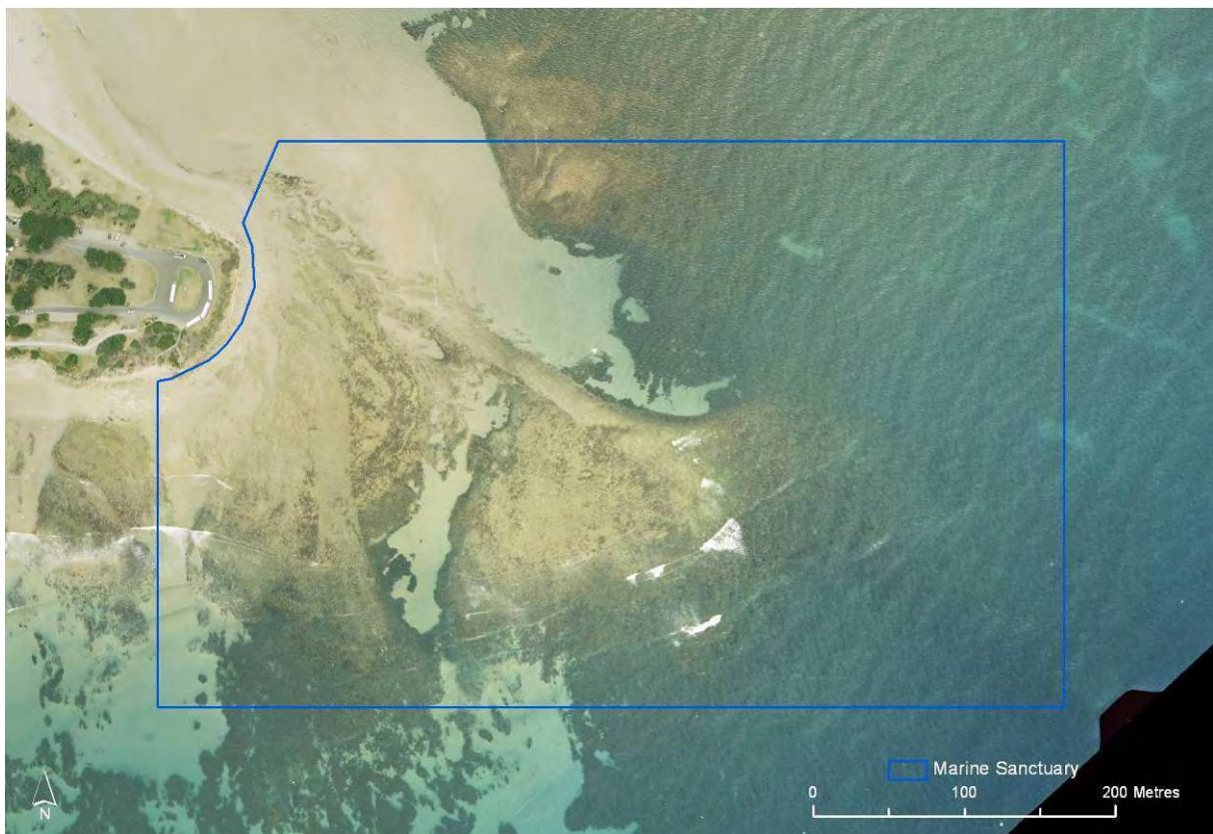
**Figure 33.** Point Danger 2003 aerial photography (Geomatic Technology, 13/12/03).
