# **PARKS VICTORIA TECHNICAL SERIES**

**NUMBER 37**

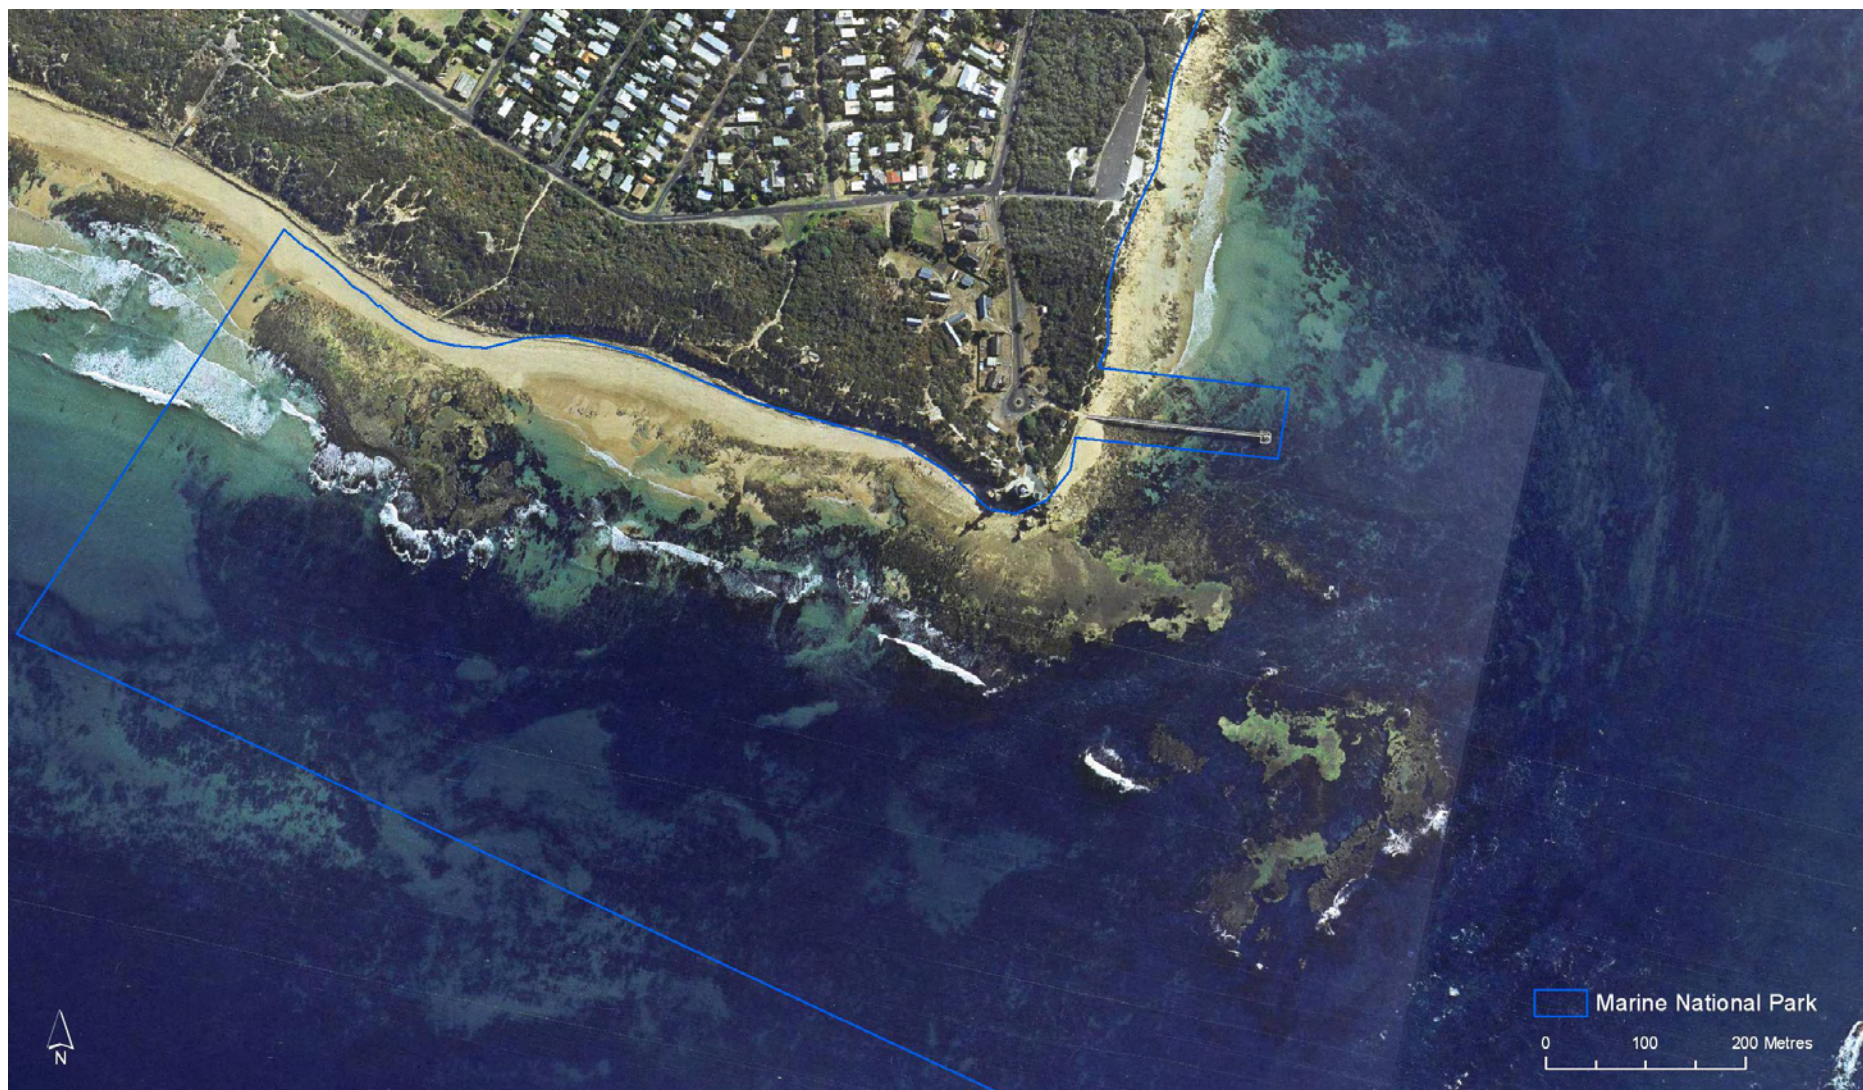
**Figure 6.** Port Phillip Heads MNP - Point Lonsdale 1997 aerial photography (QASCO 12/4/97). Photography ortho-rectified by PIRVic.

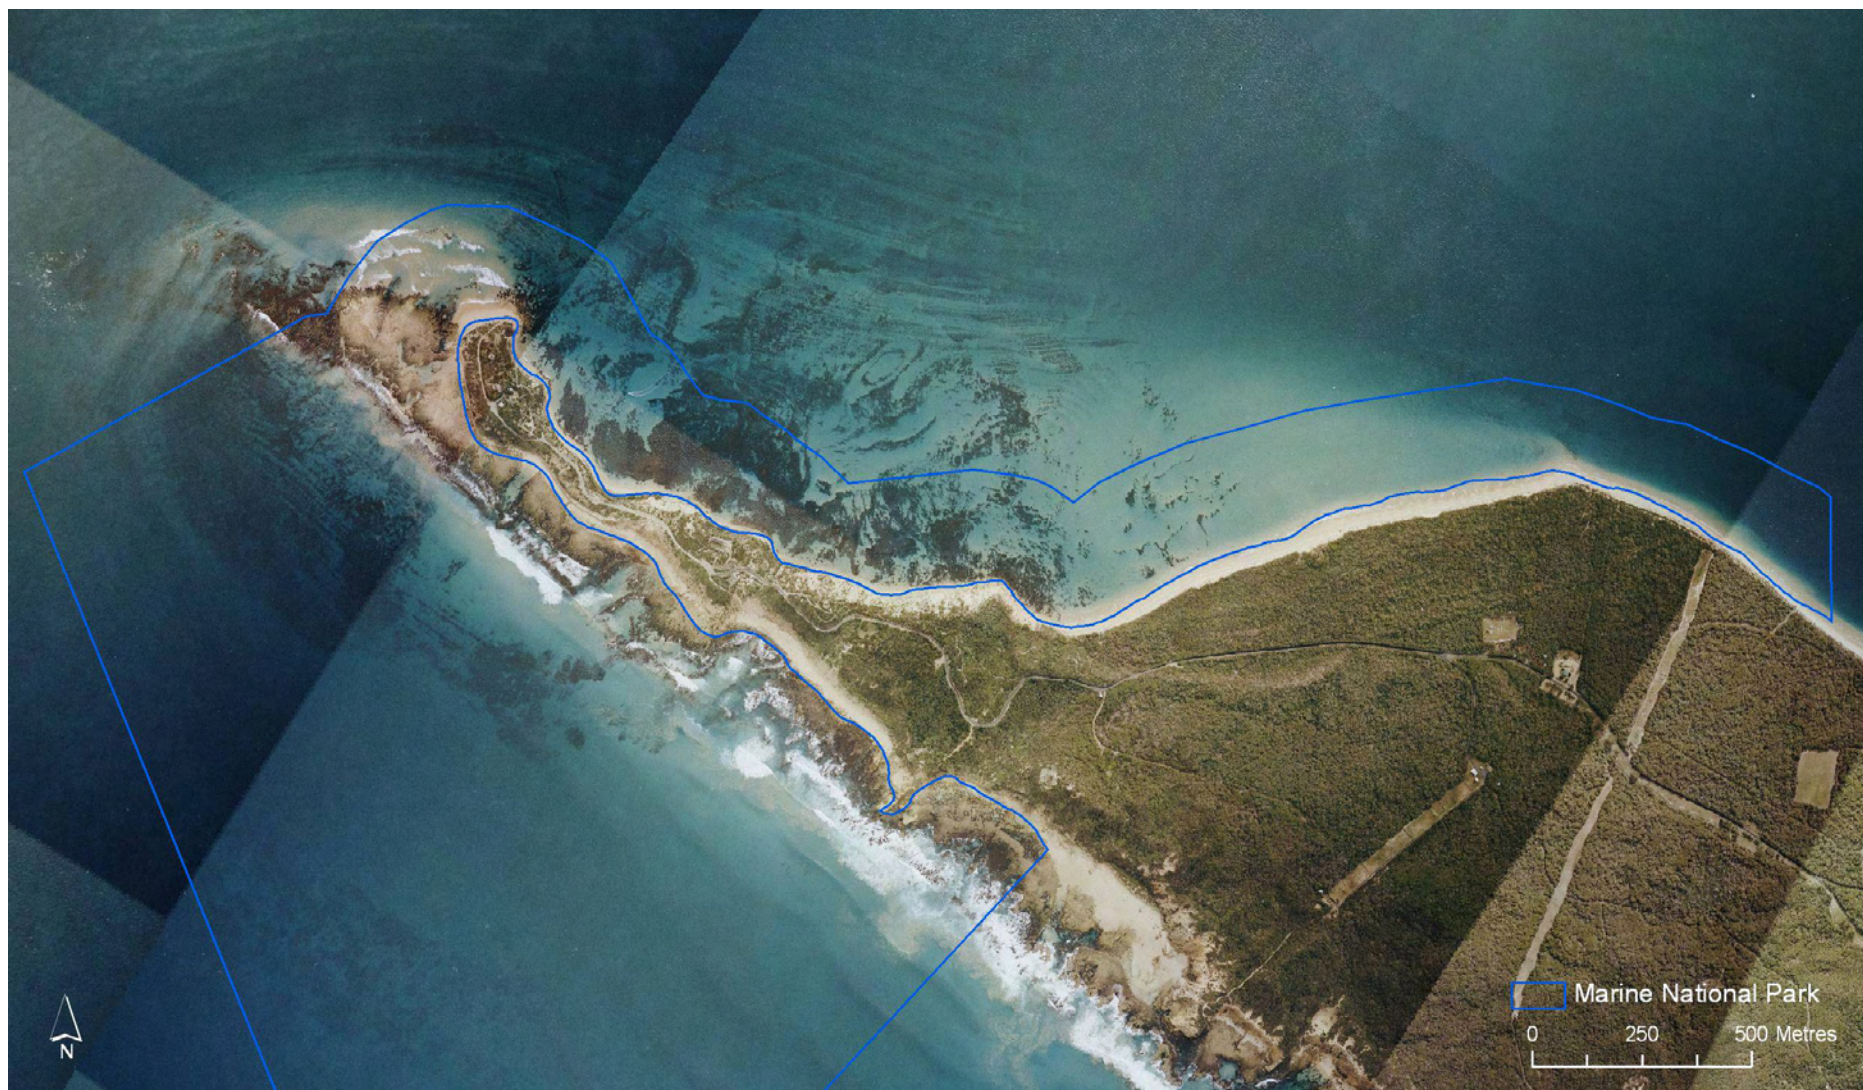
**Figure 12.** Port Phillip Heads MNP - Point Nepean 2003 aerial photography (Hydro Tasmania 21/07/2003).

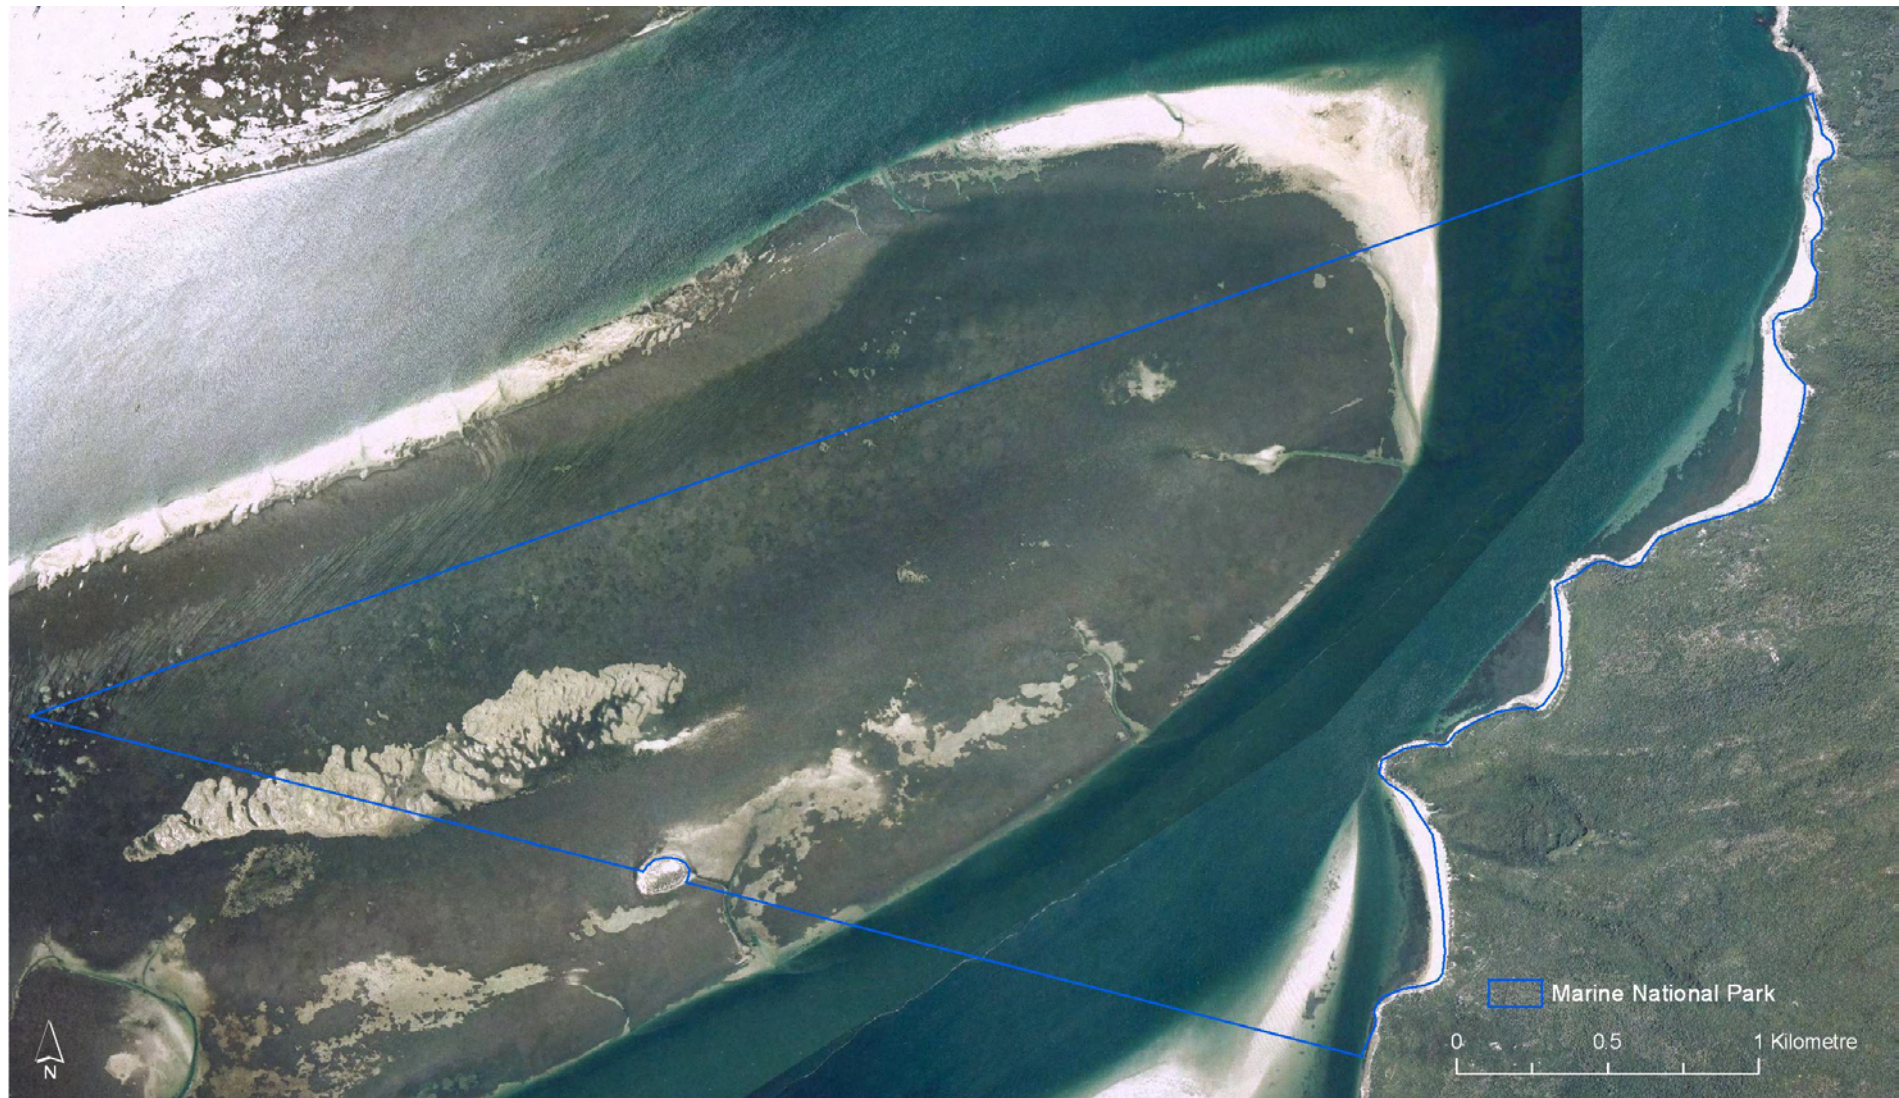
**Figure 23.** Corner Inlet MNP (north) 2004 aerial photography (QASCO 18/02/04).

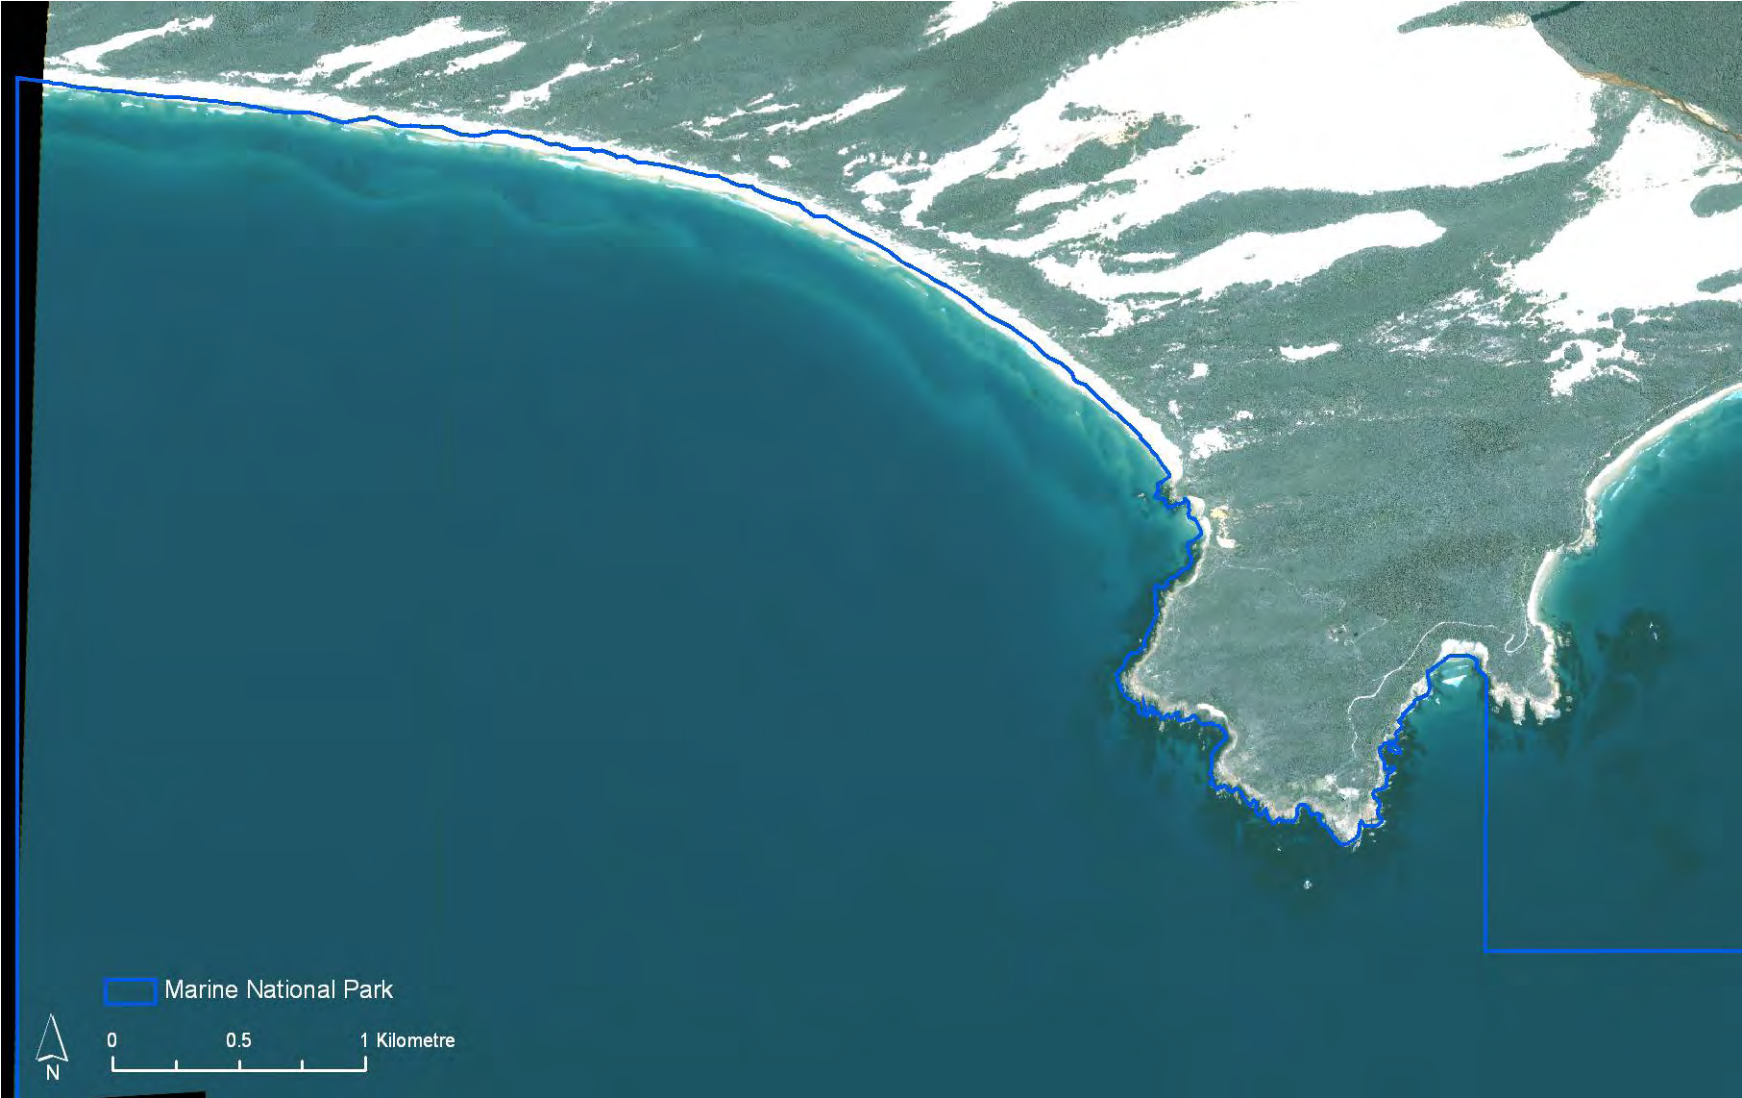
**Figure 33.** Point Hicks MNP 2004 Ikonos satellite image (Space Imaging 12/10/04).
