**Flinders Pier
Marine Ecology
and Pier Removal
Impact Assessment
2021**

May 2021

Flinders Pier Marine Ecology and Pier Removal Impact Assessment

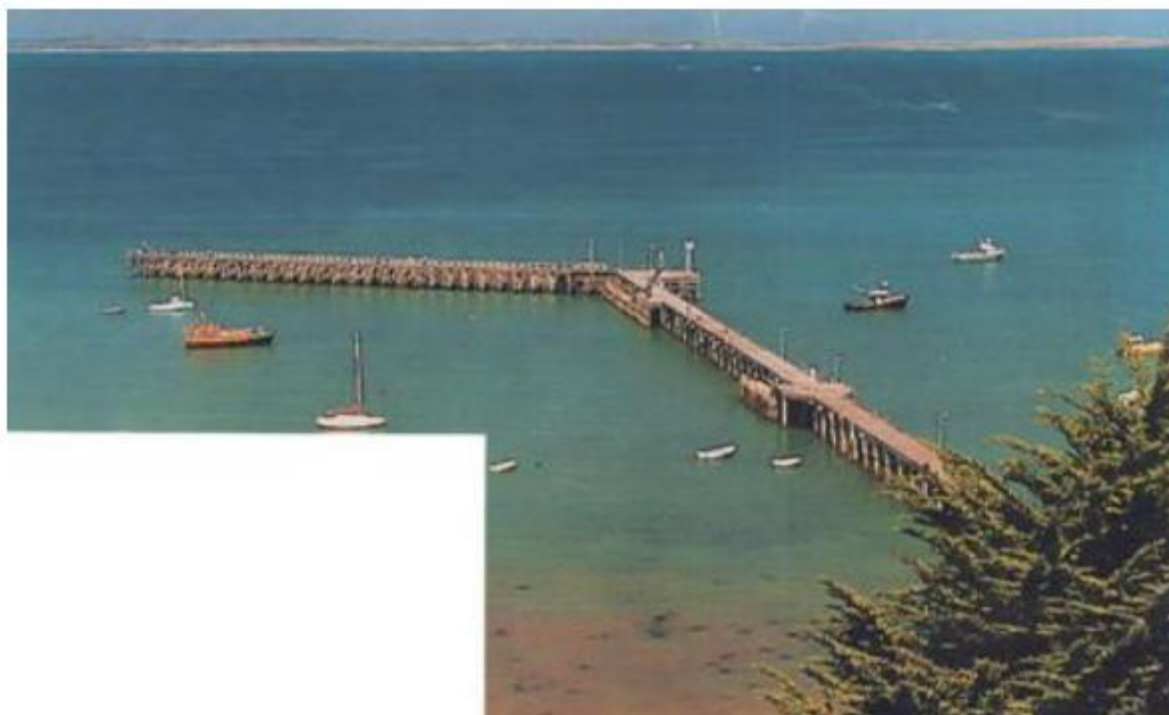
Figure 2. Flinders Pier with breakwater 1999

The pier structure comprised pairs of wooden piles that supported a wooden deck, hand rails, steps and loading landings located approximately midway along the pier and at the end of the pier. A wooden wave screen extended approximately 100 m northeast from the end of the pier. The wave screen was removed in 1999 due to storm damage and general deterioration (Figure 2).

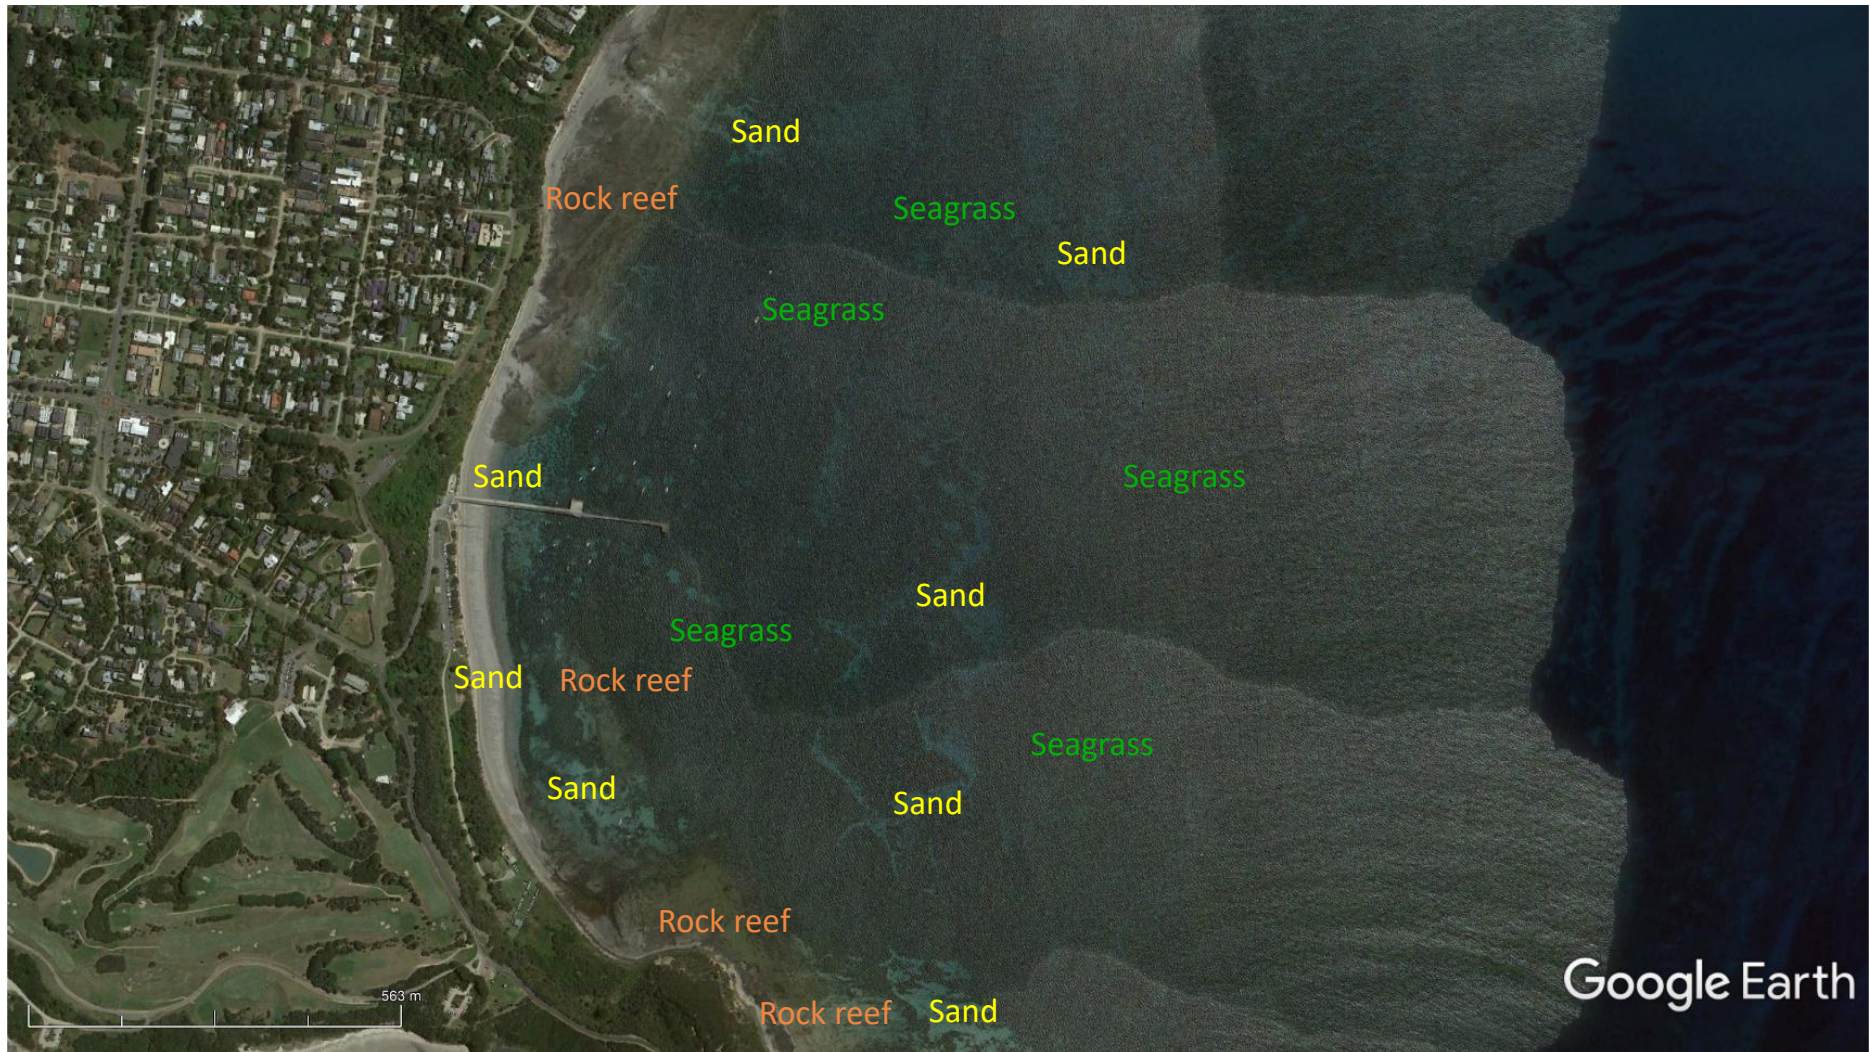
Figure 10. Seabed habits near Flinders Pier 2018

Seabed habitats can be interpreted from aerial images by marine scientists with appropriate experience in the area. Figure 10 shows seabed habitats on a Google Earth images interpreted by CEE. Figure 11 show shows the same area with habitats and biotopes mapped on DELWPs Coast Kit management App.

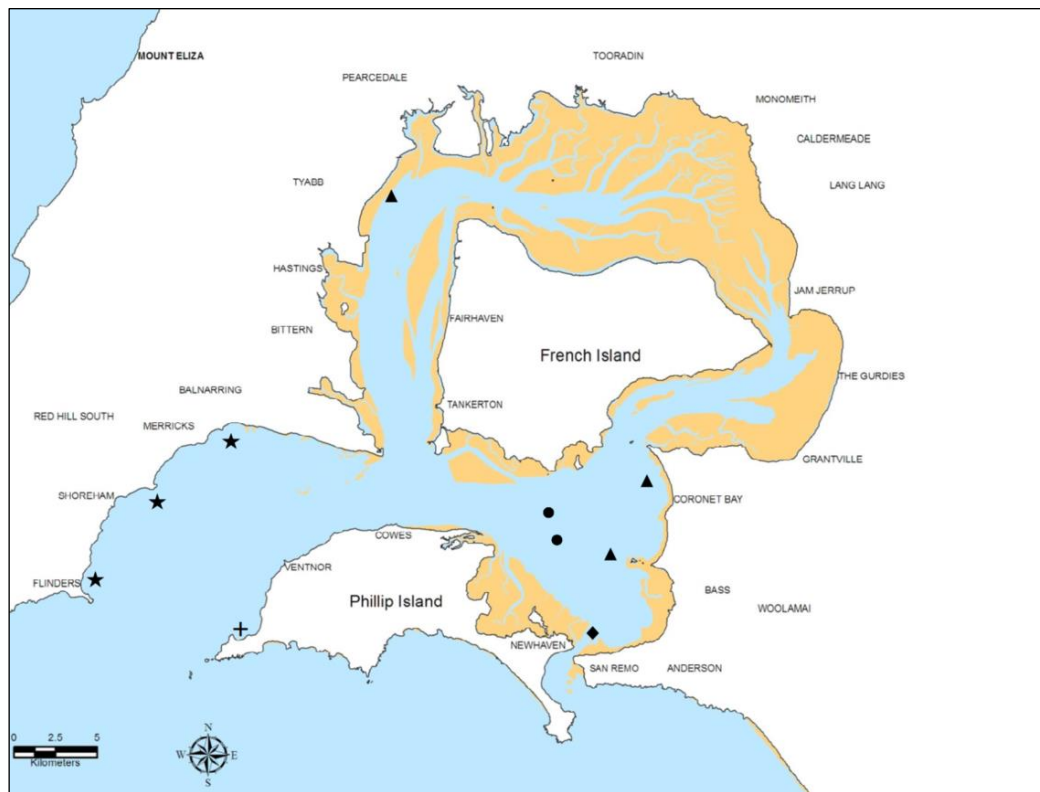
Figure 14. Fish habitats surveyed by University of Melbourne

★ Seagrass (*Amphibolis*) ● Invertebrate reef + Rocky reef ▲ Macroalgae (*Caulerpa*) ◆ Biogenic reef (Rhodolith) (Jenkins et al 2013)

The nature of fish communities associated with different habitats in Western Port was investigated in 2013, including seagrass habitat at Flinders (Jenkins et al 2013). The study identified differences in fish communities in two seagrass species beds (*Zostera* and *Amphibolis*), soft seabed macroalgae (*Caulerpa*), rocky reef macroalgae and biogenic reef (rhodolith) habitats in the Western Entrance of Western Port (Figure 14).

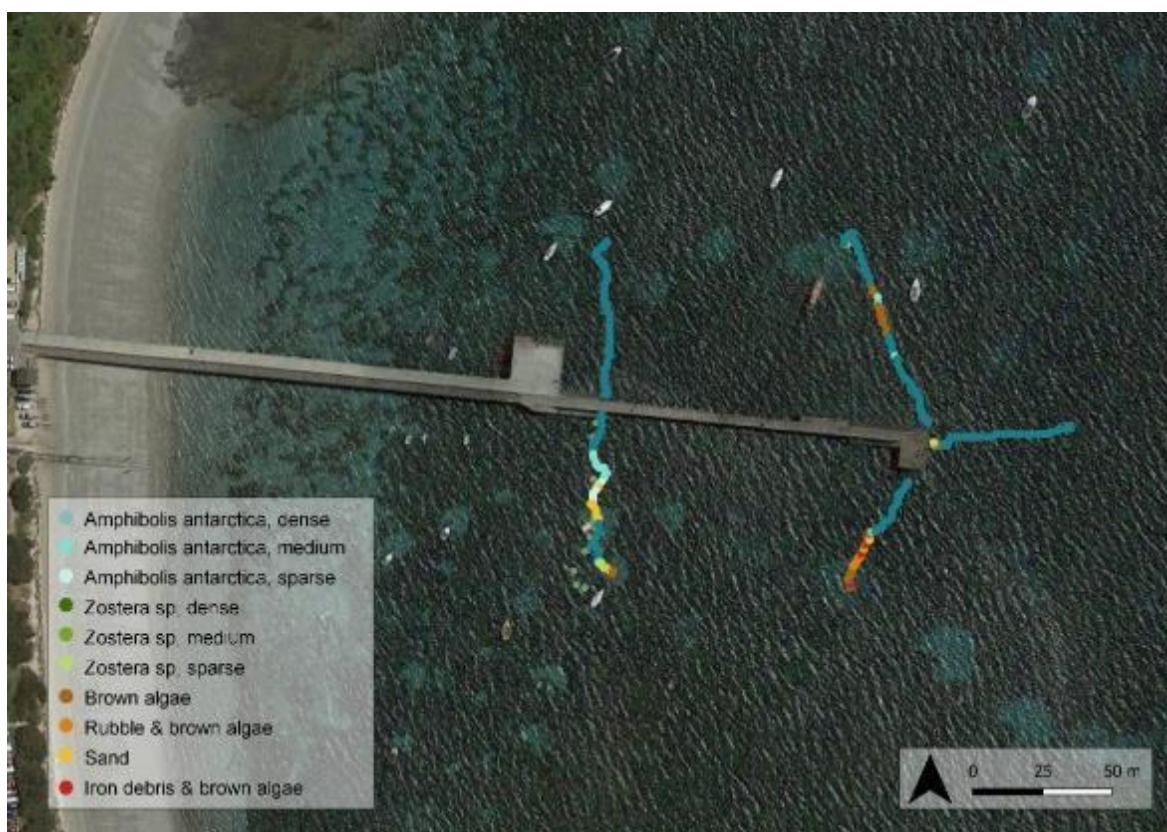
Figure 21. Transect mapped biological categories at Flinders Pier, 2020
(Biological distributions from CEE December 2020 survey Base overlaid on 2018 Google Earth photo)

Two seagrass species were recorded along the transects in both June 2007 and December 2020: *Amphibolis antarctica*, *Zostera nigricaulis*. The transects were located on subtidal seabed at depths of around 1.5 m to 2 m below lowest low tide. A third species, *Z. muelleri* is found on the shallower seabed. Each species is native and common to the Southern coast of Australia and occupy slightly different ecological niches.

The seabed along the transects showed is similar patterns of predominantly dense *Amphibolis antarctica* meadows along all transects in both years, with minor variations resulting from mooring chain scour of the seabed and seagrass, the exposure of rock rubble beneath the *Amphibolis* canopy and growth of filamentous brown algae on seagrass stems (Figure 27).

Overall the comparison shows that the density of *Amphibolis* seagrass along the same transect alignments directly observed *insitu* by biologists 13 years apart was remarkably similar. This confirms that significant interannual variability in intertidal *Zostera* habitat compared to the relatively constant *Amphibolis* density around Flinders Piers interpreted from Figure 26 is reasonable.

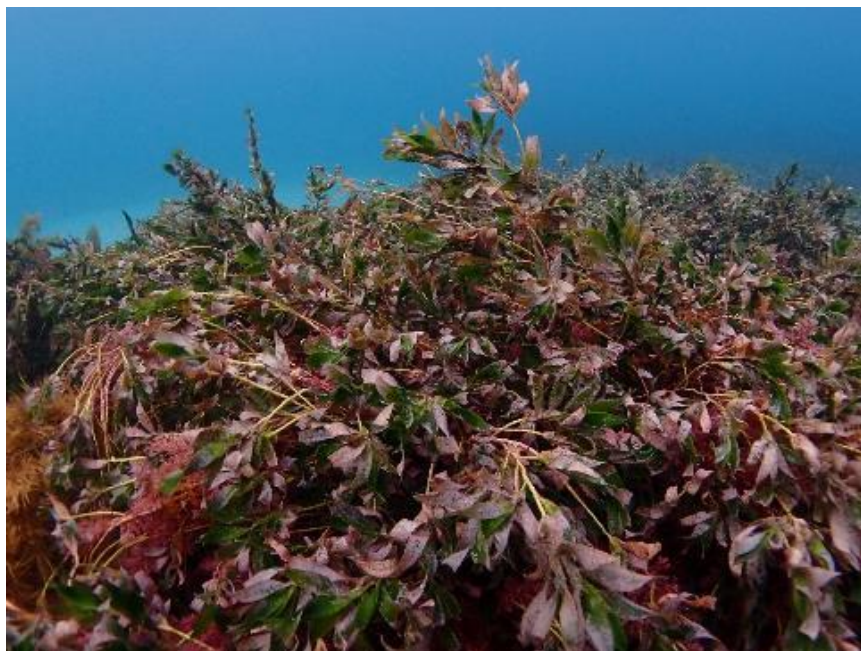
Figure 22. Sea nymph seagrass (*Amphibolis antarctica*)

Characterised by a woody stem and relatively short leaves at the top of the plant that are arranged in 180° (Flinders, December 2020)

Amphibolis usually forms extensive meadows in moderately waved exposed shallow sandy or rock rubble areas such as Flinders and it is easily differentiated from *Zostera muelleri* and *Z. nigricaulis*. *Amphibolis* is recognised by its woody stems and proportionally short, broadish leaves that are twisted 180° (Figure 22). *Zostera* species have long, narrow leaves and are common in sheltered Victorian waters. The distinctive dark stem of *Z. nigricaulis* readily differentiates it from *Z. muelleri* (Figure 23).

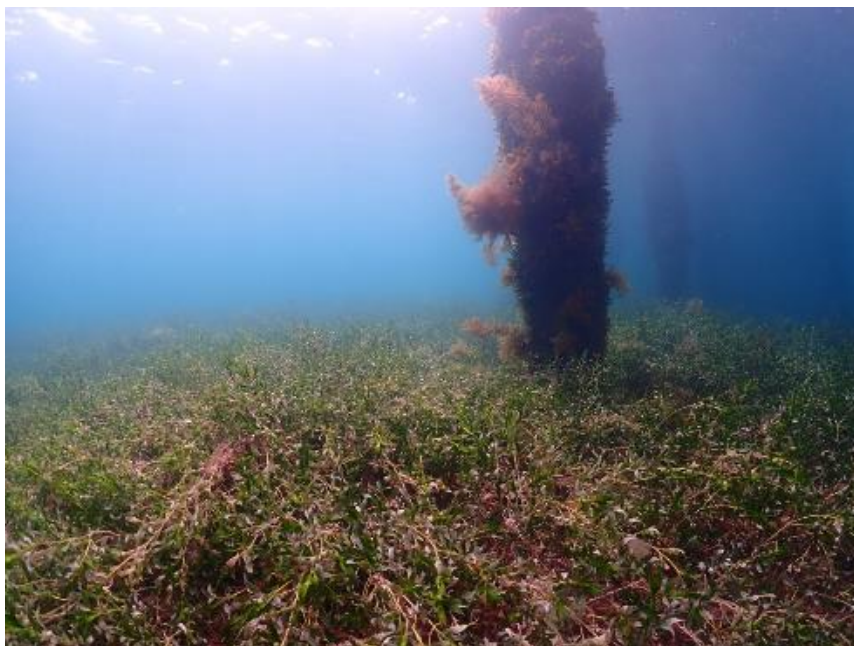
Figure 30. Dense *Amphibolis antarctica* seagrass meadow under and around Flinders pier offshore section, December 2020

East (offshore) of the first lower landing, as water depth slowly increases, dense *Amphibolis* beds are found underneath the pier (Figure 30) until at around pile 63. The deck of the pier expands to the lower landing at pile 63 and *Zostera* patches replace the *Amphibolis* beds (Figure 31) until the expanse of the service deck area results in sufficient shade to exclude seagrasses.

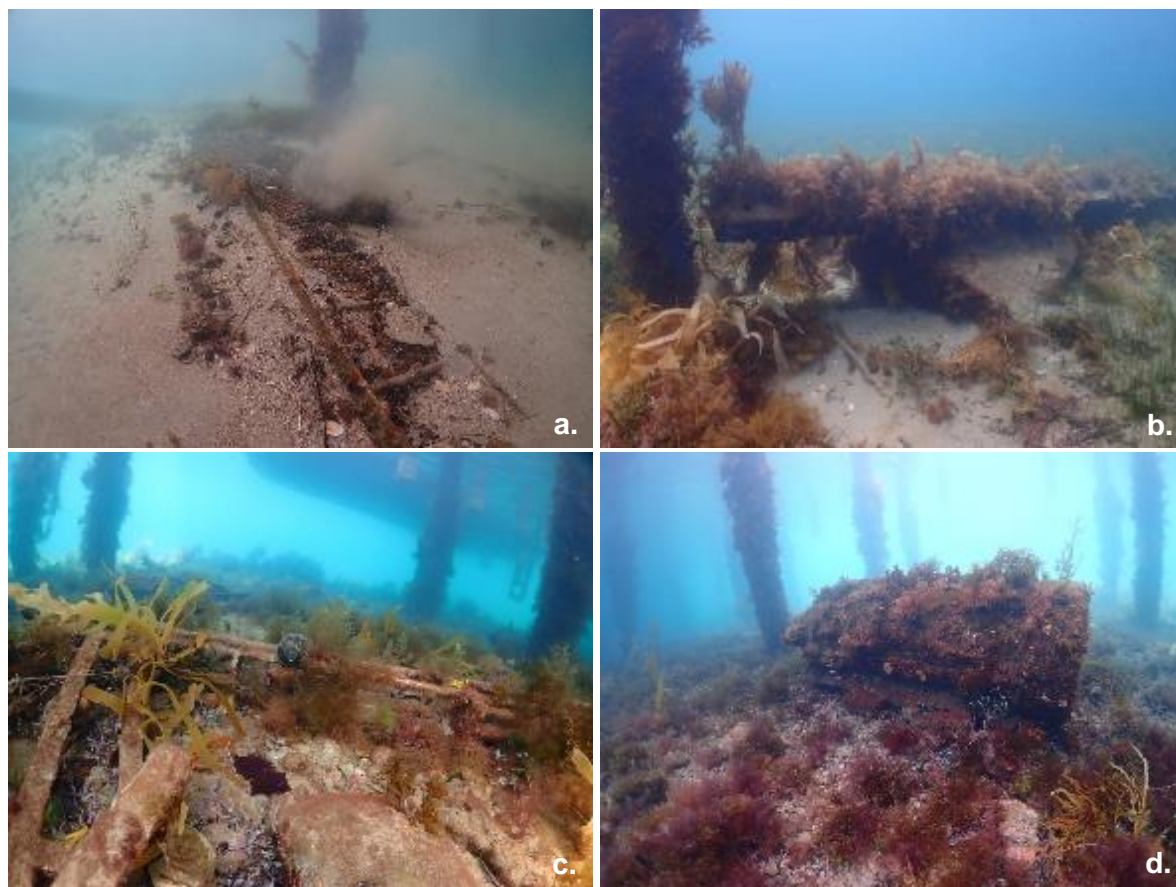
Figure 34. Debris under the Flinders Pier, December 2020.

Scattered debris (timber, iron, tyres and other litter) was observed along the pier and it is generally covered in marine growth including algae and invertebrates (Figure 34).

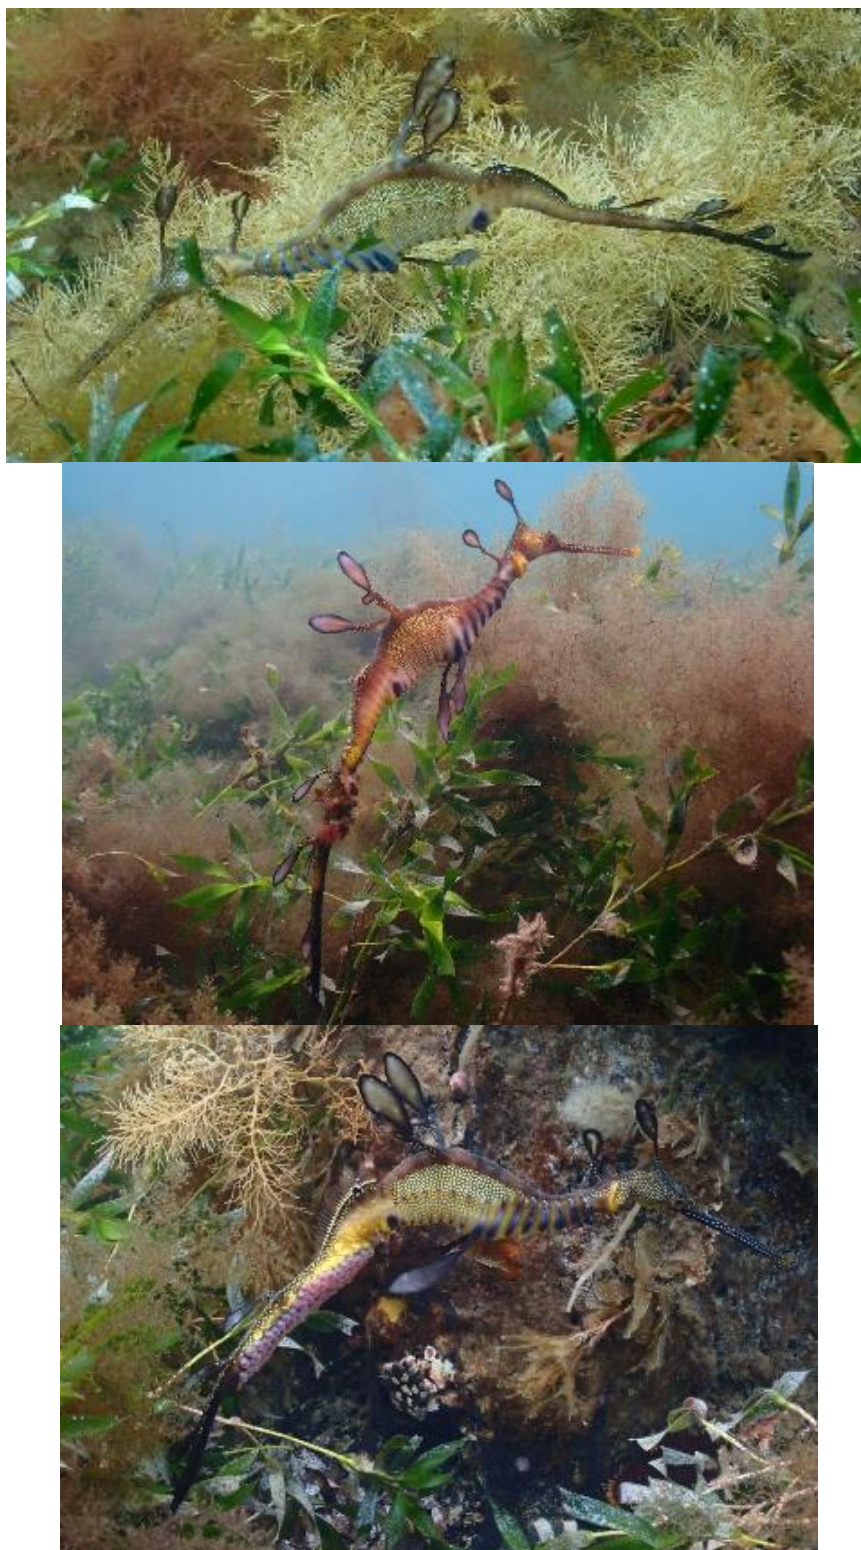
Figure 54. Weedy seadragons *Phyllopteryx taeniolatus* at the Flinders pier December 2020.

- *Top seadragon is possibly a female due to her narrow tail and is not carrying any eggs.*
- *Middle individual is a male among red algae and seagrass under the outer jetty and appears to be carrying a few eggs the base of his tail, algae seems to be growing from upper brooding patch.*
- *The bottom individual is a male next to a pier pile carrying a large number of eggs.*

Three of five sighted in under Flinders Pier December 2020 are shown in Figure 54. The top individual among brown macroalgae and seagrass alongside the pier is possibly a female due to her narrow tail and is not carrying any eggs. The middle individual is a male among red algae and seagrass under the outer jetty and appears to be carrying a few eggs the base of his tail, algae seems to be growing from upper brooding patch. The bottom individual is a male next to a pier pile carrying a large number of eggs.

Weedy seadragons are very well camouflaged in macroalgal and *Amphibolis* beds. Consequently, they are usually seen close to sand patches under and along the pier or at the base of piles. It is not uncommon for four or more seadragons to be observed during a single dive at Flinders Pier. They are also frequently seen on natural sand patches in the *Amphibolis* beds elsewhere in Kennon Cove but are not usually seen in the sand patches created and occupied by swing moorings. Figure 55 shows three of four seadragons observed during snorkelling inspection of seagrass/reef/sand habitat near shore approximately 500 m north of the pier in 2021. Figure 54 and Figure 55 demonstrate the range of colours and patterns that distinguish individual seadragons.

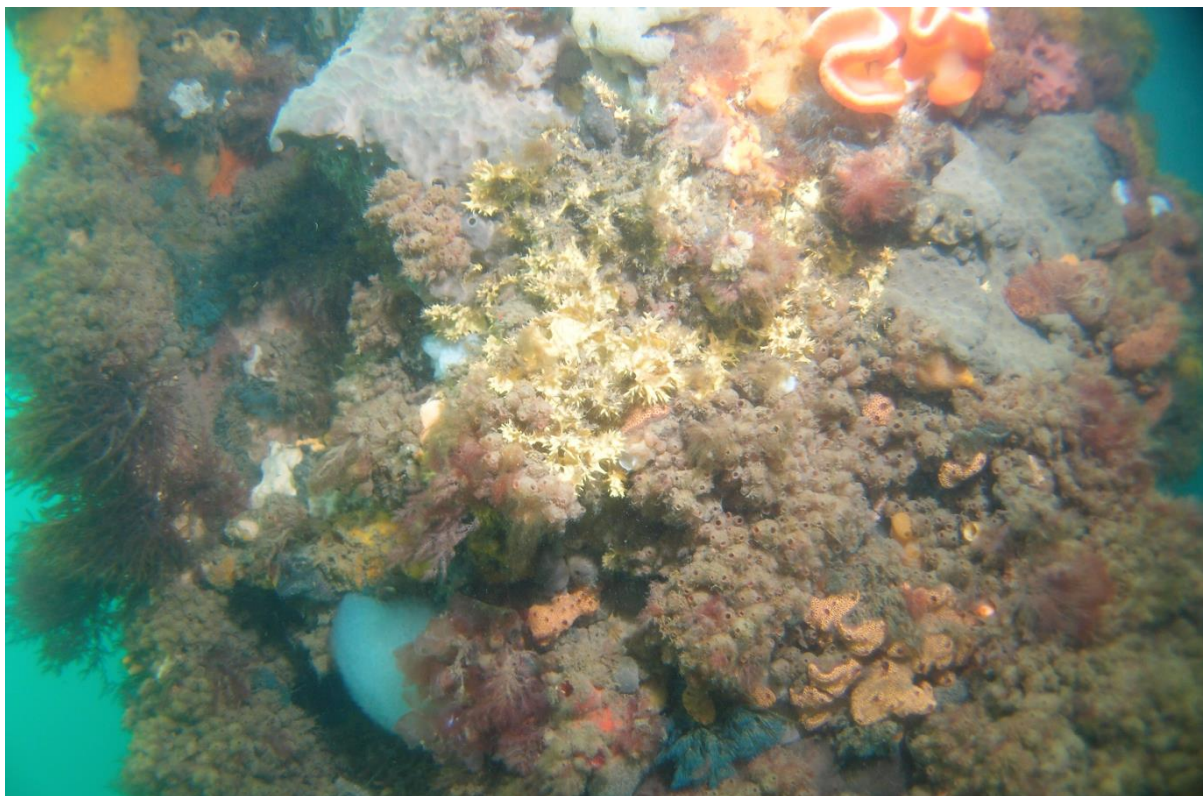
Figure 69. Encrusting invertebrates on steel jetty pile, North Arm Western Port

Ultimately the community on the artificial surface will comprise species that occur on reefs and seagrass meadows of the Central Victorian Marine Bioregion and are suited to the particular environment at the Flinders Pier. Examples of marine communities growing piles in at Blairgowrie Harbour and North Arm of Western Port are shown in Figure 68 and Figure 69.
