# WATTLE PARK

## CONSERVATION MANAGEMENT PLAN

No. 1012 Riversdale Road, Burwood, City of Whitehorse, Victoria

October 2023

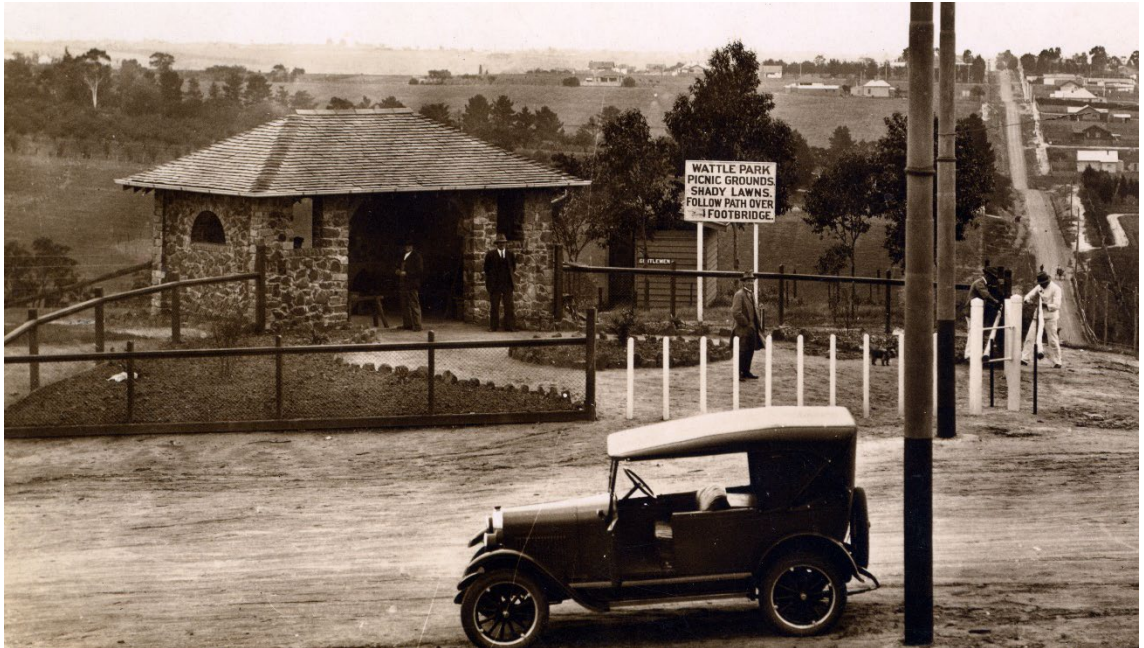
The connection between the park and the tramways was emphasised in a new ornamental stone entrance structure (and tram shelter) at the corner of Warrigal and Riversdale roads (built in 1929, Figure 11). Another tram shelter, built in the same rustic style with rough-coursed stonework, was introduced to the east of the main entrance on Riversdale Road. The connection was also expressed in the recycling of tramways materials through the late 1920s and 1930s. Examples included fencing using cables salvaged from Melbourne's cable tram network; redundant trams cars recycled as play equipment and picnic shelters.

Figure 11 Entrance to Wattle Park, at the intersection of Riversdale and Warrigal roads, c. 1930s  
Source: Box Hill Historical Society (B5810)

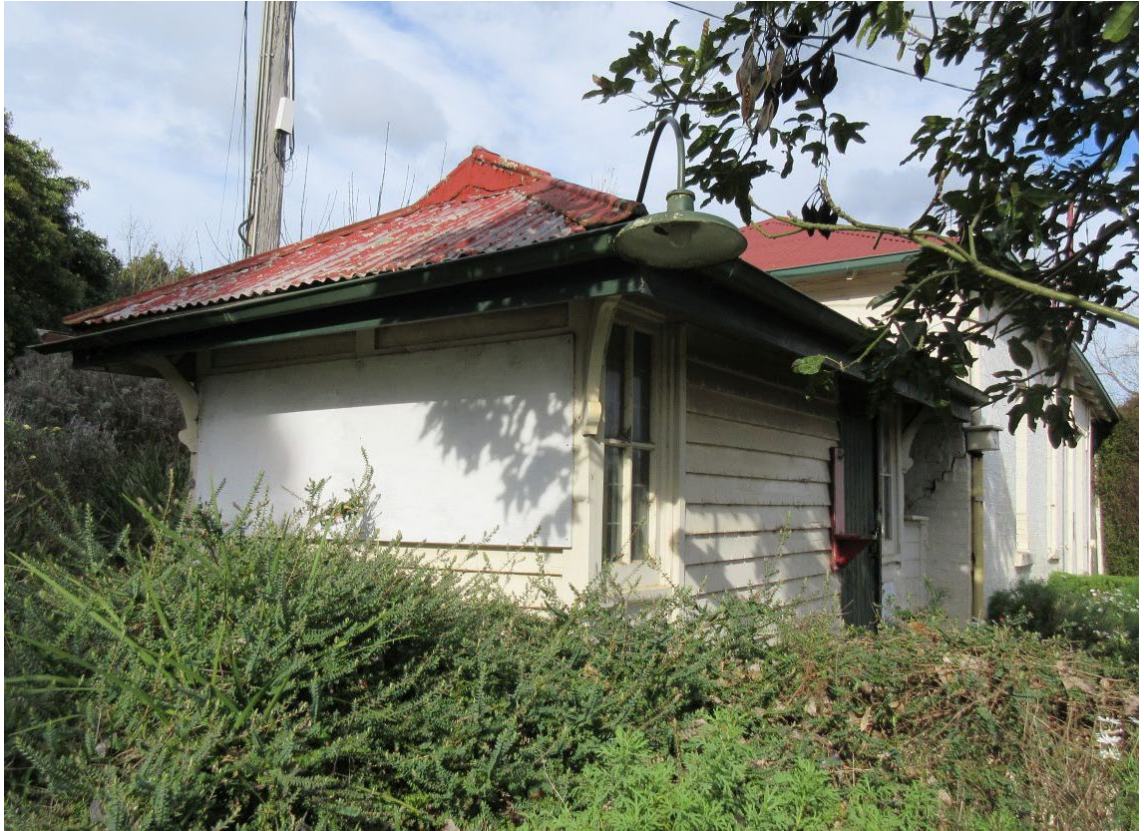
Figure 19 Former tram waiting shelter, now known as the curator's office: looking south

Principal design and oversight for the buildings, infrastructure and site layout undertaken from 1925-1938 was the responsibility of the M&MTB's architect A G Monsborough. The connection between M&MTB and Wattle Park was reflected in the recycling of tramways materials, the adaptation of a 1912 tram waiting shelter as an office (Figure 19), the use of the park to cultivate flowers for M&MTB properties and advertisements which promoted access to the park by tram. The longstanding association of Wattle Park with the tramways is also reflected in a memorial tree dedicated to a former member of the M&MTB, Sir Stephen Morrell. Today, this association is maintained through the interest and recurring involvement of the Melbourne Tram Museum, and in the continuing performances of the Melbourne Tramways Band.

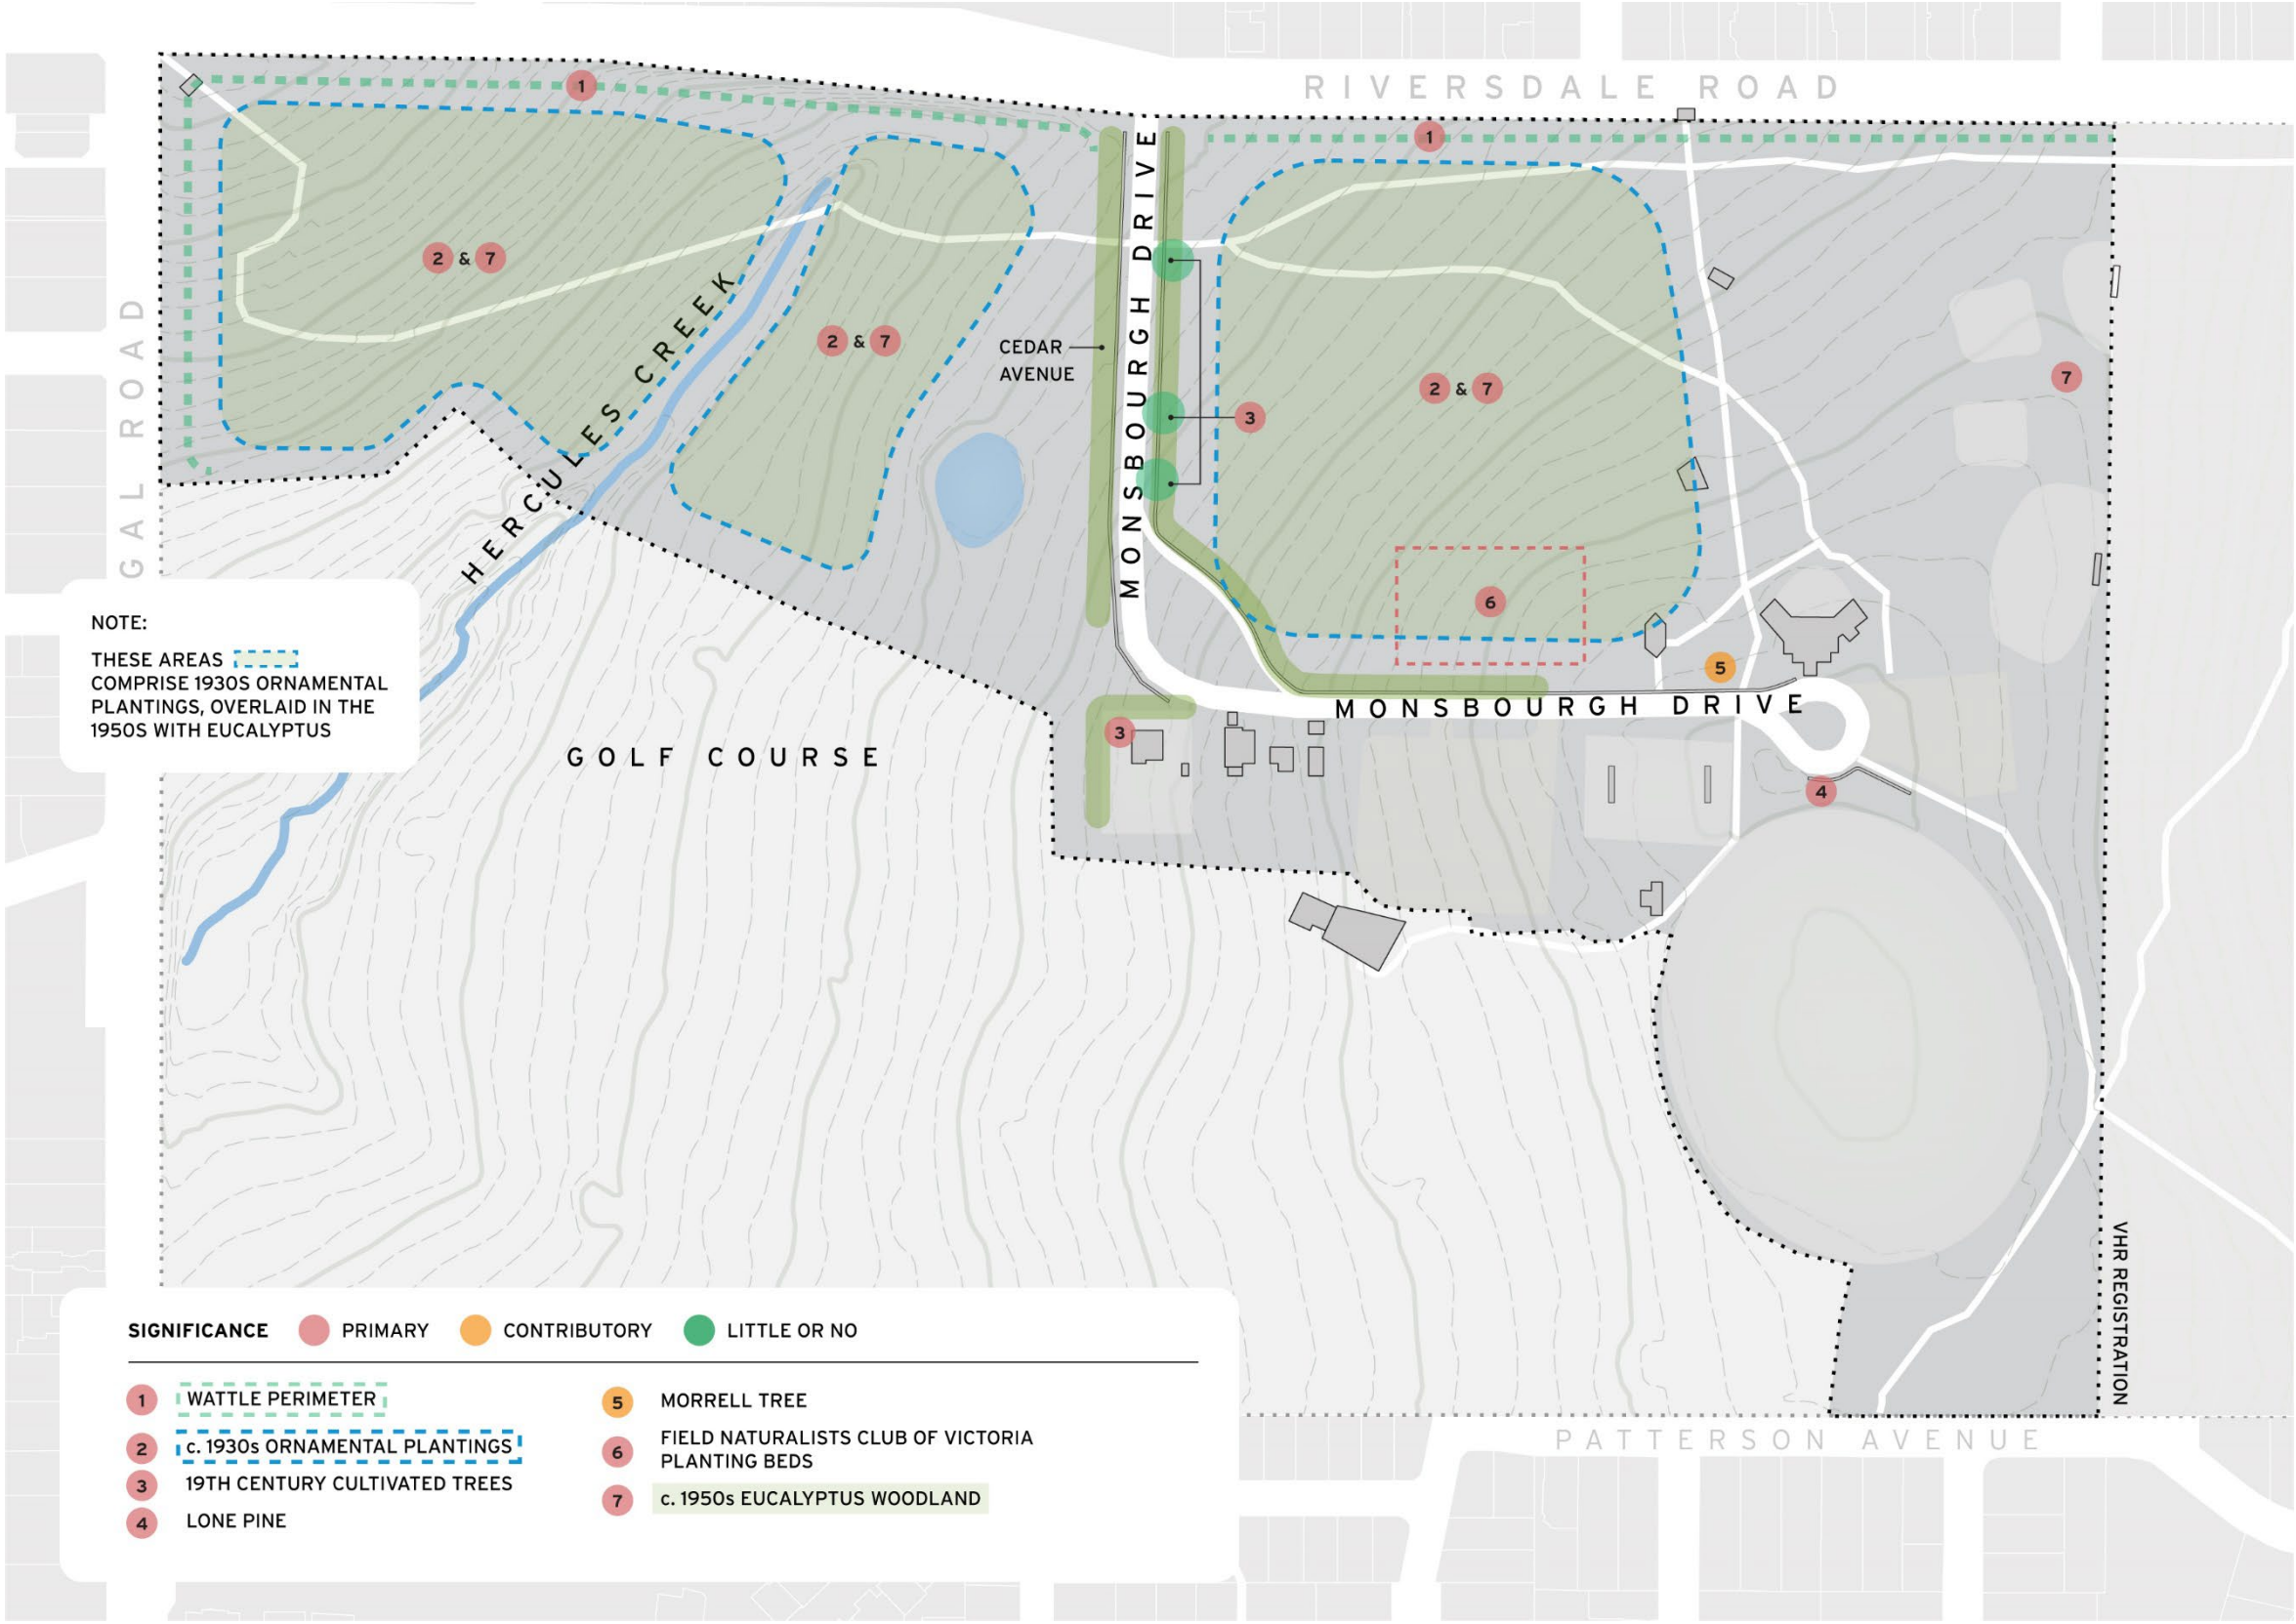
Figure 22    Levels of significance: soft landscape elements

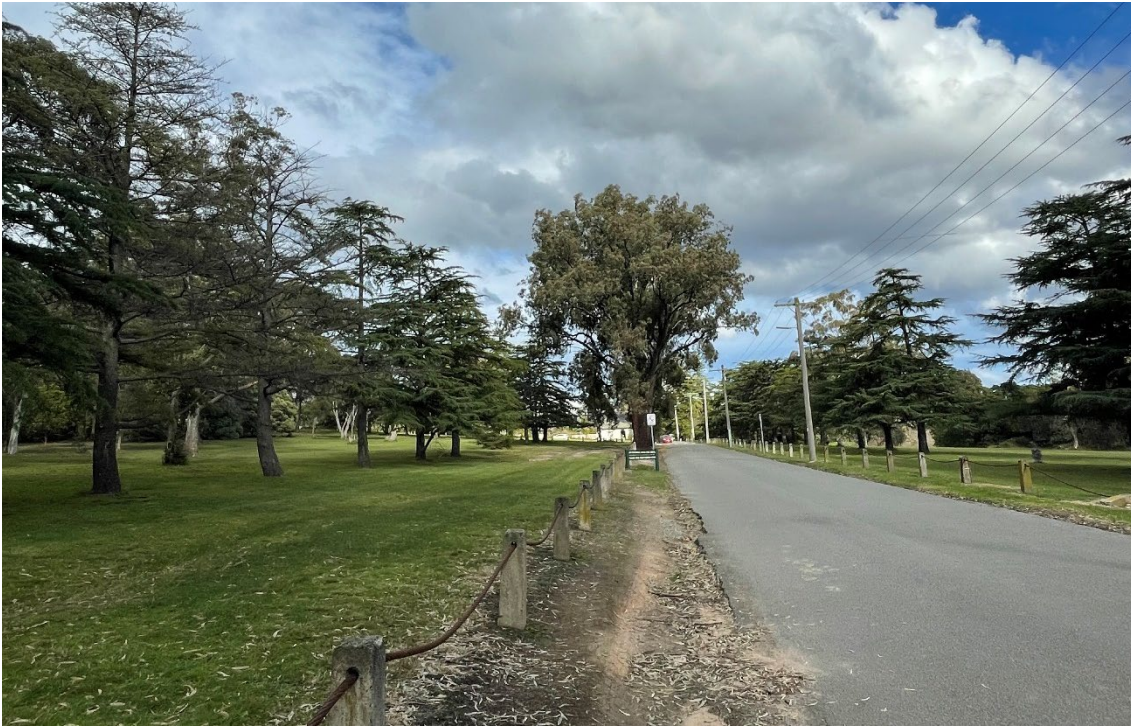
Wattle Park's entrance driveway (Monsborough Drive) is an L-shaped roadway originating from Riversdale Road, extending first south to the Curator's Cottage and then east to the Chalet and the drive's terminus in a modern car park. It is lined by an avenue of Deodar Cedar (*Cedrus deodara*) as well as several older gum trees that predate the establishment of the park (Figure 25). The Cedar avenue was installed in c. 1933.

Figure 25 View looking south along the driveway from close to the Riversdale Road entrance

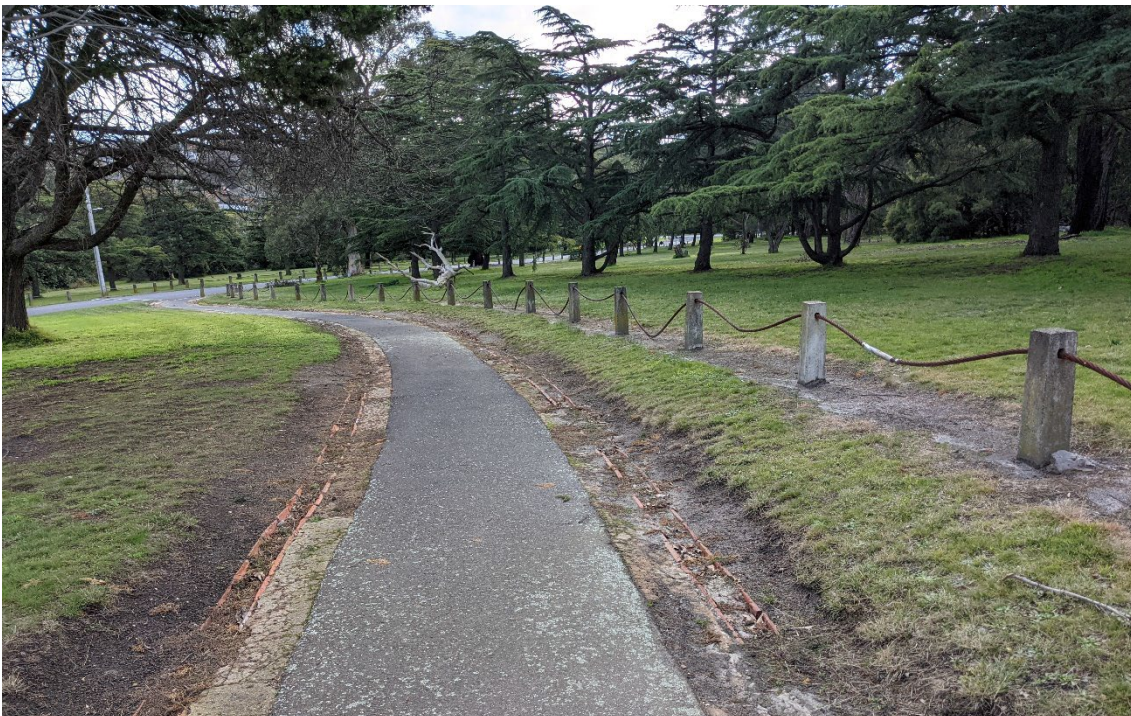
At the corner where the drive turns to the east a serpentine walkway was formed pre-1931. Today this is an asphalt-surfaced walk with a flush concrete border and terracotta tile drains to both edge (Figure 26). Originally this was most likely a granular path, with the terracotta drains installed either in a dry trench or on a buried concrete footing; the concrete border is a requirement of the current asphaltting. The wedge-shaped area between the drive and walkway contained an ornamental bed (possibly of roses) with a row of five trees set behind it as a formal backdrop; symmetrically from centre, these were Swamp White Oak (*Quercus bicolor*) (x1), Golden Monterey Cypress (*Hesperocyparis macrocarpa*) (x2), Canary Island Palm (*Phoenix canariensis*) (x2). A single specimen each of the White Oak and Cypress remain.

Figure 26 Serpentine pathway connecting the north-south driveway with its return leg to the east

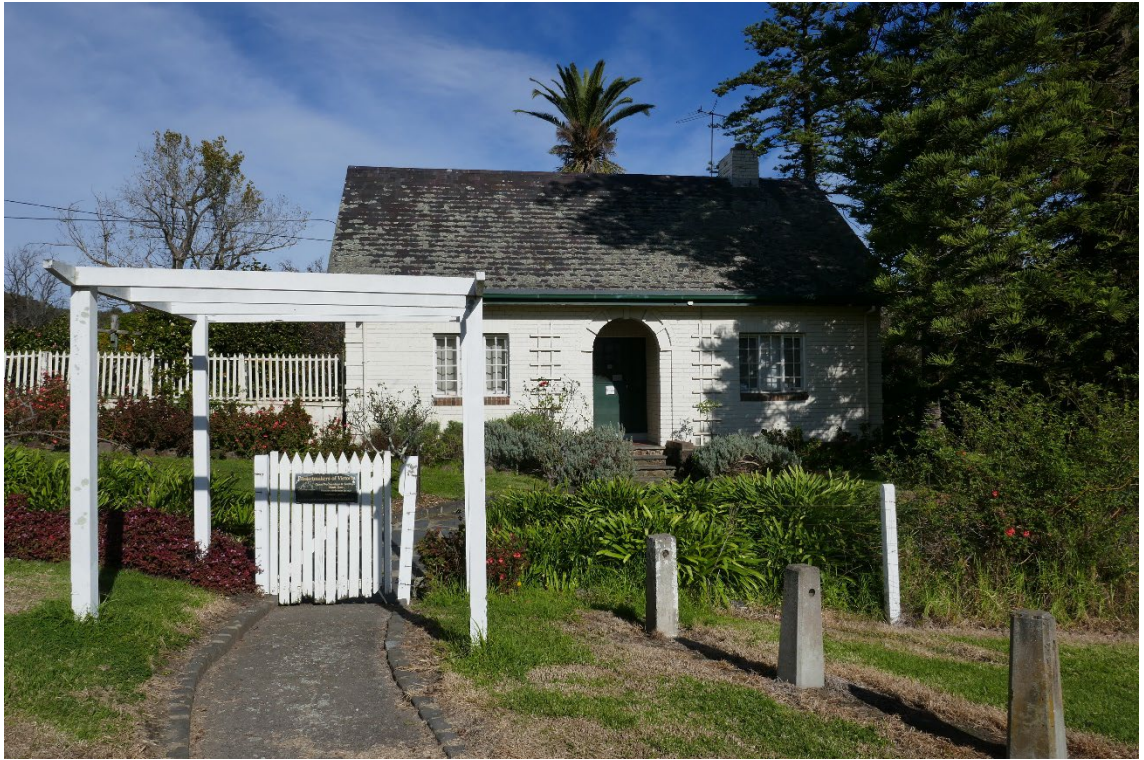
The Curator's Cottage is a single storey brick residence with gabled slate roof (Figure 27). It was designed by A G Monsborough and executed in the English Domestic style also employed on the Wattle Park Chalet. The cottage was constructed in c. 1930-1932 on a portion of the footprint of the 1860s Goyder homestead. Its first resident was Captain Cornelius Arthur Curtis, a World War I veteran employed by the M&MTB as the park curator from the early 1930s until his death in 1939.

Figure 27 Front (north) elevation of the curator's cottage

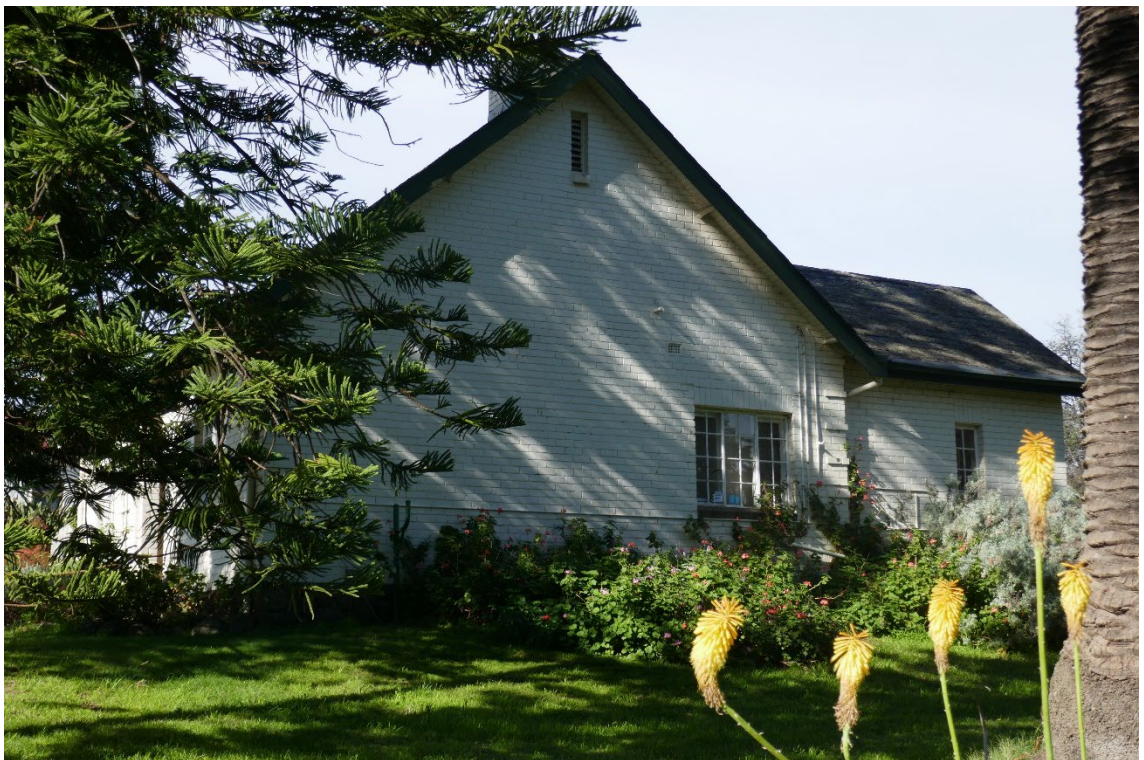
The cottage stands within a levelled and partly sunken garden setting at the south end of the entrance driveway. The Curator's Cottage garden forms an integral ornamental setting to the residence, and is bounded to the west (and north/south-west) by a crescent-shaped row of alternating Norfolk Island Pine (*Araucaria heterophylla*) and Canary Island Palm (*Phoenix canariensis*) specimens. This boundary feature and the tree and palm specimens appear to date to the nineteenth century homestead garden and were retained in construction of the 1932 residence (Figure 28).

Figure 28 West elevation of the cottage, viewed from within its garden setting

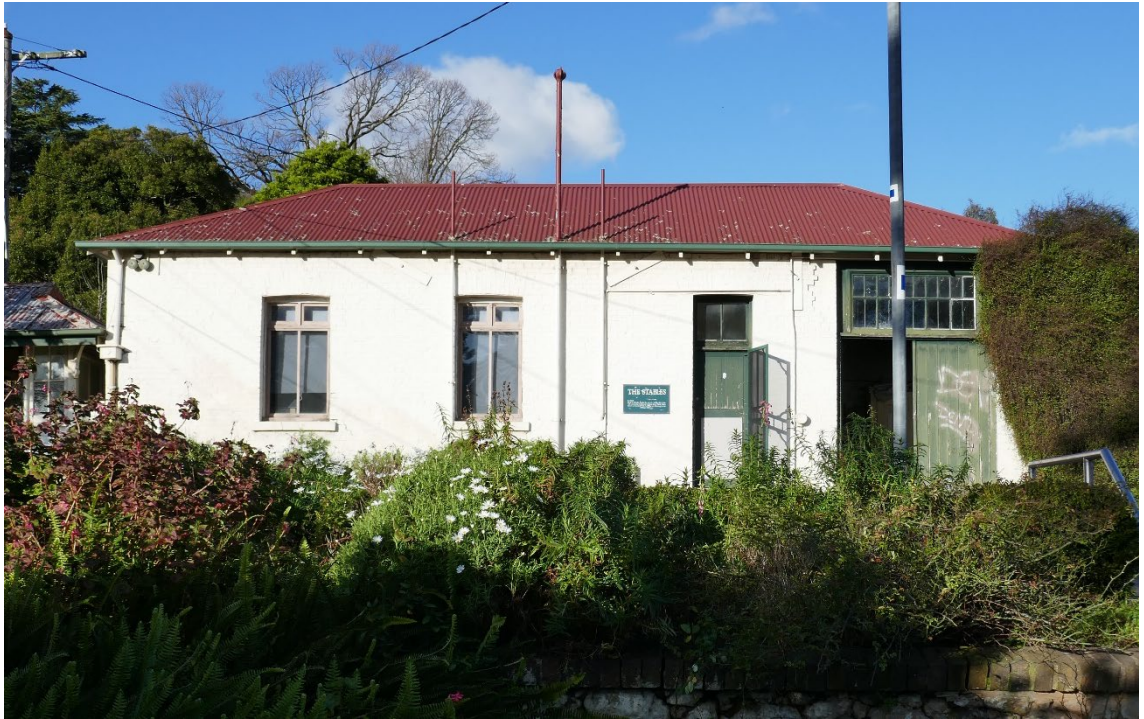
The stables building is a remnant of the former farm. Believed to date to the 1860s, it is the only surviving building from the pre-park era and represents a tangible link to the land's use for pastoral purposes. It is a single storey brick structure on bluestone footings (Figure 29), oriented north-south with the front elevation facing west; a works area is to the rear (east). The curator's cottage is in close proximity to the north (see Section 5.3.2). The brickwork is laid in English bond, and there are segmental heads to door and window openings. The windows are timber casements with timber louvres over; the sills are bluestone. The hipped roof is clad in corrugated sheet metal, painted red, with raked eaves.

Figure 29 Front (east) elevation of the Stables

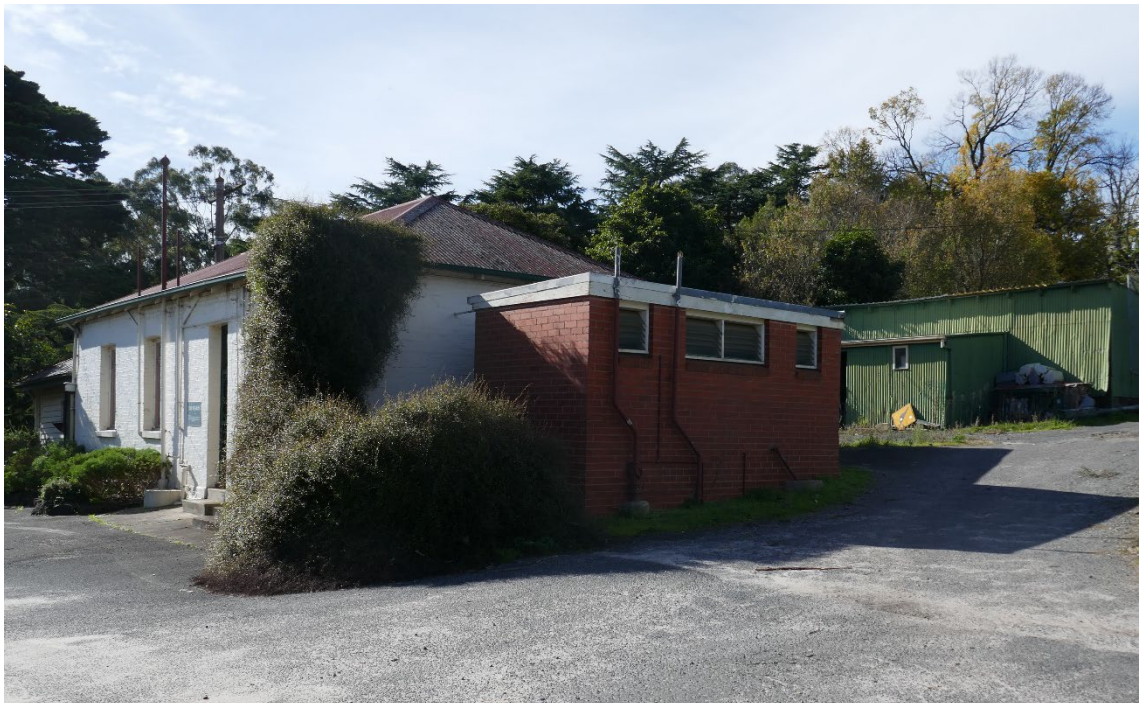
Figure 30 Addition to rear (west) of the Stables

There is a large open-sided addition to the rear of the stables and a skillion-roofed addition in red face brick to the south (dates not established), see Figure 30.

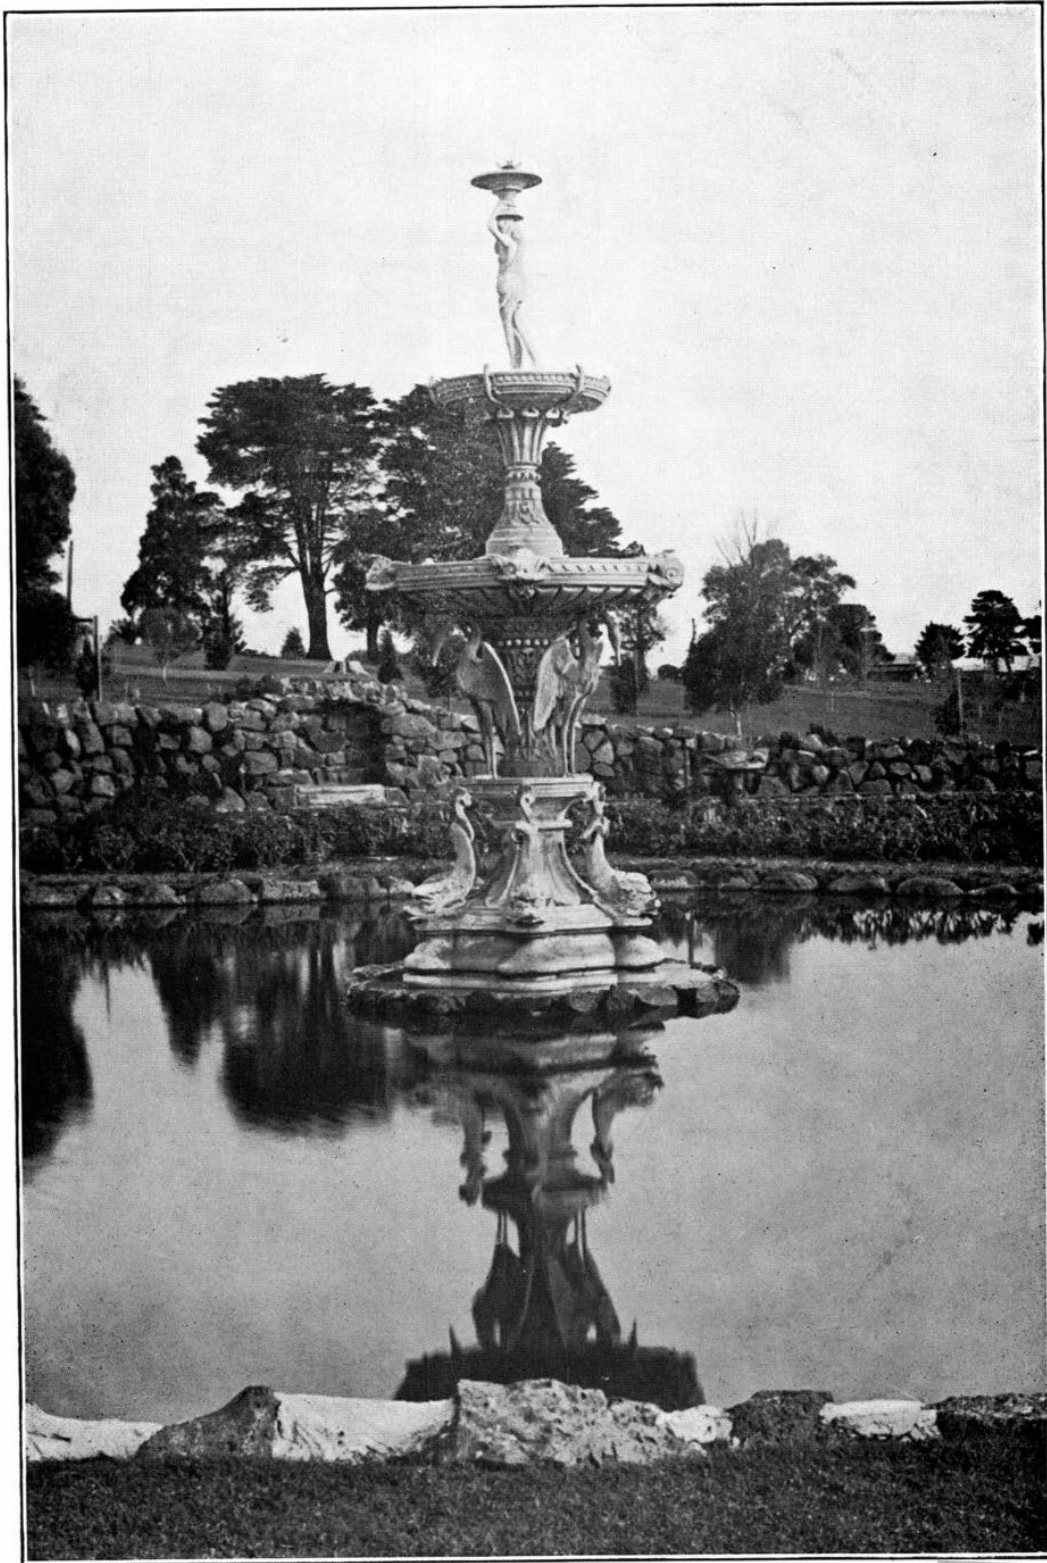
FOUNTAIN AT WATTLE PARK.

The larger fountain to the north consisted of two tiered bowls with edges and pedestals elaborated with fish and birds (Figure 31). In March 2022, the fragments of this fountain were removed for storage. An identical fountain is located at 64 Churchill Street in the nearby suburb of Mont Albert – the fountain appears to have been a commercial design sold in late nineteenth or early twentieth century Melbourne. The Churchill Street fountain was itself reportedly moved from a previous residential address in Balwyn in the late 1920s.<sup>24</sup>

Figure 31 The north fountain at the Lily Pond, 1936  
Source: M&MTB Annual Report

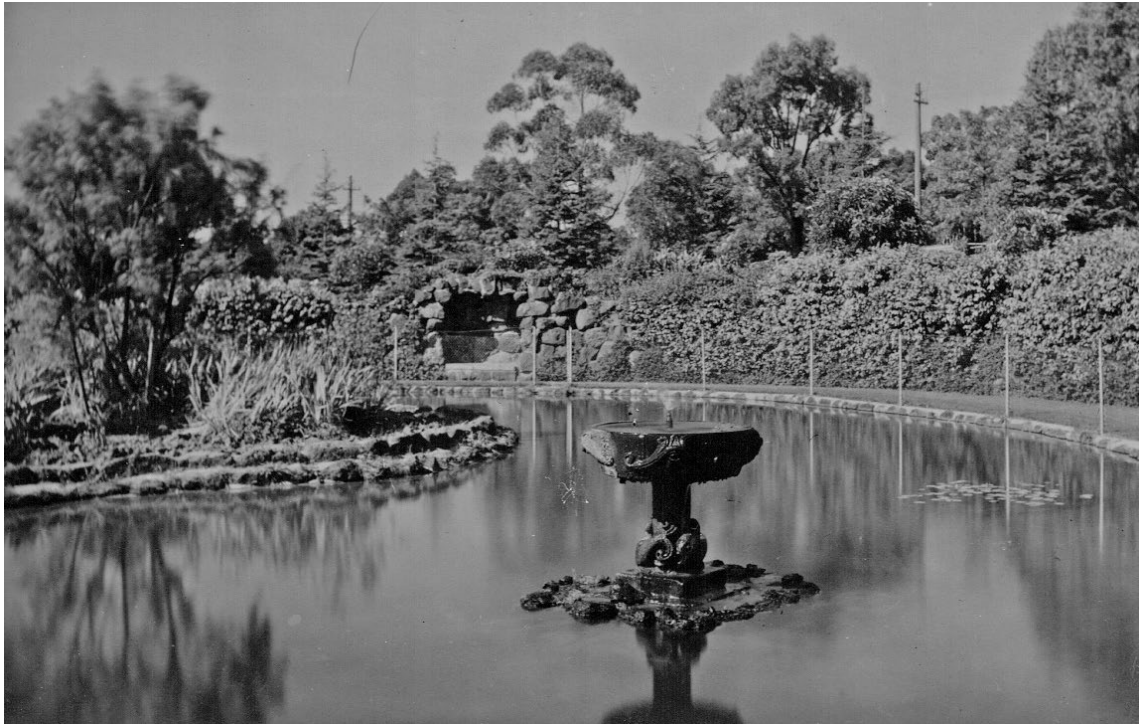
Ten water lily boxes constructed of bluestone were located symmetrically around the pond. The pond was enclosed on the uphill side with a semi-circular bluestone rubble wall with grotto seating. Climbing fig (*Ficus pumila*) was grown over the rubble wall, and a ringing border was planted both upslope (*Photinia serrulata* and other shrubs) and downslope (not extant, plantings of Bottlebrush and Paperbark are more recent) encircling the pond. The pond is reported to have been stocked with goldfish, and is referred to as 'The Fish Pond' in a c. 1940s postcard (Figure 32).

Figure 32 View of the Lily Pond c. 1940: the south fountain is in the foreground and the grotto-style seat is at rear  
Source: Postcard (private collection)

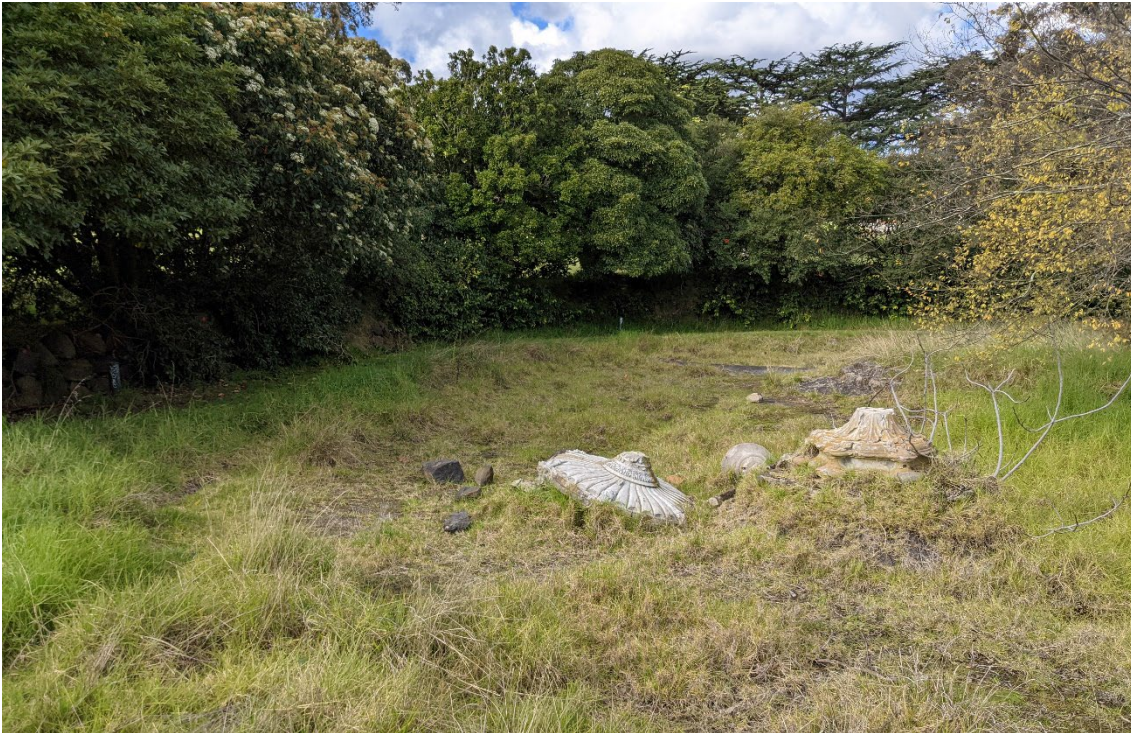
Figure 33 View of the north end of the Lily Pond, September 2021: the fountain fragments have since been removed for storage

The pond dates to a time when formal, programmed use of ornamental features could be supervised to an extent by park staff. As conceived, the Lily Pond was an ornamental feature consistent with a pleasure garden use. The maintenance, programming and security required to maintain such use has not been a feature of the park operations for many decades – the pond is unlikely to have been maintained to original standards since rationalisation of park budgets and management in the 1950s. It has continued to deteriorate due to attrition, vandalism, lack of budget for repairs, and the absence of a programmatic and structural relationship to Wattle Park’s present layout and use.

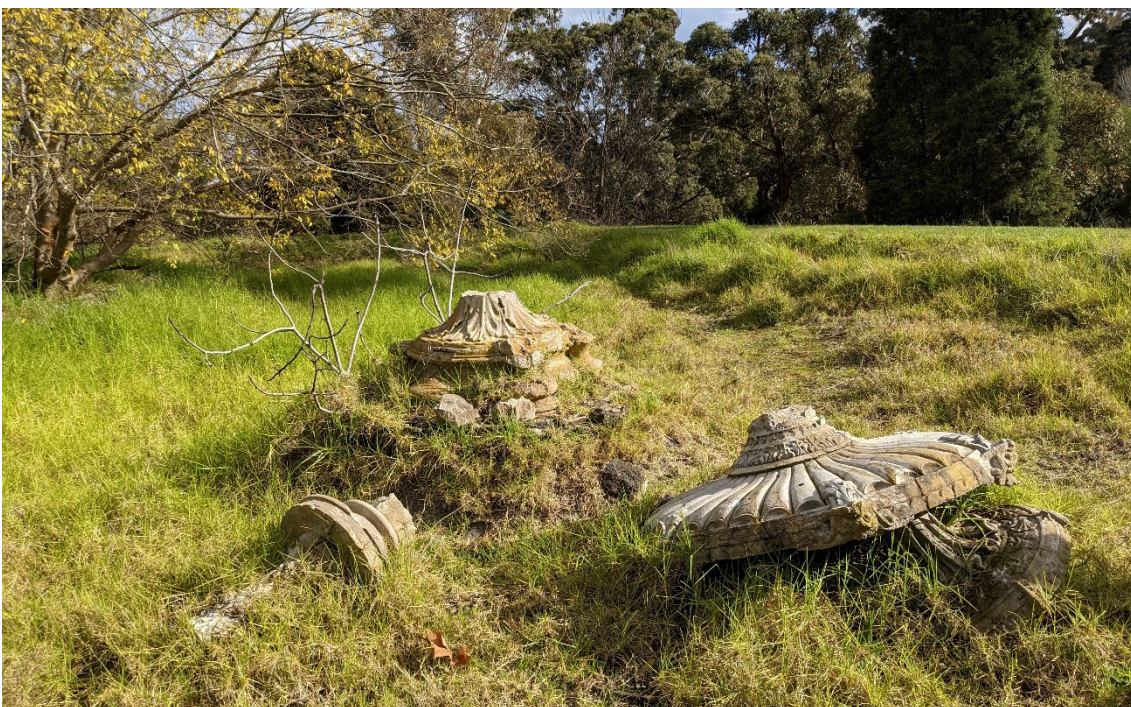
The Lily Pond is in a ruinous condition due to vandalism, physical deterioration of concrete waterproofing and decades of neglect (Figure 33 and Figure 34). The poor condition of the Lily Pond was noted in the 1993 Conservation Plan. An effort to correct the waterproofing of the pond bottom in the mid-1990s was reportedly unsuccessful. In addition to the state of decay seen in 1990s photographs, it was reported in 2007 that ‘the deterioration of the cast and pressed cement fountains is extensive’ and that efforts to access heritage grants to undertake further repair works had proven unsuccessful.<sup>25</sup>

Figure 34 View of the Lily Pond (June 2021)

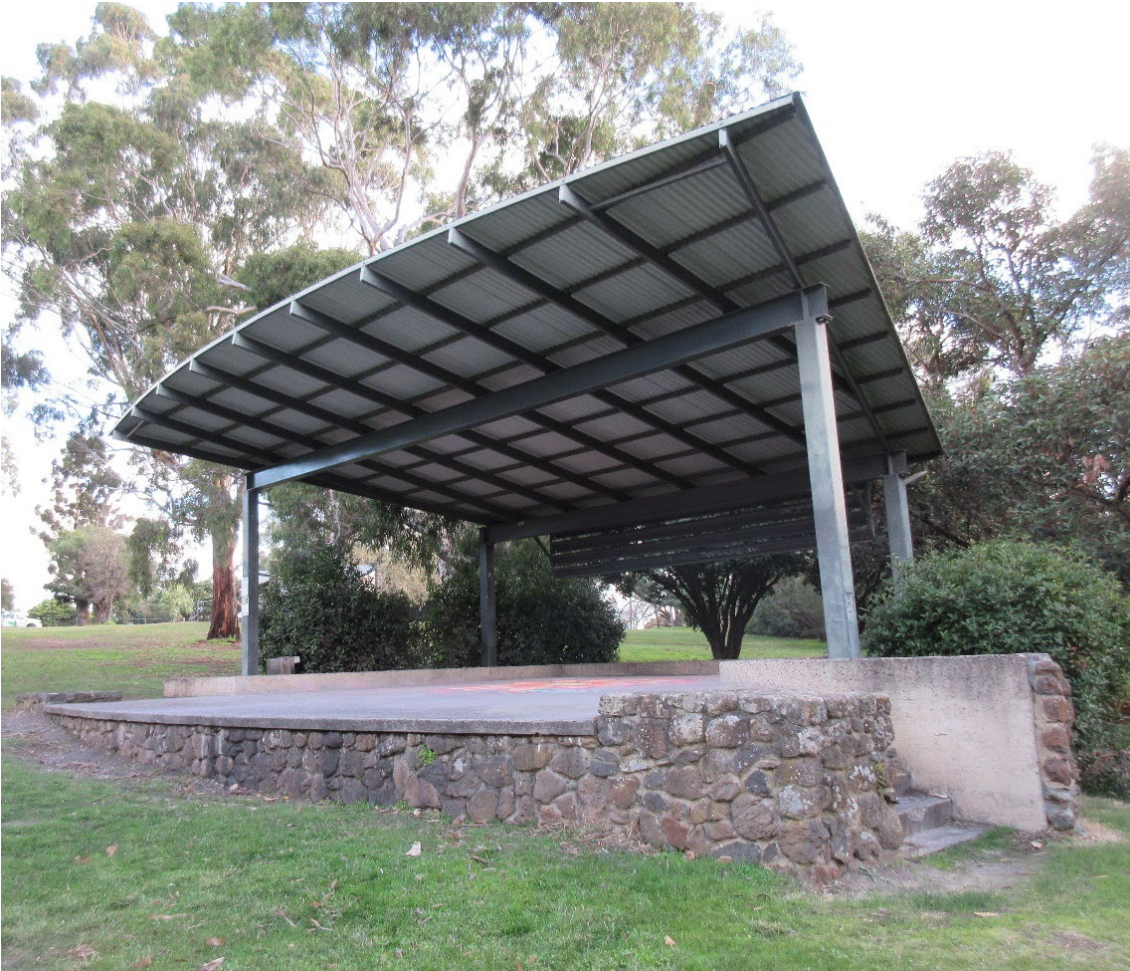
Figure 39 The Band Rostrum

**(Policy 23) The Band Rostrum could be retained and conserved in a state of good repair.**

- Undertake remedial works identified in the 2021 Condition Assessment.
- Manage plantings in the vicinity of the Band Rostrum to maintain an appropriate setting for performances.

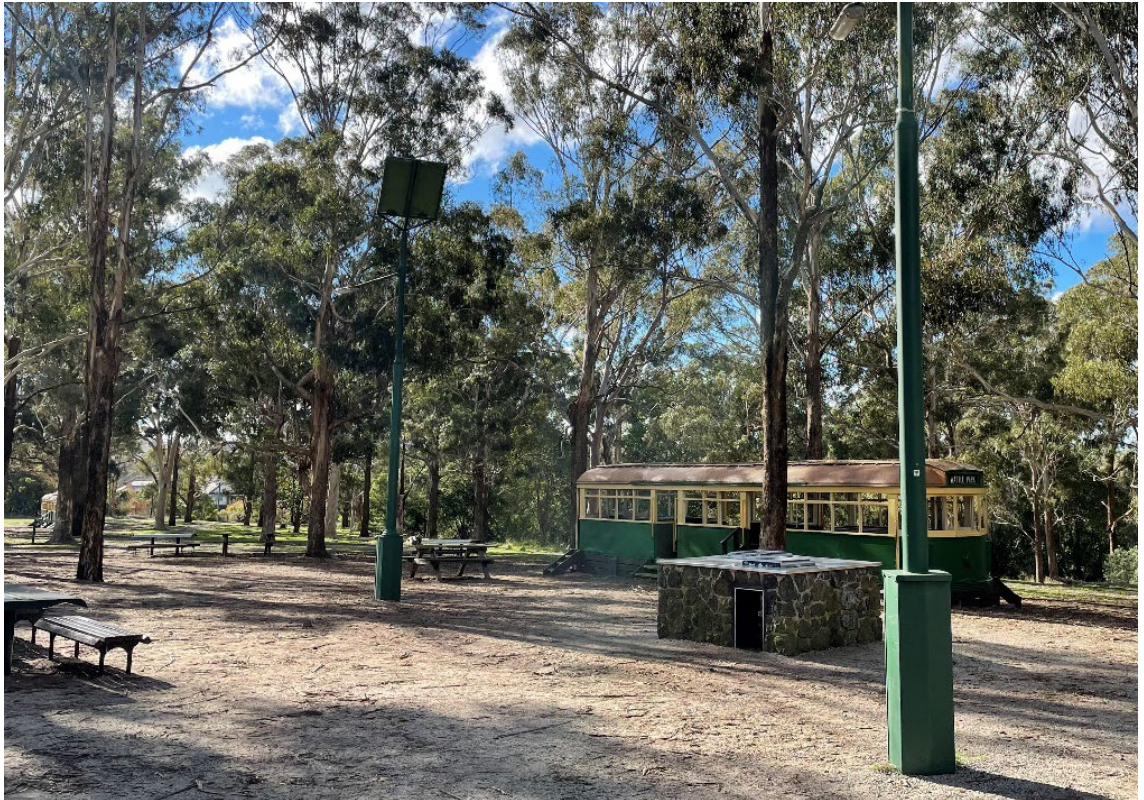
Figure 41 Looking north-east from the picnic area towards the southern tram body, part of the children's playground

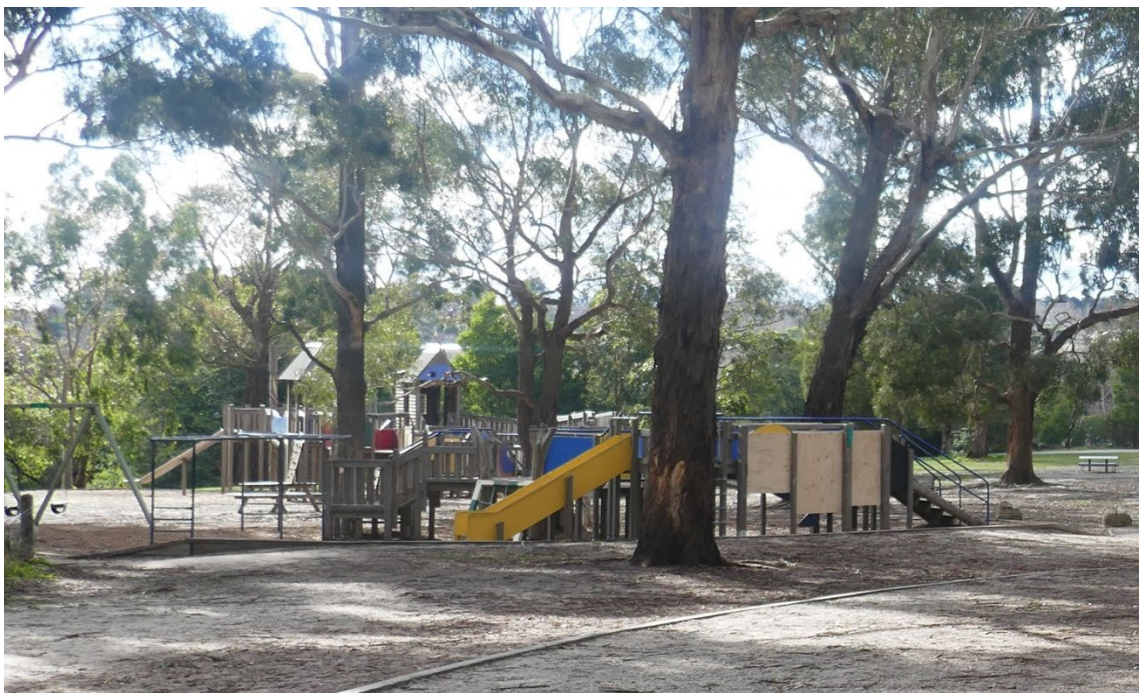
Figure 42 The children's playground (installed in 1997)

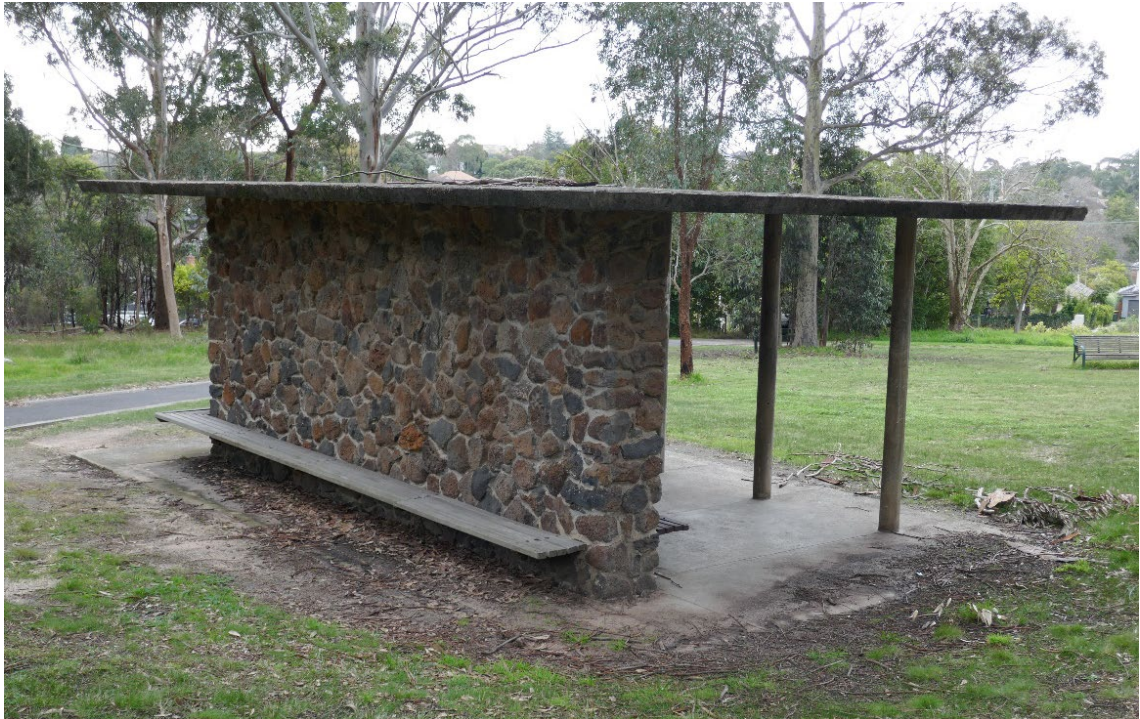
The shelter is essentially an L-shaped random basalt rubble wall with a suspended reinforced concrete slab roof with a bevelled fascia, which is supported by three reinforced concrete columns at the open end (Figure 43). The roof extends in a wide eave over the south and west sides underneath which are timber seats affixed to the wall. Similar seats continue around the inside.

Figure 43 View of the playground shelter looking north-west

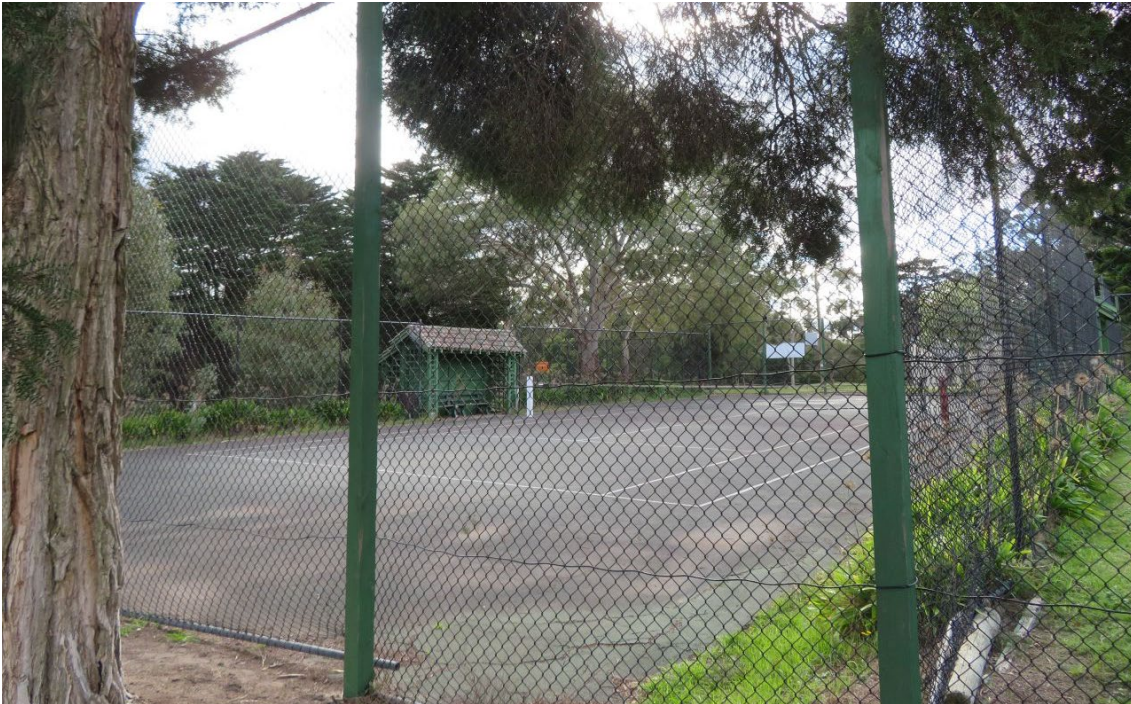
Figure 44 The middle (of three) tennis court

The tennis court precinct is historically significant as part of the original recreation facilities planned by the M&MTB. Aesthetically the two shelters continue the picturesque theme of the English cottage style, which provides a distinctive and unifying theme among the early park structures (Figure 44).

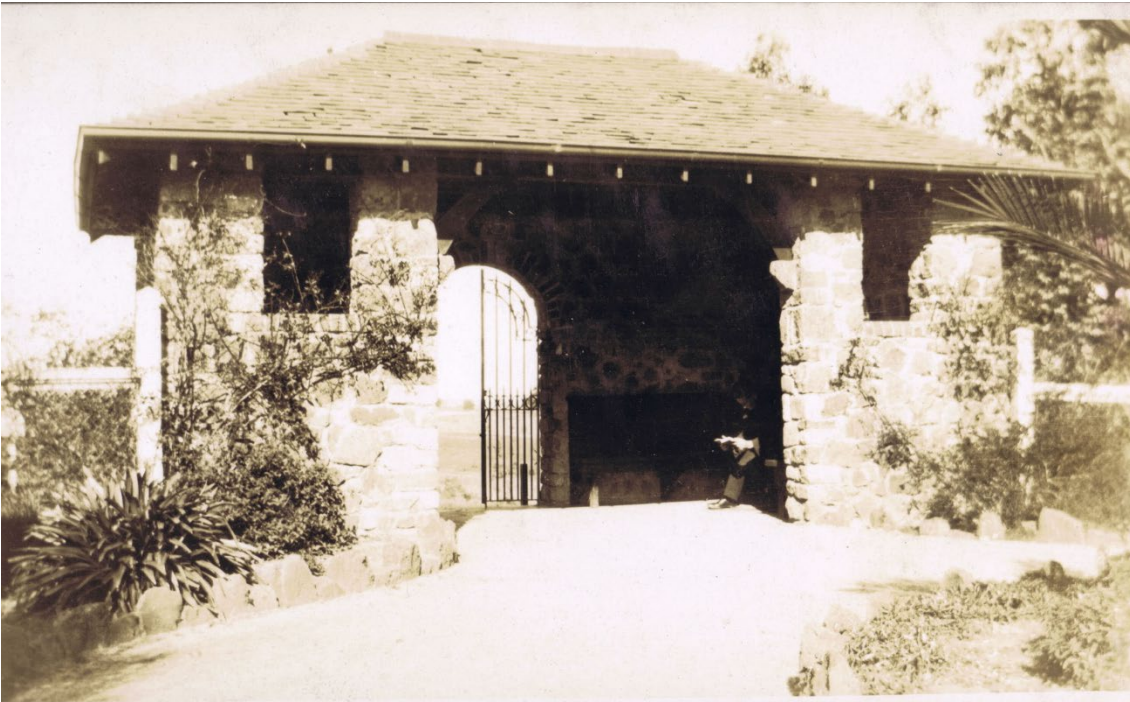
Figure 47 Tram Waiting Shelter at the corner of Warrigal and Riversdale roads, 1930  
Source: M&MTB Annual Report, 1930 (courtesy of the Melbourne Tram Museum)

Two rubblestone tram waiting shelters were constructed by the M&MTB in c. 1928-1929 along the northern boundary of Wattle Park (Figure 47 and Figure 48). The shelters also serve as entries to the park.
