# WATTLE PARK

## CONSERVATION MANAGEMENT PLAN

No. 1012 Riversdale Road, Burwood, City of Whitehorse, Victoria

October 2023

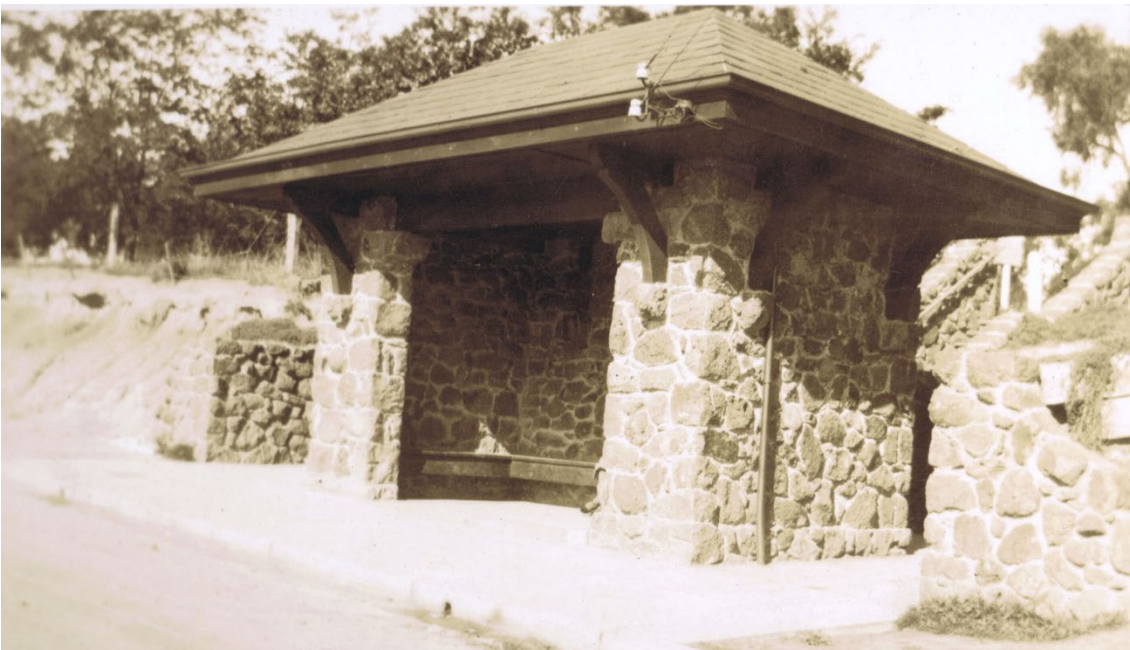
Figure 48 Central Tram Waiting Shelter on Riversdale Road, 1930  
Source: M&MTB Annual Report, 1930 (courtesy of the Melbourne Tram Museum)

Two rubblestone tram waiting shelters were constructed by the M&MTB in c. 1928-1929 along the northern boundary of Wattle Park (Figure 47 and Figure 48). The shelters also serve as entries to the park.

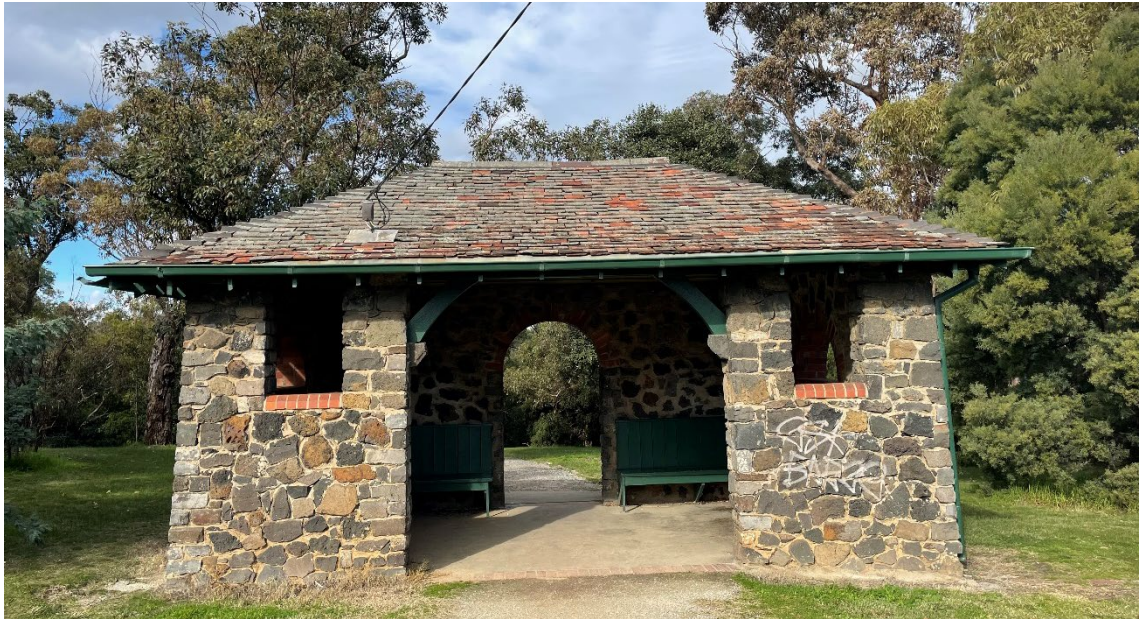
Figure 49 North-west elevation of the Tram Waiting Shelter at the corner of Warrigal and Riversdale roads

The west waiting shelter stands on levelled and slightly mounded ground at the north-west corner of Wattle Park, facing the intersection of Riversdale and Warrigal roads (Figure 49). It is of rubblestone construction with tapered corner piers, arched door and window openings with brick dressings, timber-lined ceiling and interior bench seats, and a hipped terracotta tiled roof (Figure 50). The shelter was originally set within ornamental garden beds, and laid out as a gatehouse, including a pair of iron gates set in the rear archway; a c. 1929 photograph (see CMP cover, see also Figure 47) was taken through this gateway (the gates have since been removed from the site).

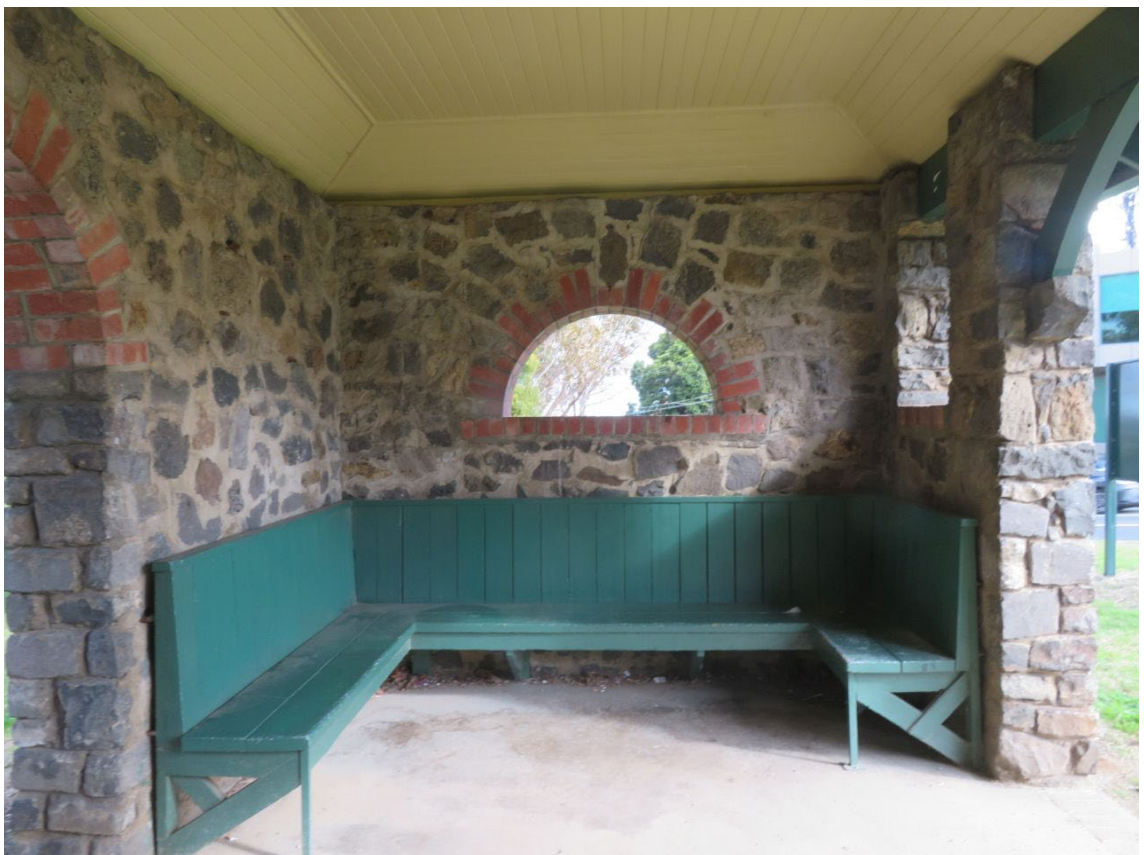
Figure 50 Seating inside the Tram Waiting Shelter at the corner of Warrigal and Riversdale roads

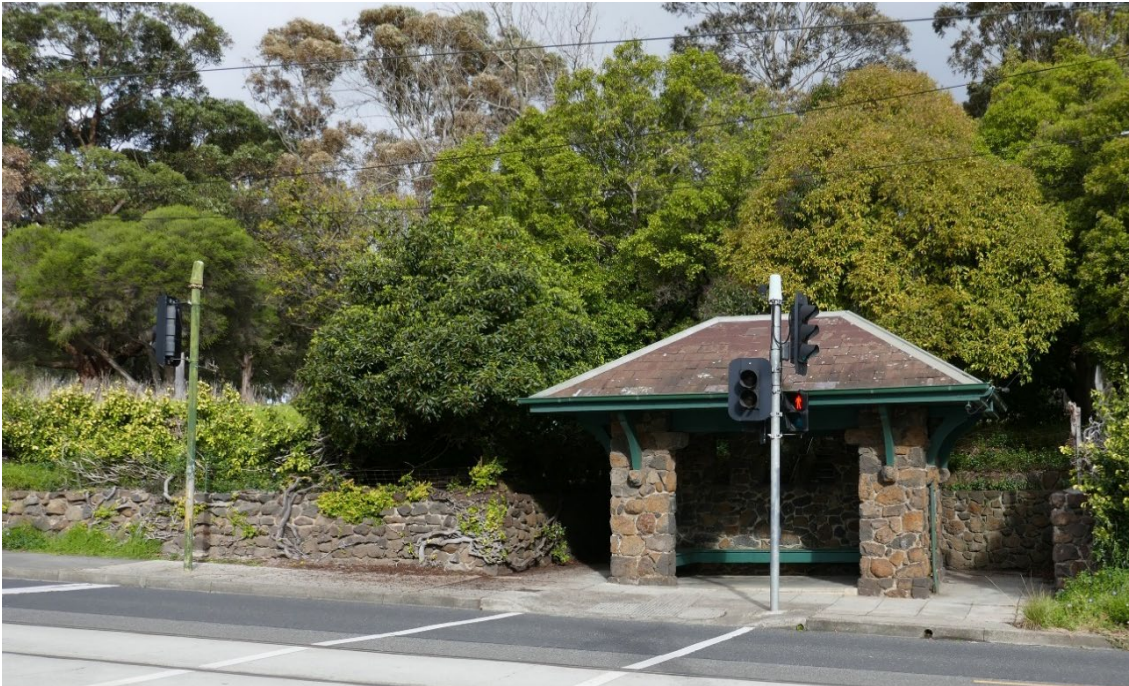
Figure 51 View of the central Waiting Shelter and associated walling from Riversdale Road

The central waiting shelter is set within the several metre deep cutting for Riversdale Road where the tramway was cut through the ridge that runs through the centre of the park. This is a rectangular shelter with rubblestone walls on three sides and an open face to Riversdale Road, with a hipped slated roof supported on massive corner brackets (Figure 51). A timber bench lines the interior walls, with rectangular window openings above on the rear wall. Rubblestone walls retain the embankment and former ornamental planting beds around the shelter (including a series of terraced levels within the planting beds to either side), and a staircase with bluestone risers, recycled slate treads and water pipe handrails takes the entry path over the top of the embankment into the park (Figure 52).

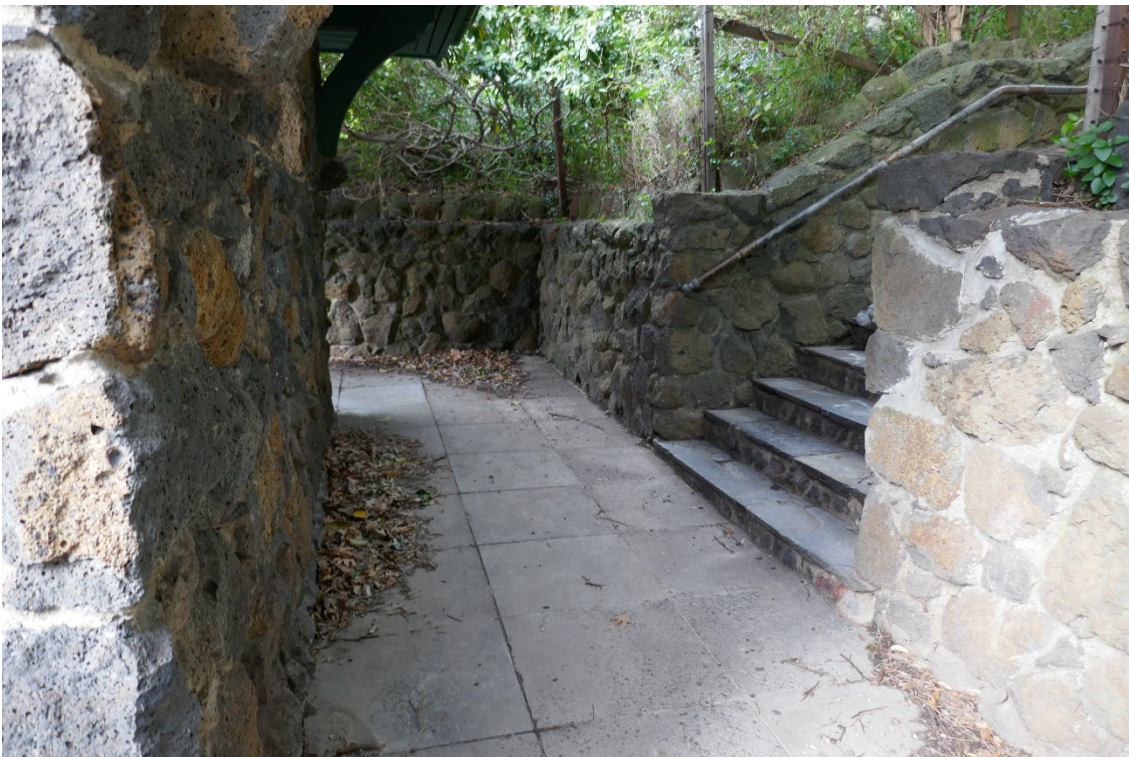
Figure 52 Paved area to the rear of the central Waiting Shelter, with steps providing access to the park

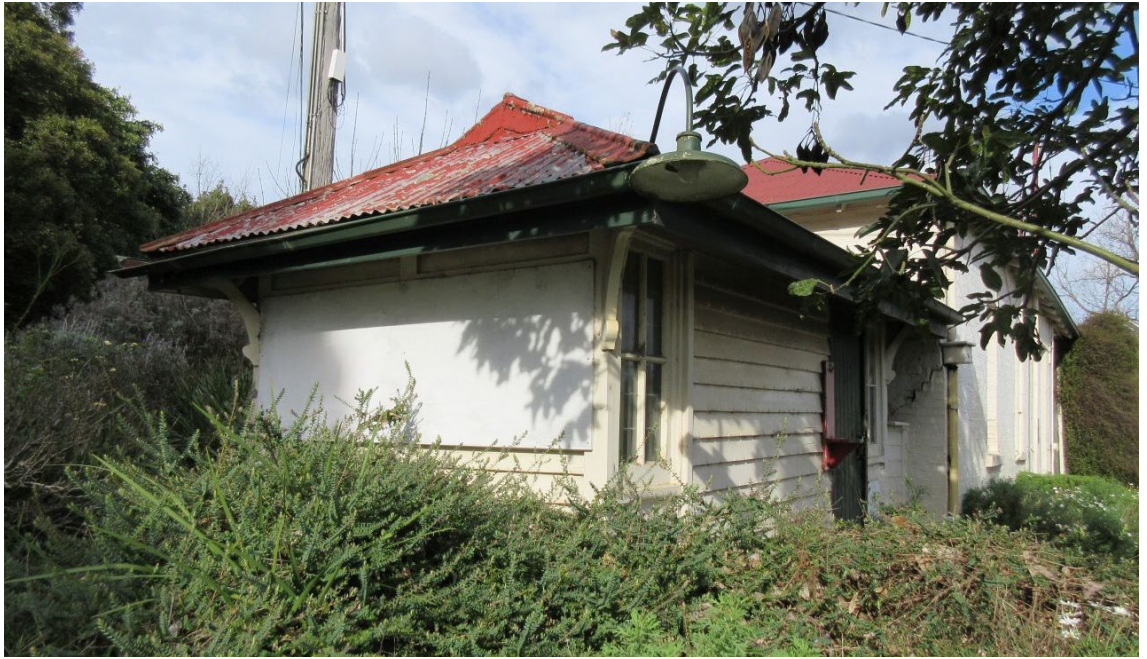
Figure 53 The Curator' Office: west (right) and north (left) elevations, with the Stables visible at rear

The Curator's Office is a small timber building abutting the former Stables (see Section 5.1.3, see Figure 53 and Figure 54). The building was originally constructed as a tram waiting shelter and turnstile for the Prahran and Malvern Tramways Trust's electric tramway in Dandenong Road, to a design by Leonard J. Flannagan. It is a shingled weatherboard building, with a Dutch gable roof supported on decorative timber brackets, chamfered corner posts and exposed internal trusses.

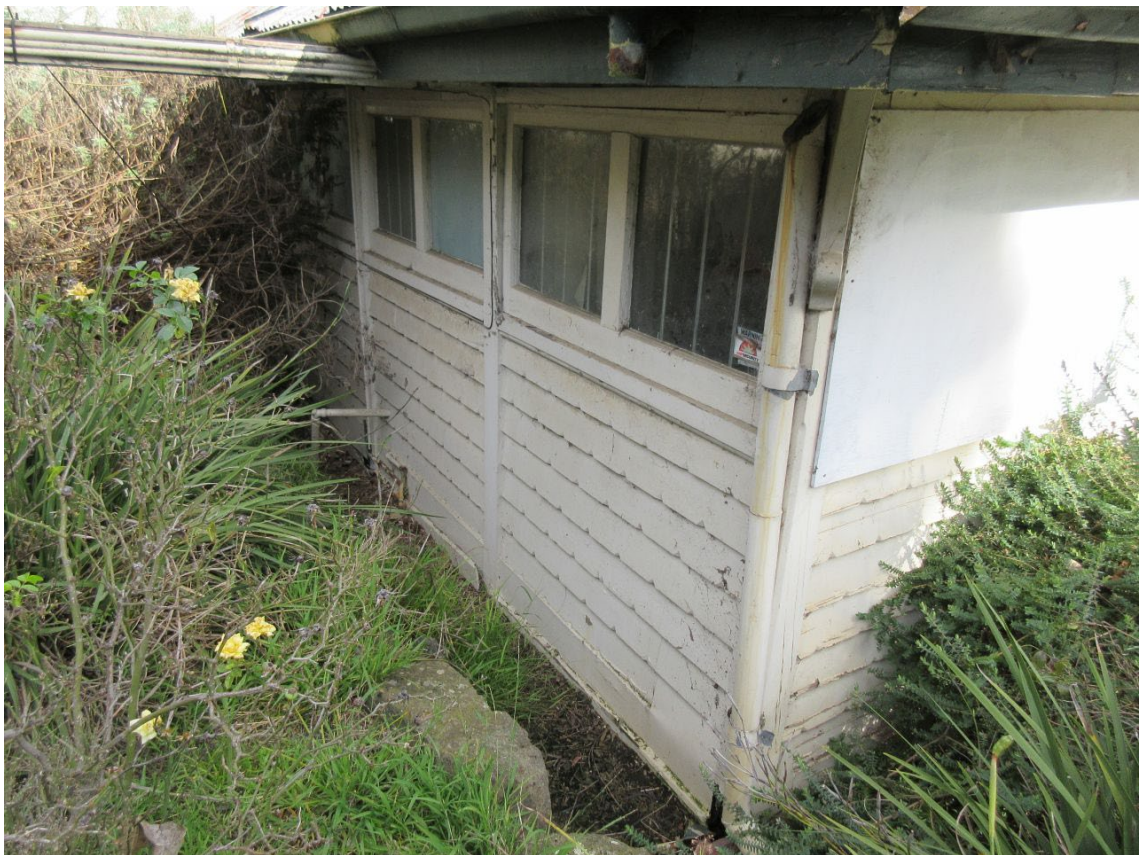
Figure 54 The rear elevation of the Curator's Office

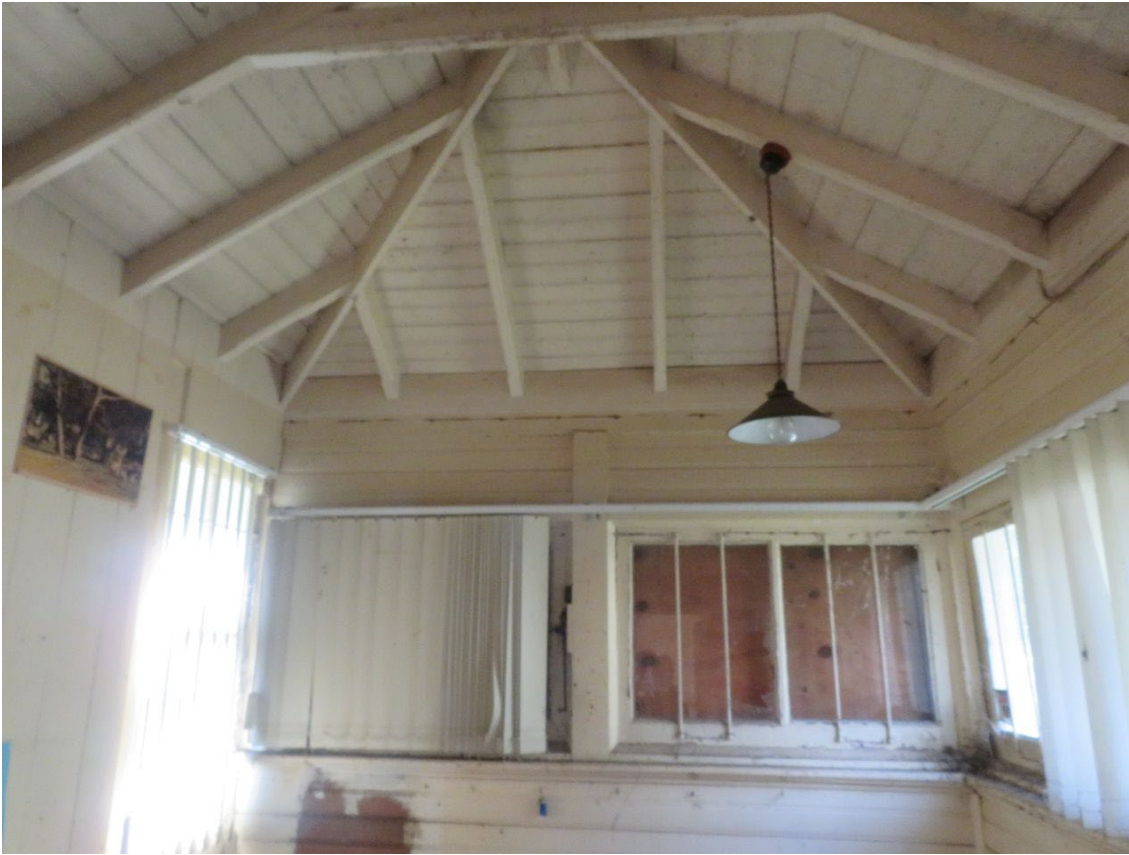
Figure 55 Ceiling detail

The tram shelter was relocated to Wattle Park in c. 1927-1932, and adapted as a site office, including completion of the building weatherproofing and installation of doors and pivot sash windows. The building includes various original and adapted internal finishes, hardware, built-in cupboards and other joinery (Figure 55).

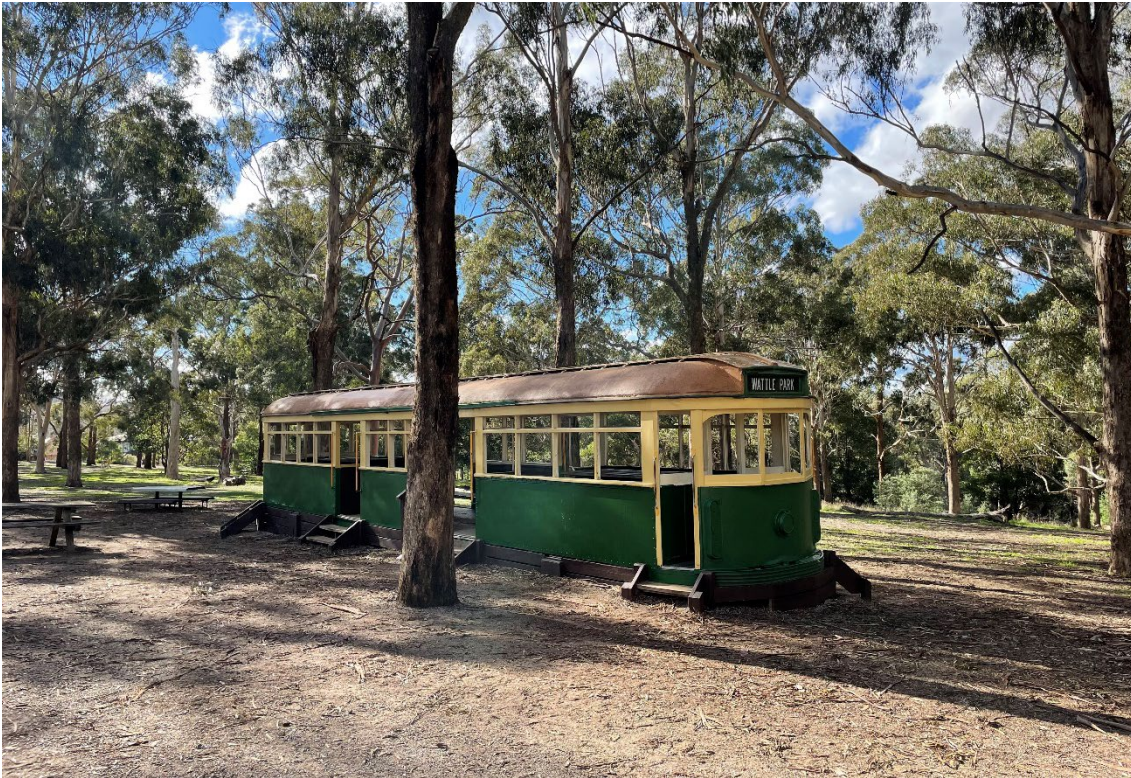
Figure 56 The southern W Class tram body

- Correct existing material damage to return the tram bodies to a safe condition.
- Undertake regular preventative maintenance including painting, roof and gutter maintenance, and repair of damaged timber and metal elements.

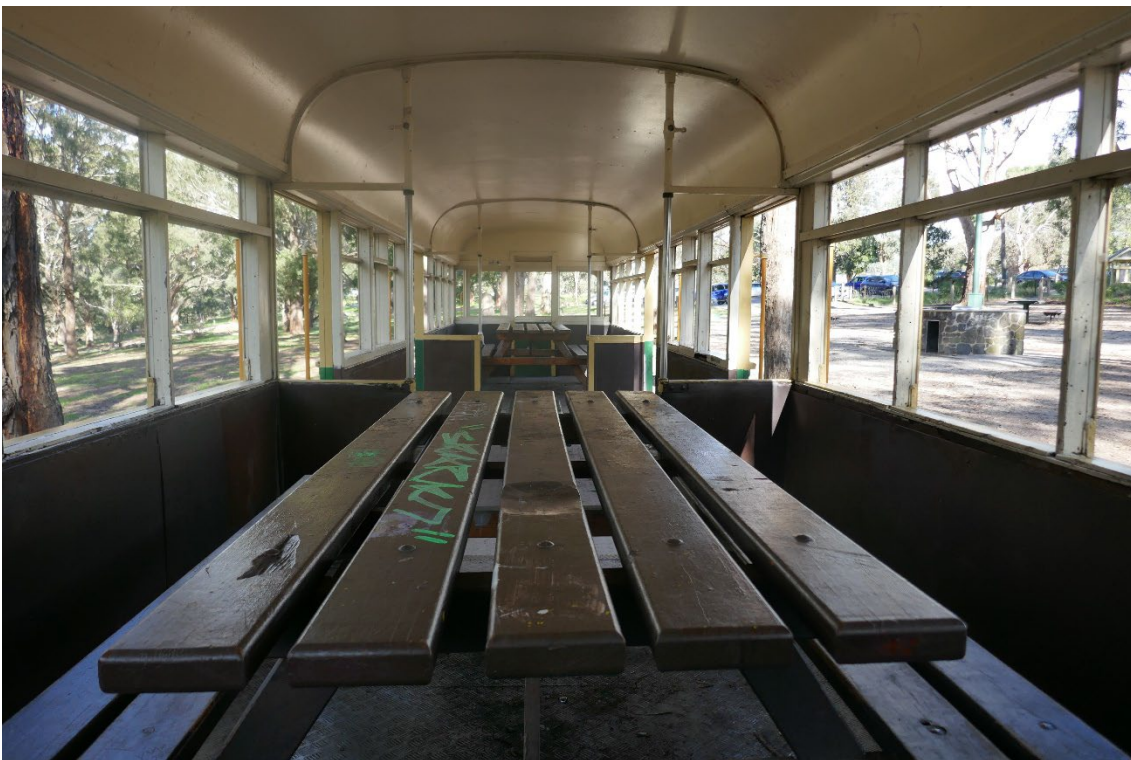
Figure 57 Tram interior, as adapted

The condition of the current tram bodies is poor. There is substantial damage and deterioration of the timber and steel sheet materials in each body due to vandalism, weathering and corrosion, and insufficient regular maintenance of painted surfaces to protect the underlying materials. The entry stairs to each tram shelter are not compliant (Figure 56 and Figure 57).

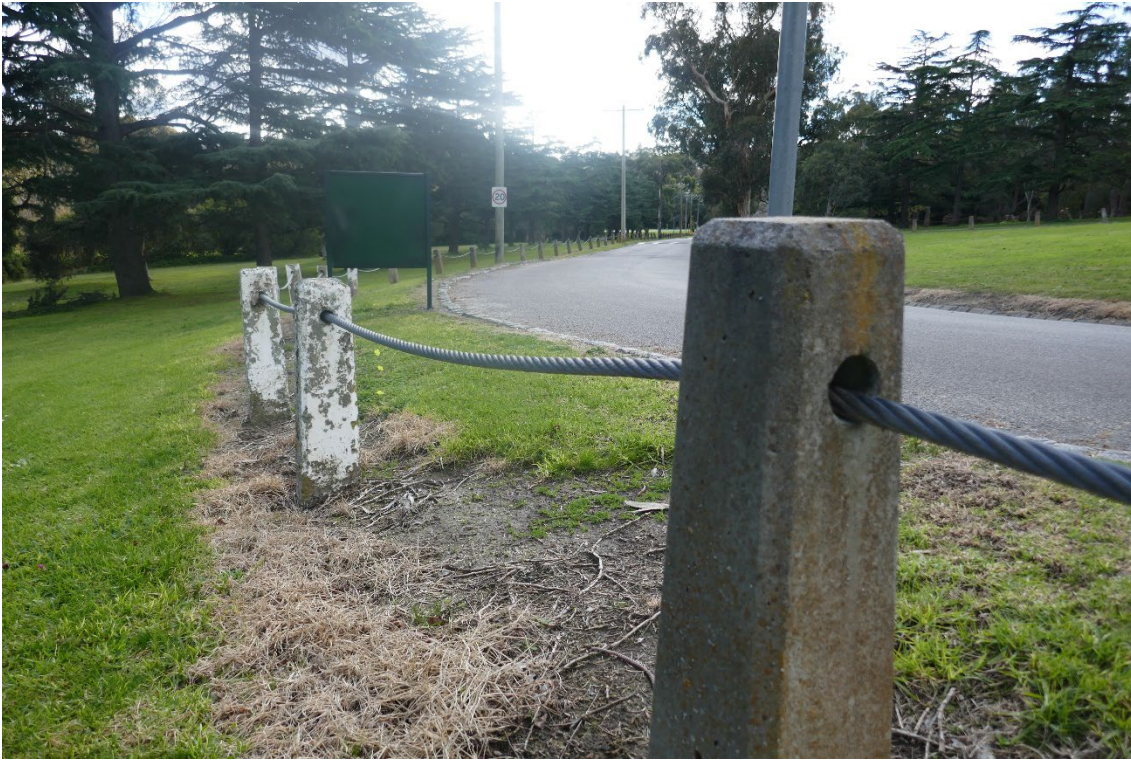
A survey of the current condition of the cable fencing was prepared by Aecom in 2021. Excluding those used as bollards, nearly 30 per cent of the concrete posts presumed to be in original positions were found to have a material or structural fault (compromised footing, existing supporting pickets or concrete damage).

Figure 58 The age, condition and presentation of the concrete bollards varies

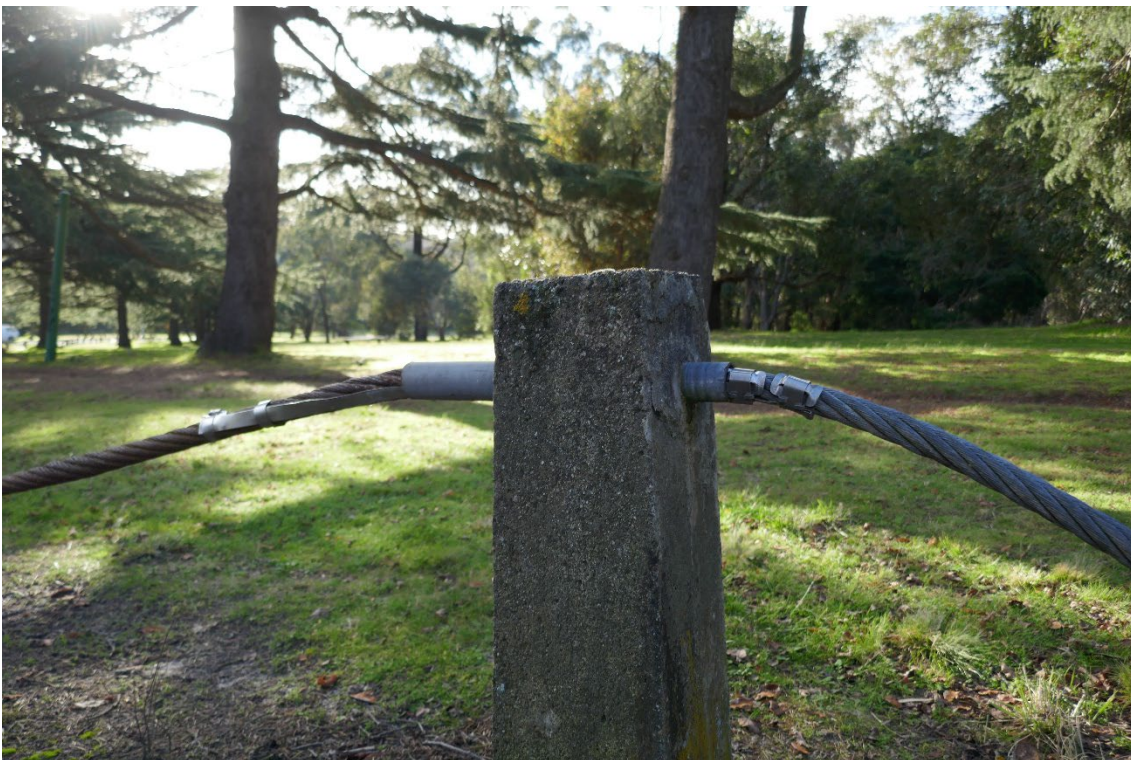
Figure 59 Evidence of previous efforts to make-good failed sections of cabling

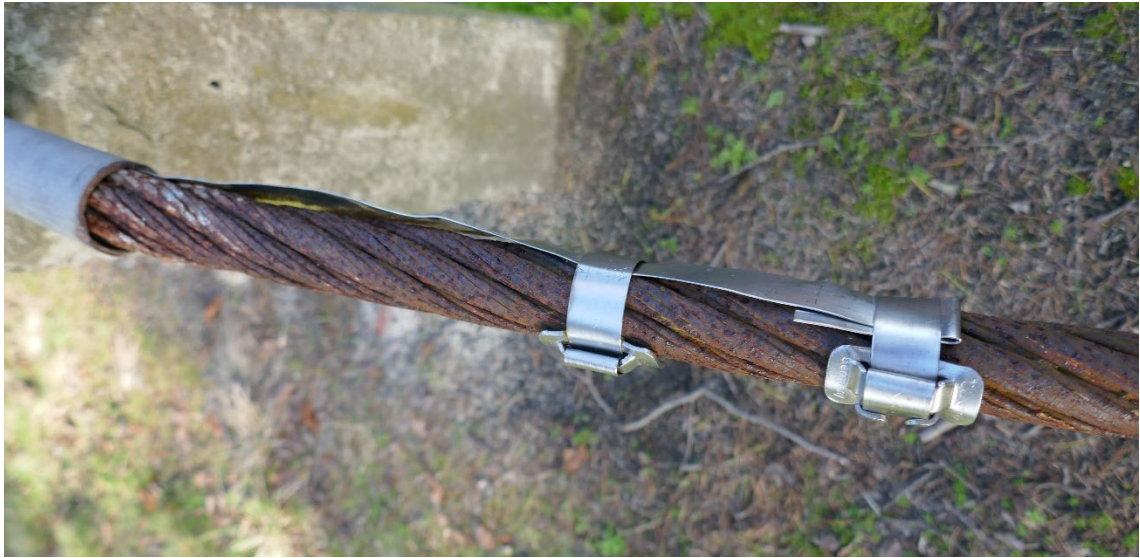
Figure 60 Evidence of previous efforts to make-good failed sections of cabling

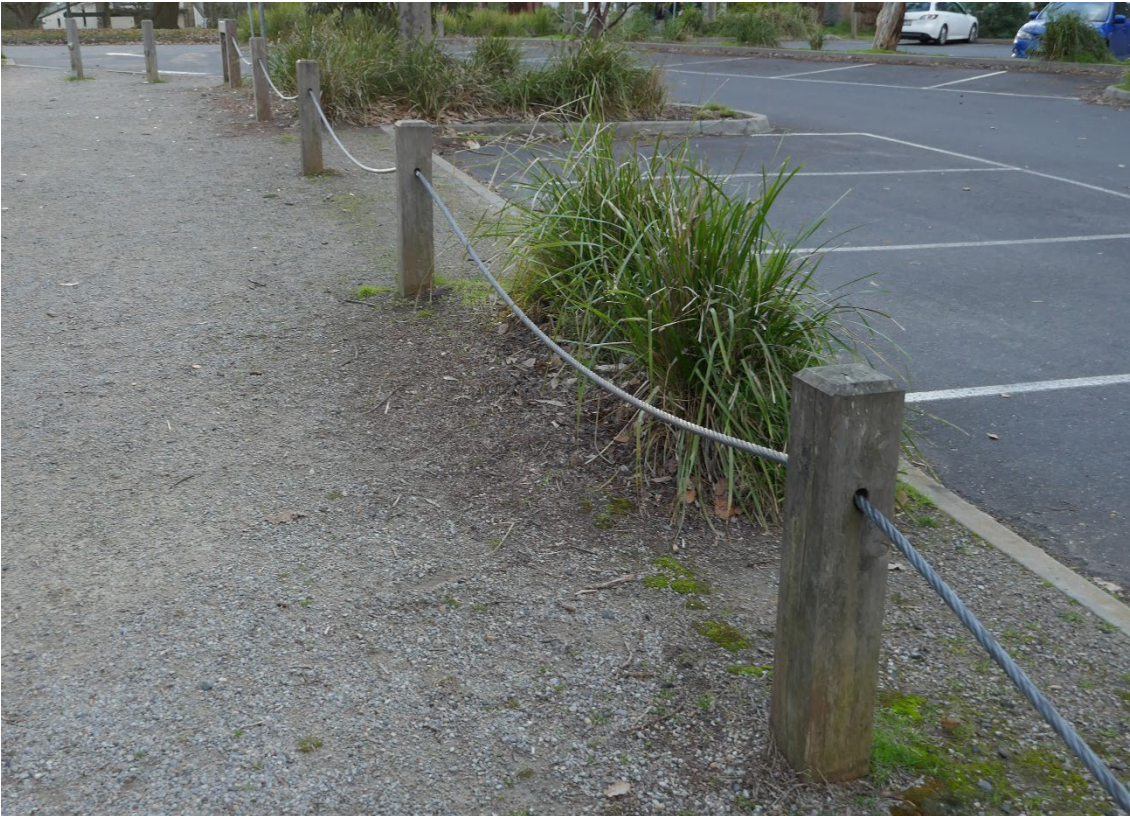
Figure 61 Modern fencing at the Chalet car park referencing the original cable fencing

The representation of the original arrangement in different materials (i.e. timber posts with modern cabling, as per the installation at the Chalet car park, Figure 61) may reasonably be contemplated for the balance of the fencing.

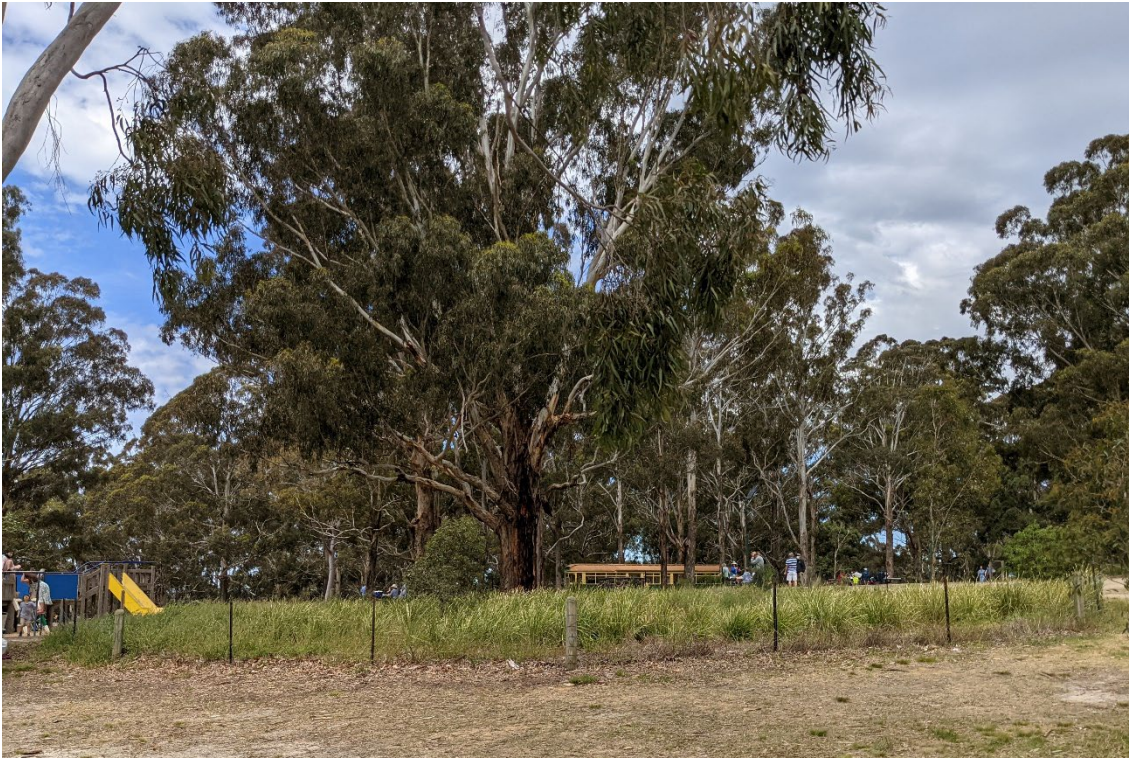
Figure 67 Native trees within fenced native groundcover beds east of the Chalet

Fenced native groundcover beds recently established east of the Chalet support the retention of a number of planted native trees and some trees large enough to possibly predate the park development (Figure 67).

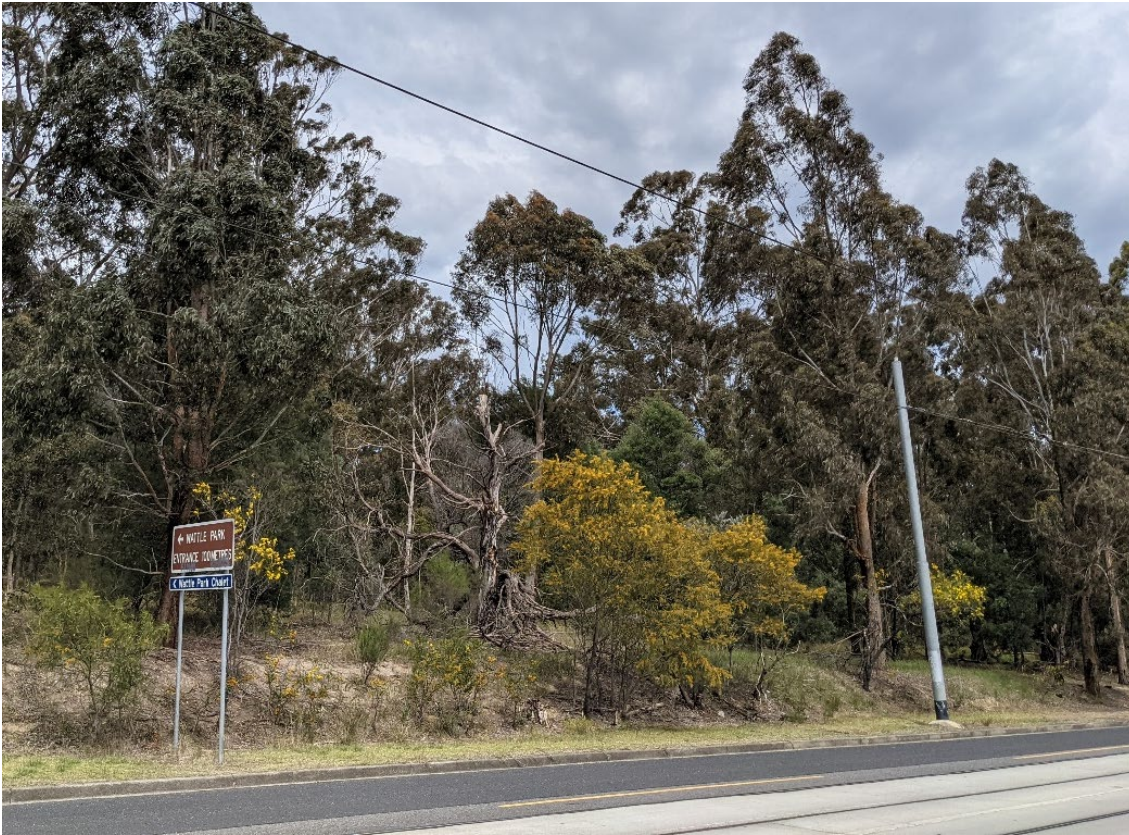
Figure 68 Riversdale Road boundary: the wattle perimeter is much reduced

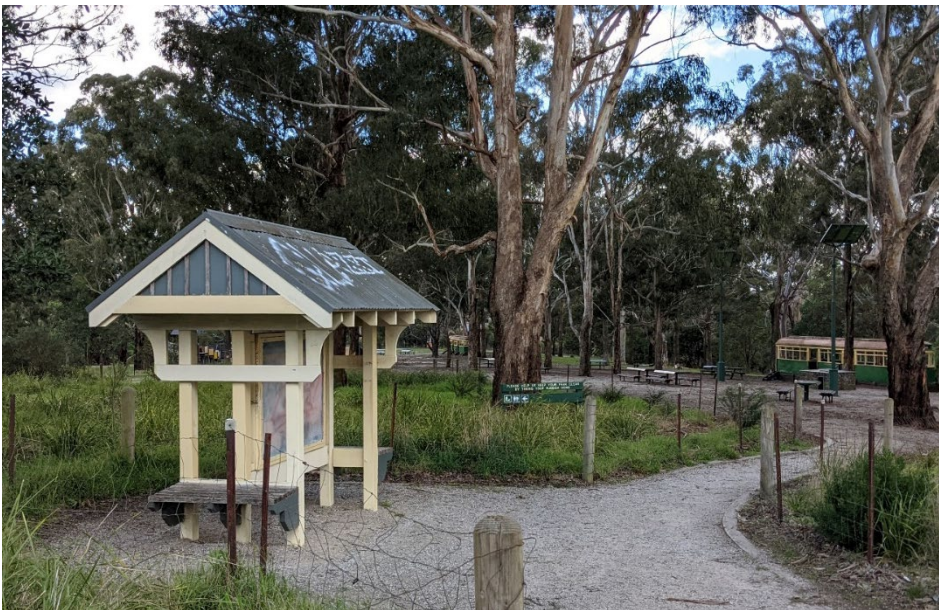
Figure 70 Shelter to the north of the Chalet car park

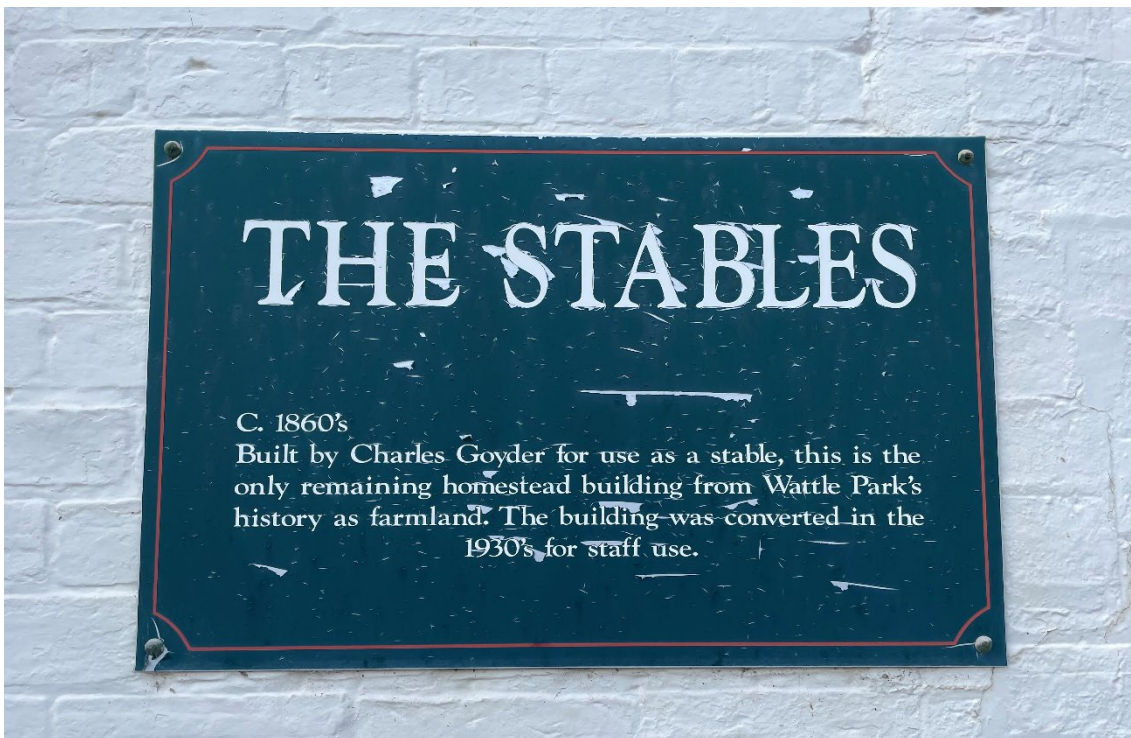
Figure 75 Old generation signage mounted to the wall of the Stables

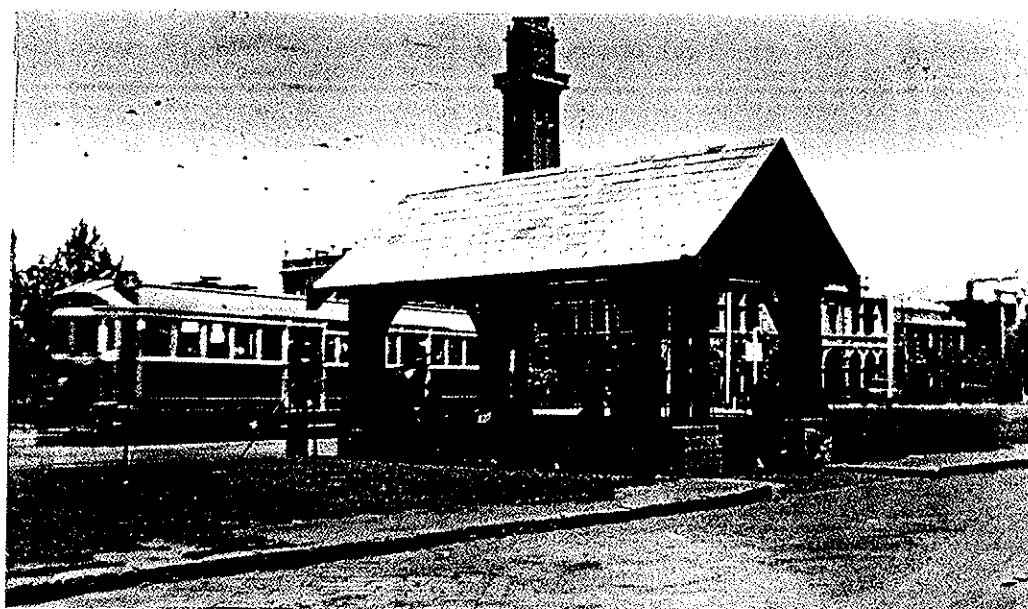
*Figure 13 This 1933 tramway shelter still stands at the corner of Victoria Parade and Brunswick Street,. Source: Tramways Museum Society Collection.*

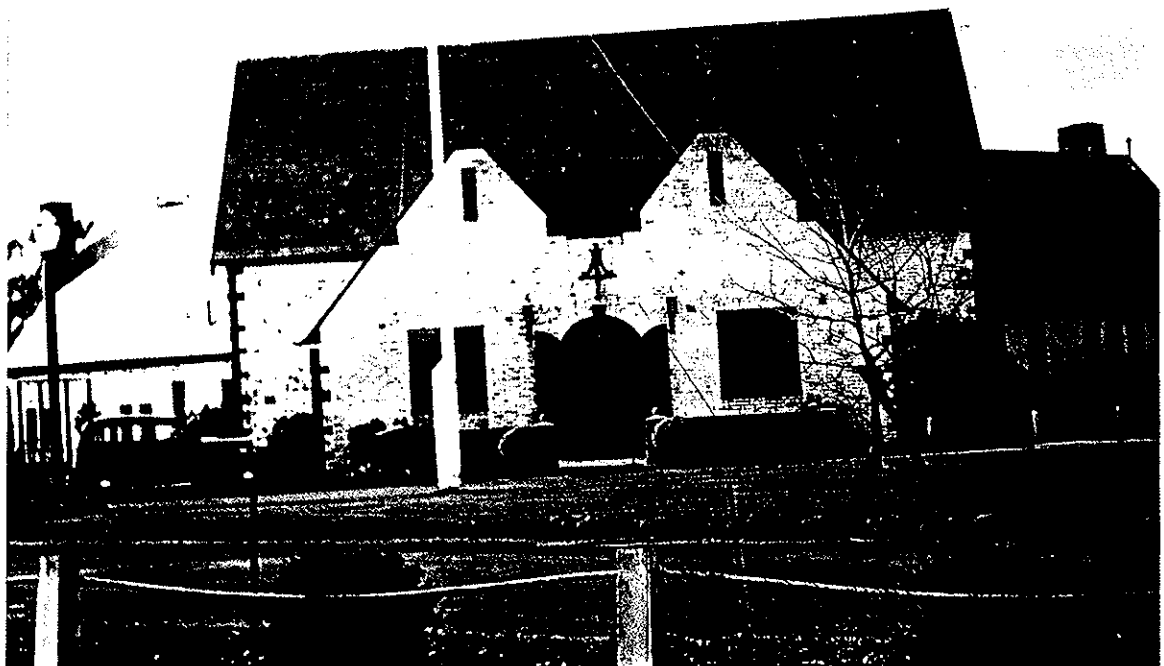
*Figure 17 View of the front of the Chalet in 1936. Note light, flagpole and newly planted tree in the turnaround. Reproduced from the M&MTB Annual Report, 1936.*

In order to provide meals and entertainment for the increasing number of visitors, the 'Chalet' was constructed in the Park. It is the only major building ever constructed in the Park and was designed by Monsbrough in the English domestic style after Lutyens. (Figs 17 and 18) Its construction was commenced in 1928.<sup>106</sup> Being situated on the highest point of the Park and having a steeply pitched roof, the building was soon referred to as the Tramway Board's 'Buffalo', due to its similarity to the guest house at Mount Buffalo in north west Victoria, acquired by the Victorian Railways in 1924.<sup>107</sup>

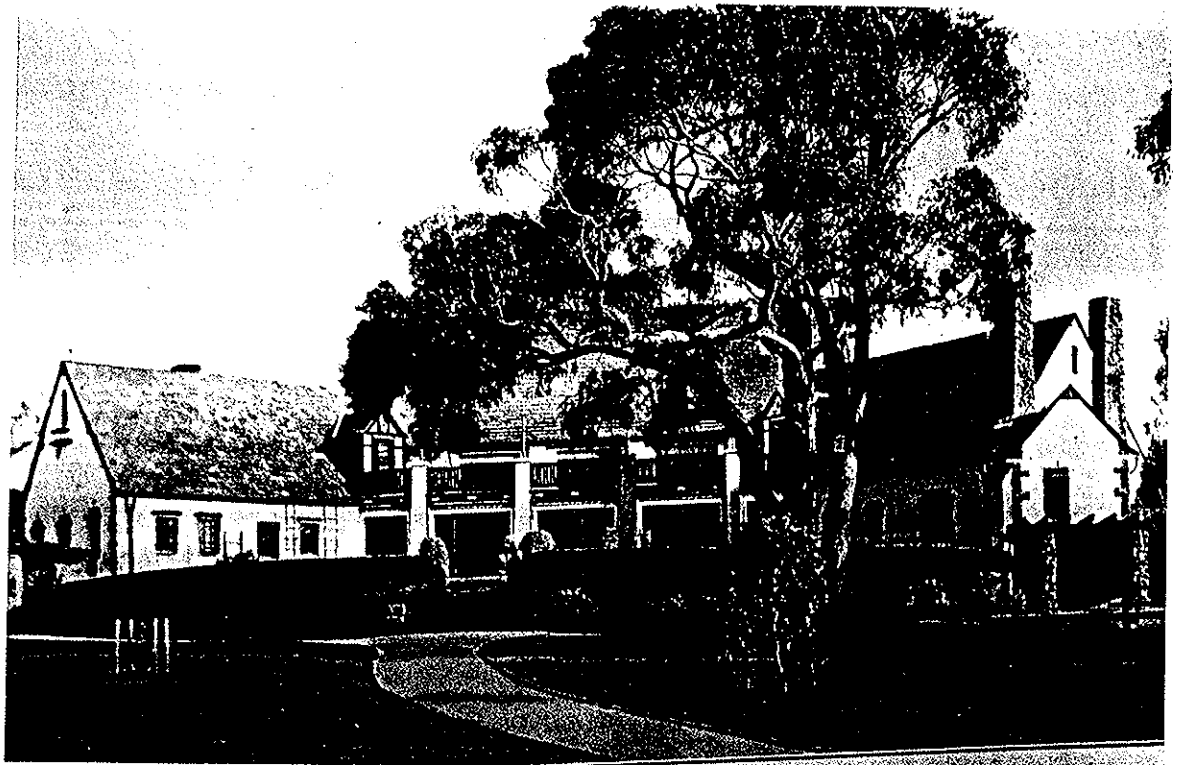
*Figure 18 Rear view of the Chalet in 1949. Reproduced from the M&MTB Annual Report, 1949.*

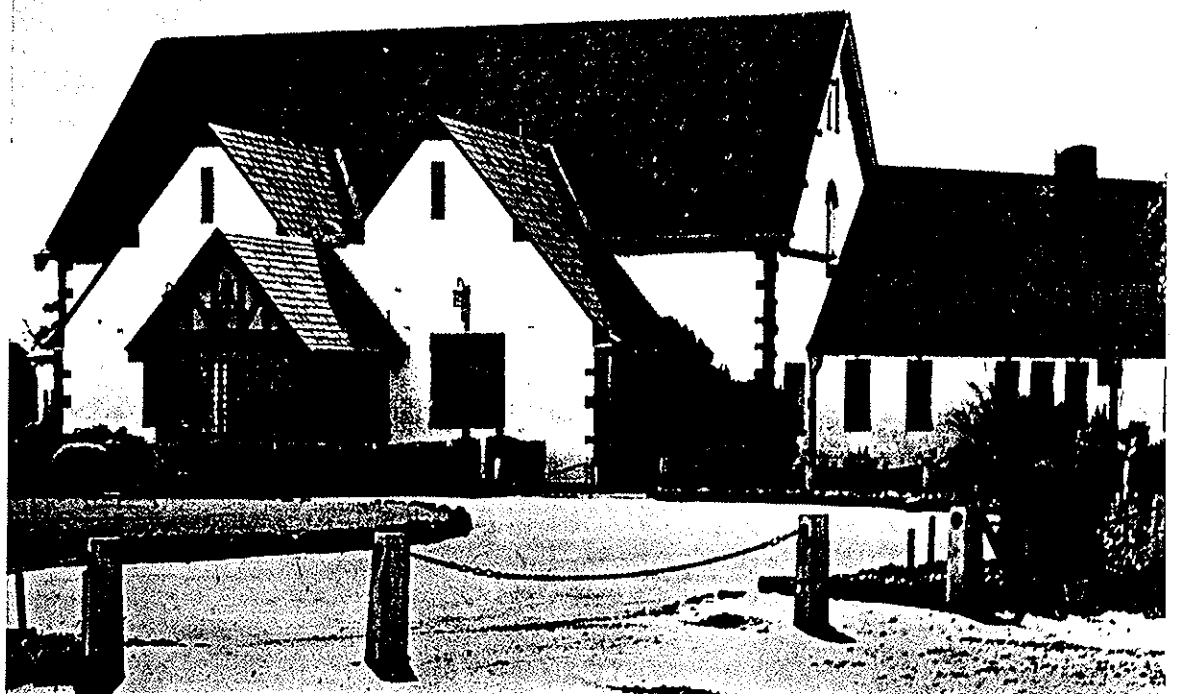
*Figure 21 The Chalet, Wattle Park showing the new porch entry. Reproduced from the M&MTB Annual Report, 1937.*

J Howatt became the first lessee of the new building, and soon offered a 'Chalet Party Night' every Saturday with dancing and refreshments for three shillings, and orchestral concerts on Sundays (Fig. 20).<sup>108</sup> The Chalet was an instant attraction. By October 1928 the Chalet was serving afternoon tea to over 500 patrons on Saturdays and Sundays.<sup>109</sup> On Cup Day of the same year more than 30,000 people visited the park.<sup>110</sup> In 1937, a new porch was added to the Chalet (Fig. 21).

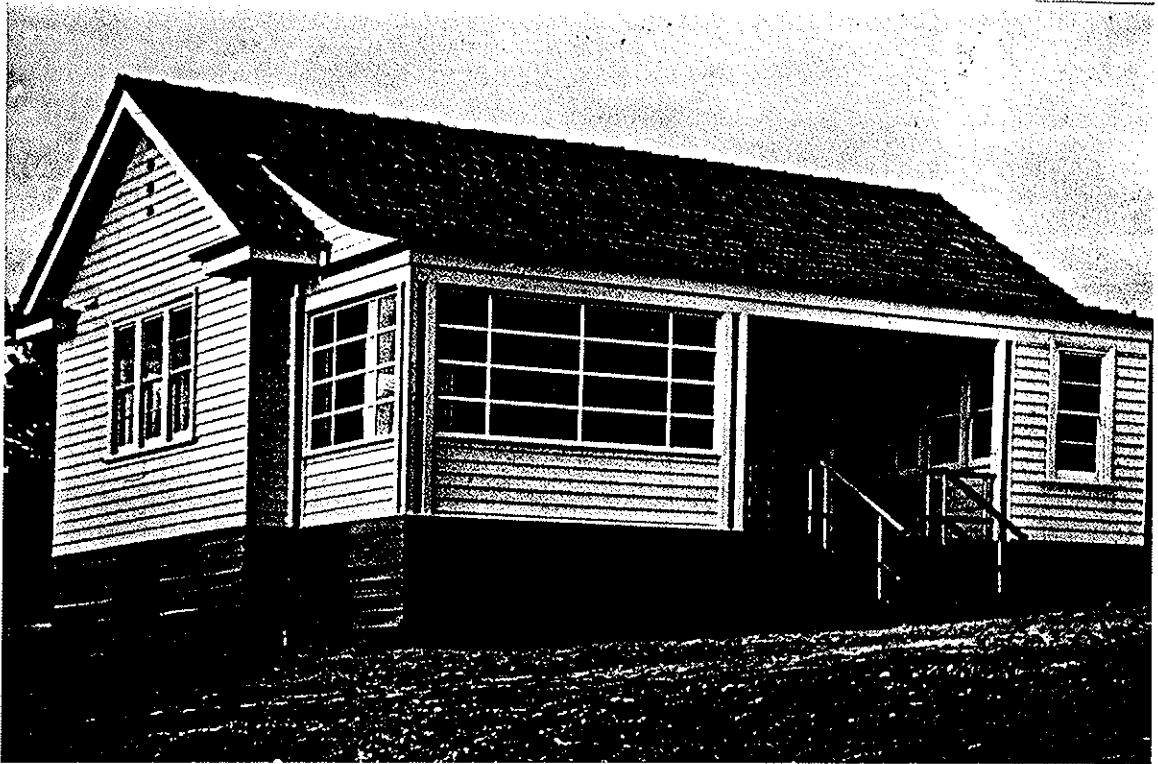
Figure 29 *The New Golf House, pictured in 1937. Reproduced from M&MTB Annual Report, 1937.*

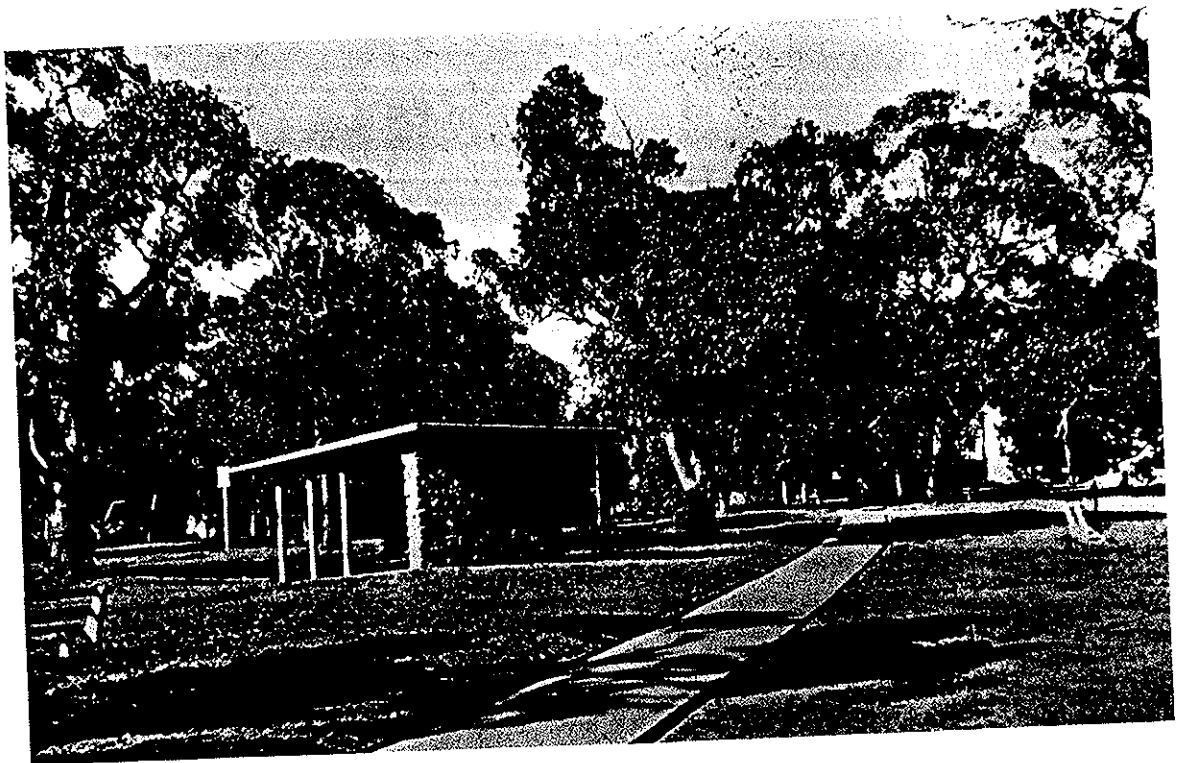
*Figure 33 This shelter in the Children's Playground was constructed in 1952. Reproduced from the M&MTB Annual Report, 1952.*

The last major improvements to the park's building stock occurred in the 1950s and early 1960s with the construction of a stone and concrete shelter in the children's playground north of the chalet (1952, Fig. 33), timber dressing sheds beside the sports oval (1959), a timber golf club house (1960, Fig. 34) and the concrete block golf professional's shop (1963).<sup>150</sup> These buildings were designed by the board's architect H R Steains, who succeeded Monsborough in 1938.

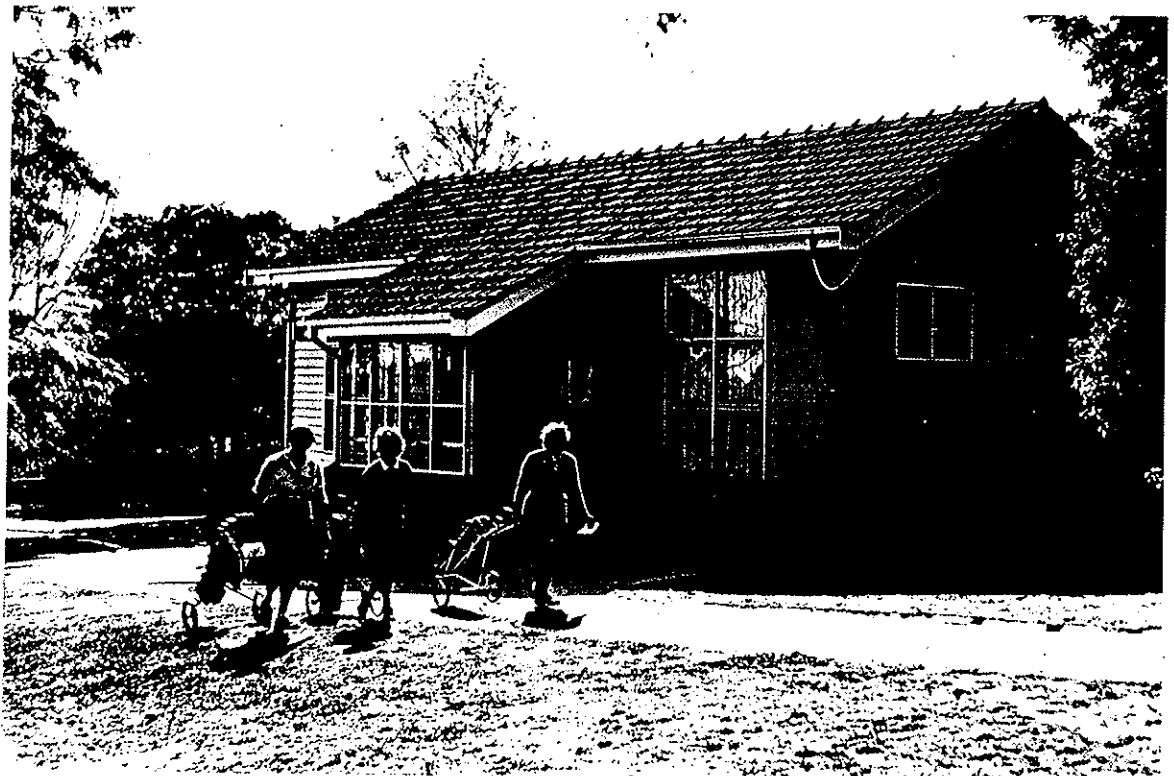
*Figure 34 The Board's architect, H R Steains, designed the new golf house, which was constructed in 1960. Reproduced from M&MTB Annual Report, 1960.*
