# WATTLE PARK

## CONSERVATION MANAGEMENT PLAN

No. 1012 Riversdale Road, Burwood, City of Whitehorse, Victoria

October 2023

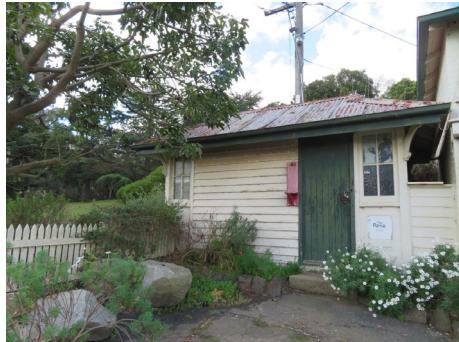
| Building Number | Building Name | Year |
|---|---|---|
| | A single-story shingled weatherboard structure (former Tramways terminal) with a Dutch gable roof supported by decorative corner brackets and chamfered corner posts. | |

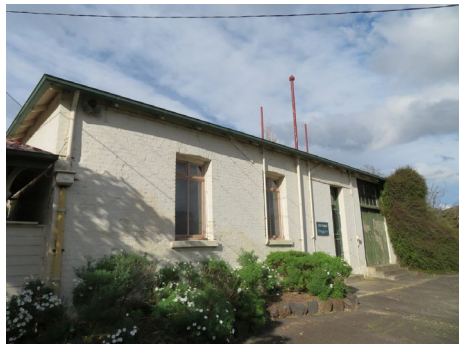
| Building Number | Building Name | Year |
|---|---|---|
| | A single storey brick structure on bluestone / rubble footings. Segmental heads to door and window, openings and hipped corrugated iron clad roof with raked eaves. | |

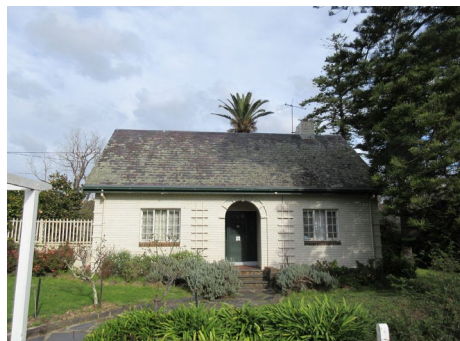
| Building Number | Building Name | Year |
|---|---|---|
| | A small single storey brick building with a gabled slate roof at the front, and a lean-to at the rear with a sheet metal roof. Steel casement windows, clinker brick window dressings, a centrally placed entry door beyond the arched porch, and slate paving to the front door. | |
| <p>Condition and integrity both noted as good in Appendix B-13.</p> <p>Recommends repairing the slate roof and remove the lichen, and retaining and conserving the external fabric and principal interior decorative features. Notes scope for internal adaptation to offices and meeting spaces, and that the porch has been infilled.</p> | | |

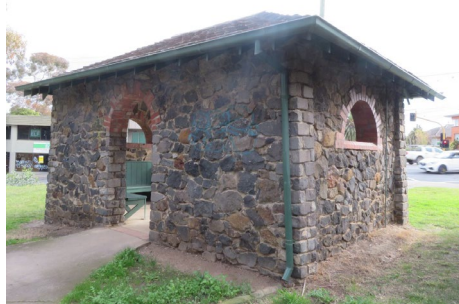
| Building Number | Building Name | Year |
|---|---|---|
| | A rectangular park and waiting shelter of rubblestone construction with tapered corner piers, arched openings and window openings with brick dressings, timber-lined ceiling, interior bench seats and a hipped terracotta tiled roof. Corner Riversdale and Warrigal Roads. | |
| <p>Integrity and condition both noted as good in Appendix B (B-19).</p> <p>Notes missing hinges, bolts and holdfasts from the rear arch, and recommends reinstating wrought-iron gates to the rear opening. Also notes that the colour scheme is not original.</p> | | |

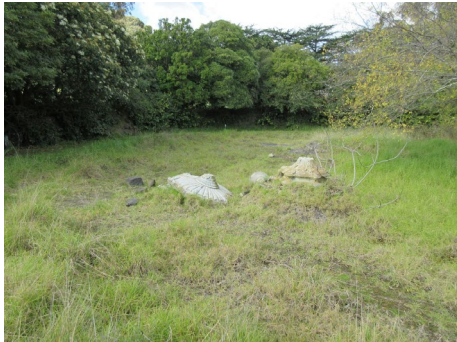
| Building Number | Building Name | Year |
|---|---|---|
| | Empty pond with large central bluestone encircled island, two unpainted cast cement fountains on rubblestone bases, eastern rubblestone wall with seating recess, and perimeter fence. The larger fountain had three tiers, with six grotesque fish at the base, and three birds supporting the upper tier. The second had a single bowl with decoration. | |
| <p>Appendix B-16 integrity noted as good, condition noted poor.</p> <p>Report states the pond is in “seriously derelict condition” and photographs show fountains damaged though intact. Noted upper tier ornament of large fountain missing. Recommends retaining and restoring pond, updating planting, remove perimeter chain wire-mesh and barbwire fence.</p> | | |

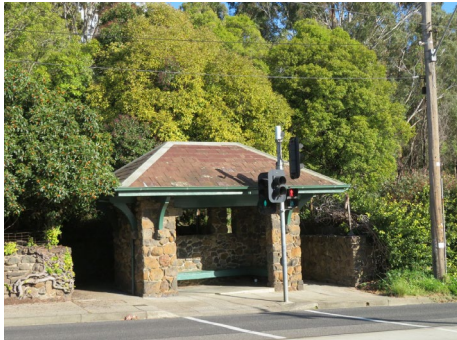
| Building Number | Building Name | Year |
|---|---|---|
| | Entry from Riversdale Road. A rectangular park and waiting shelter of rubblestone with hipped slated roof supported on massive corner brackets and timber benches. An encircling concrete paved pathway is bordered by terraced gardens, rubble retaining wall and rear stairway to the park with rubble walls and slate treads. | |
| <p>Appendix B notes good integrity and good condition overall (B-21).</p> <p>Dry stone bluestone wall to east in bad condition and requires repair. Colour scheme not original. South roof slope should be re-slated to match the original.</p> | | |
| <p>Hipped slate roof has some loose and chipped tiles particularly to south and lichen growth. Condition appears similar to 2016 HAMA Building Assessment, though some broken tiles have since been fixed.</p> <p>Quad guttering and downpipes appear recently replaced. Ridges flashed in fair condition.</p> <p>Painted timber eaves, brackets and soffit all in fair condition, appear recently painted.</p> | | |
| <p>Random basalt rubble shelter in good condition overall.</p> <p>Dry bluestone retaining walls surround the shelter in good condition.</p> <p>Stairs in fair condition (basalt risers and galvanised water pipe handrails), recycled slate treads cracked in some areas and graffitied.</p> <p>Eaves-mounted light has some rust, dust build-up and disfiguration to wire netting.</p> | | |
| <p>Timber bench seats (butt jointed Oregon boards) lining the internal walls are graffitied.</p> <p>Graffiti to internal basalt rubble.</p> <p>Ceiling V-jointed boards are in good condition.</p> <p>Ceiling-mounted light shows rust, disfiguration.</p> | | |

Undertake minor roof maintenance to slipped or cracked tiles.

Cut back vegetation as required, noting this is an ongoing maintenance item.

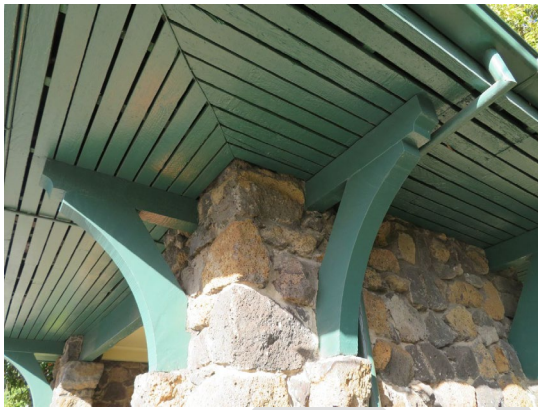
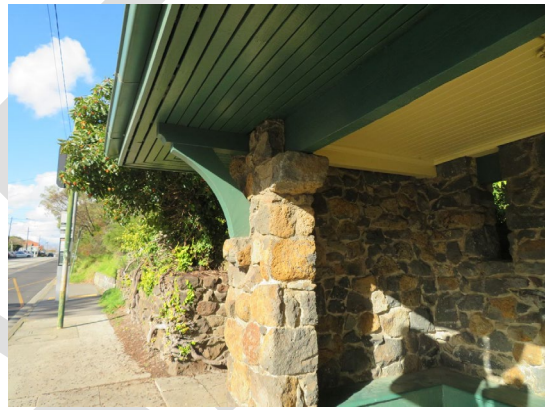
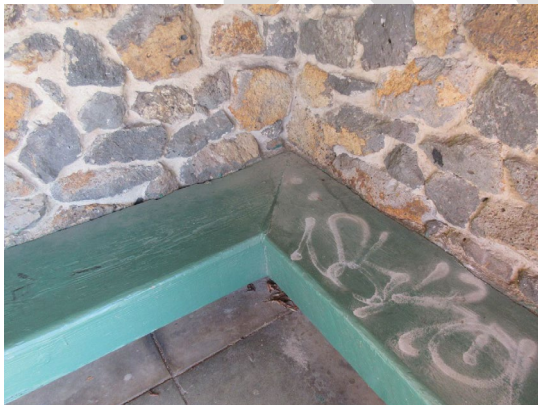
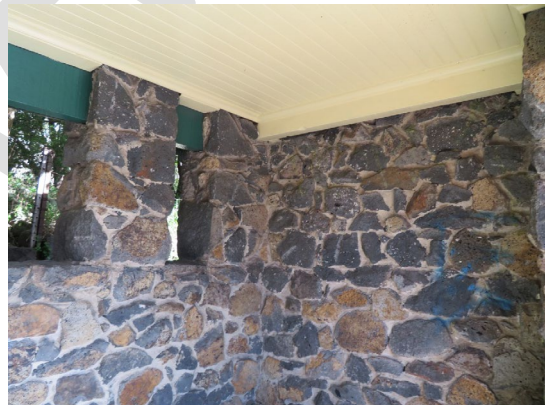
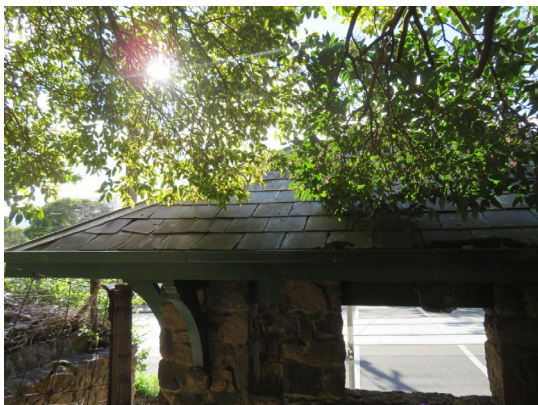
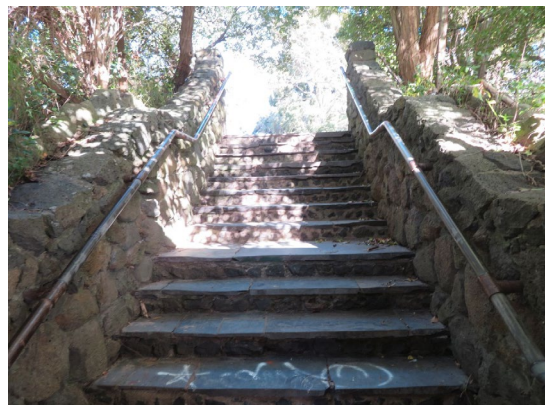
## Photographs

| Building Number | Building Name | Year |
|---|---|---|
| | L-shaped random basalt rubble wall with a suspended reinforced concrete slab roof with a bevelled fascia, supported by three reinforced concrete columns at the open end. Timber seats affixed to the inside and outside walls. | |
| Roof extends in a wide eave over the south and west sides, reinforcement exposed and rusting at underside of concrete slab roof.<br>Bevelled fascia in fair condition. Some leaf litter build-up on roof, fair condition overall. | | |
| Random basalt rubble wall shows loss of mortar in some areas.<br>Butt-jointed timber seats on south and west sides are weathered, significant paint loss due to lack of maintenance painting.<br>Concrete slab and columns in fair condition. | | |

Inspection condition of roof at height with particular attention to exposed reinforcing. Treat rust and reinstate concrete cover to reinforcing.

Prepare and paint timber benches, allow to replace 20% of boards to external seat.

Undertake minor repointing to interior and exterior stonework.

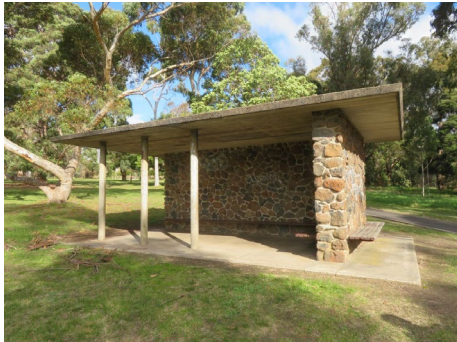
| Building Number | Building Name | Year |
|---|---|---|
| Condition not noted in Appendix B. Report recommends retaining and conserving the shelter. | | |

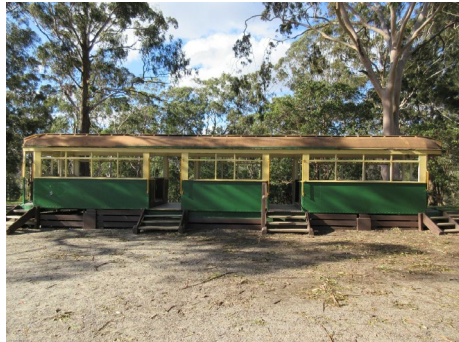
| Building Number | Building Name | Year |
|---|---|---|
| | <p>One of two SW6 class trams (885 or 936), gutted and installed on timber platforms. Bodies have been stripped of all bogies, mechanical and electrical equipment and glass. Used as picnic shelters with non-original seating inside.</p> <p>Original trams installed in 1924, W2 trams replaced these in 1963, the current SW6 trams were installed in 2007.</p> | |

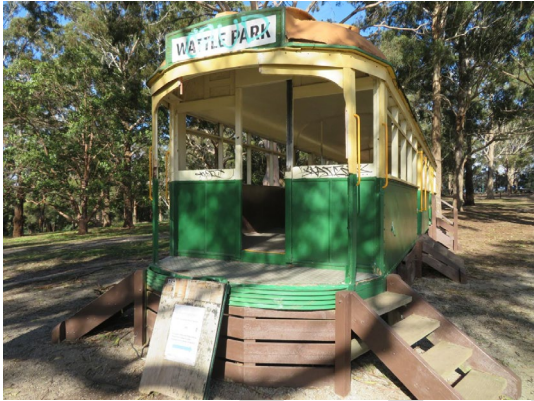
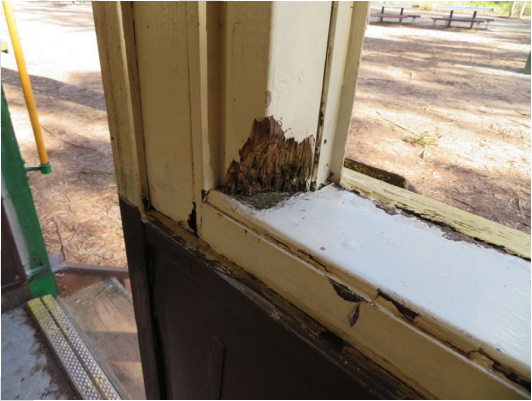
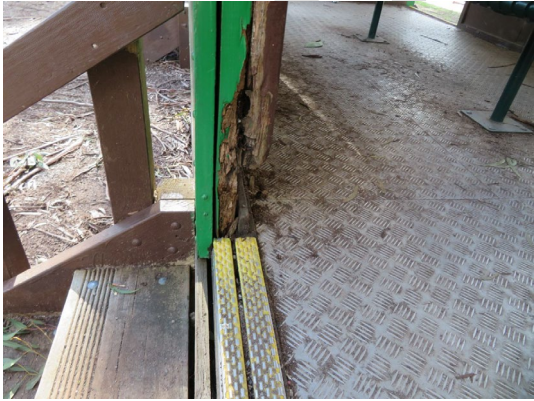
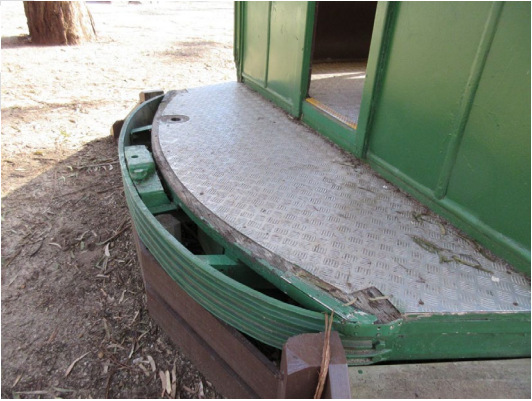
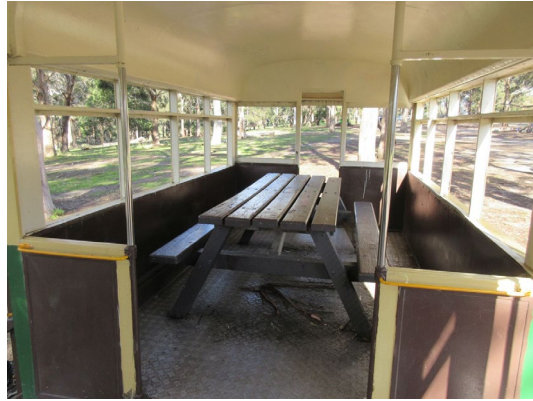
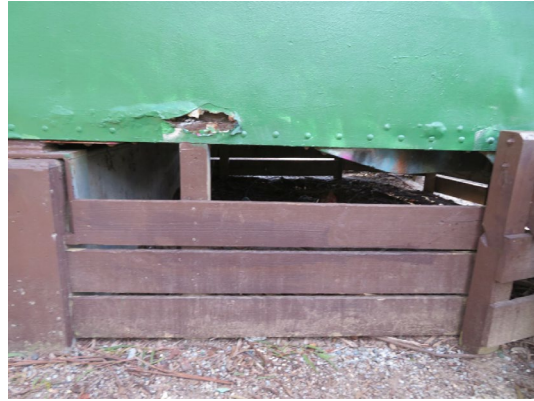
| Building Number | Building Name | Year |
|---|---|---|
| <p>Flat iron roof sheeting has significant rust.</p> <p>Gutters are rusted and damaged in numerous locations and show vegetation growth inside.</p> <p>Timber fascia is weathered along the gutter line and shows general lack of maintenance painting.</p> | | |
| <p>Entry stairs in fair condition, upgrades required to meet compliance including handrails and nosings.</p> <p>Metal cladding deteriorated / rusted at several locations, generally at the internal floor level.</p> <p>Ongoing vandalism and graffiti evident.</p> <p>Paint flaking and bubbling, general lack of maintenance painting.</p> | | |
| <p>Timber window frames are heavily weathered/deteriorated with flaking paint.</p> <p>Steel sheet flooring in fair condition, hole in timber decking at northern driver’s carriage.</p> <p>Step riser has exposed/splintered wood, flaking paint.</p> <p>Ceiling panels lifting at rails, paint flaking.</p> | | |

| <p><b>Urgent</b></p> <p>Upgrade or replace entry stairs to meet current standards including handrails.</p> <p>Remove vegetation growth from gutters, and repair and replace roof sheeting and gutters.</p> <p>Cover gaps in steel sheet flooring at northern elevation.</p> <p>Remove graffiti from exterior fabric, noting this is likely an ongoing maintenance item.</p> <p><b>Priority A</b></p> <p>Undertake repairs to timber elements where rotted, decayed or missing.</p> <p>Replace rusted metal cladding in full sheets to match existing details.</p> <p>Prepare and paint both metalwork and timberwork.</p> | |

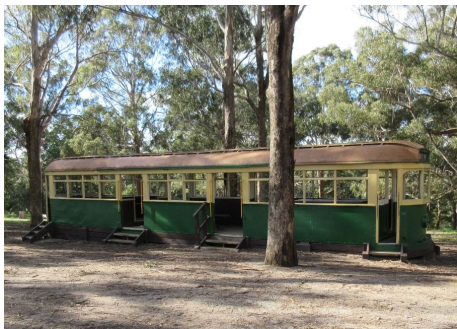
| Building Number | Building Name | Year |
|---|---|---|
| | <p>One of two SW6 class trams (885 or 936), gutted and installed on timber platforms. Bodies have been stripped of all bogies, mechanical and electrical equipment and glass. Used as picnic shelters with non-original seating inside.</p> <p>Original trams installed in 1924, W2 trams replaced these in 1963, the current SW6 trams were installed in 2007.</p> | |
| <p>Condition not noted in Appendix B.</p> <p>The current trams in place were installed in 2007. Report notes that the two W2 trams previously in their place were “the subject of vandalism and is in a seriously dilapidated condition and is covered with graffiti.” Recommends replacing missing tram, reinstating tram numbers. Previously on concrete foundations.</p> | | |
| <p>Flat iron roof sheeting has significant rust. Gutters are rusted and damaged in numerous locations and show vegetation growth inside.</p> <p>Timber fascia has signs of weathering along the gutter line and shows general lack of maintenance painting.</p> | | |
| <p>Entry stairs in fair condition, upgrades required to meet compliance including handrails and nosings.</p> <p>Metal cladding deteriorated / rusted at several locations, generally at the internal floor level.</p> <p>Paint flaking and bubbling, general lack of maintenance painting.</p> | | |
| <p>Painted timber window frames are heavily weathered/deteriorated with flaking paint.</p> | | |

| Steel sheet flooring in fair condition.<br>Step riser has exposed/splintered wood, flaking paint.<br>Ceiling panels lifting at rails, paint flaking. | | |

| <p><b>Urgent</b><br/>Upgrade or replace entry stairs to meet current standards including handrails.<br/>Remove vegetation growth from gutters, repair and replace roof sheeting and gutters.</p> <p><b>Priority A</b><br/>Undertake repairs to timber elements where rotted, decayed or missing.<br/>Replace rusted metal cladding in full sheets to match existing details.<br/>Prepare and paint both metalwork and timberwork.</p> | | |

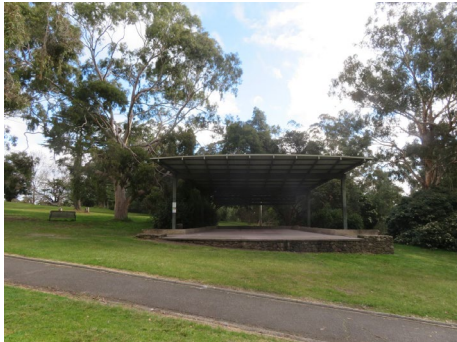
| Building Number | Building Name | Year |
|---|---|---|
| | Concrete platform with basalt rubble capping, two basalt rubble planter boxes to north and south corners (added in 1970), and a recent steel roof. | |
| Condition not noted in Appendix B.<br>Recommends retaining and conserving and providing a portable canopy for sun and rain protection.<br>Notes that the condition of the planter boxes is poor and requires repair. | | |
| New corrugated steel roof canopy, rainwater goods and supports in good condition.<br>Minor graffiti to louvers at western elevation and steel posts. | | |

| Building Number | Building Name | Year |
|---|---|---|
| Priority A<br>Remove graffiti from steel louvers / screen, noting this is likely to be an ongoing maintenance item. | | |

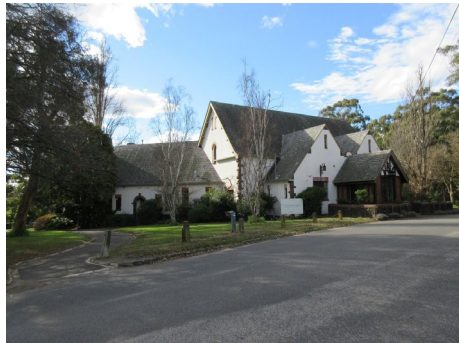
| Building Number | Building Name | Year |
|---|---|---|
| | A substantial two-storey chalet in the English domestic style after Lutyens with raised central hall with mezzanine to north facing balcony, flanking single storeyed wings, and north-facing garden with enclosing rubblestone wall. Tudor-style porch at south entry added in 1937. | |

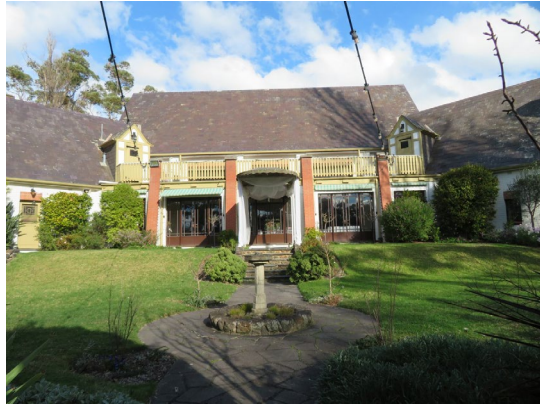
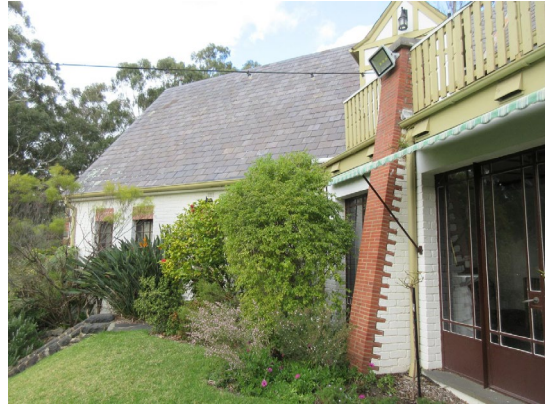
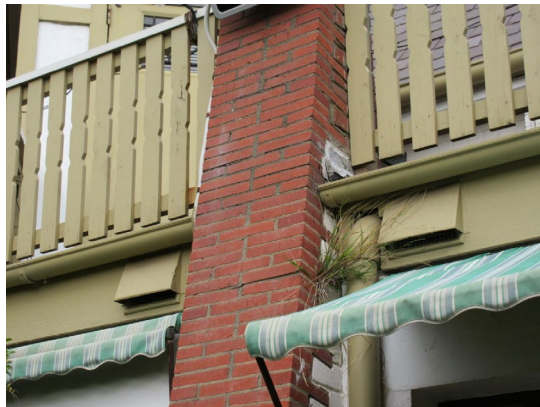
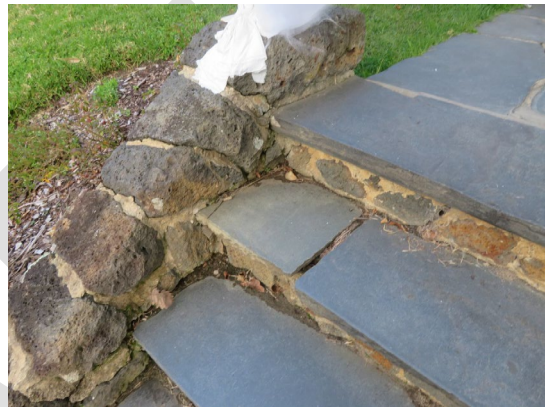
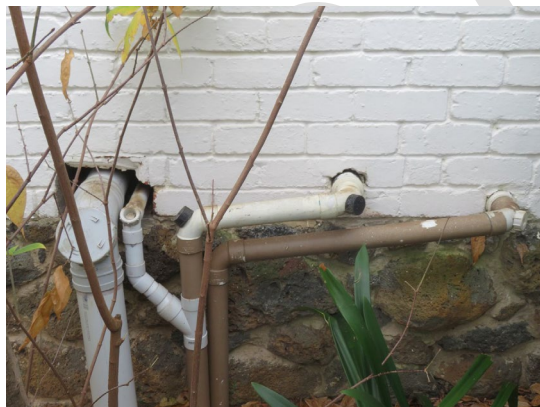
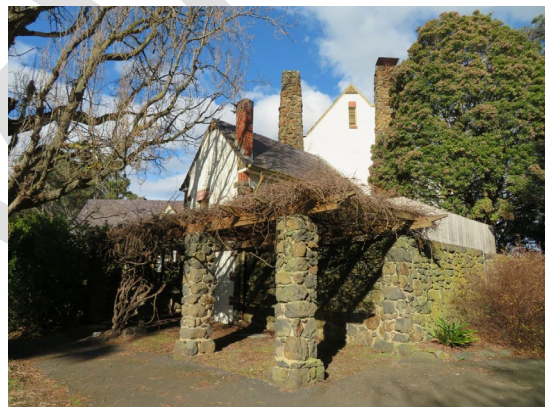
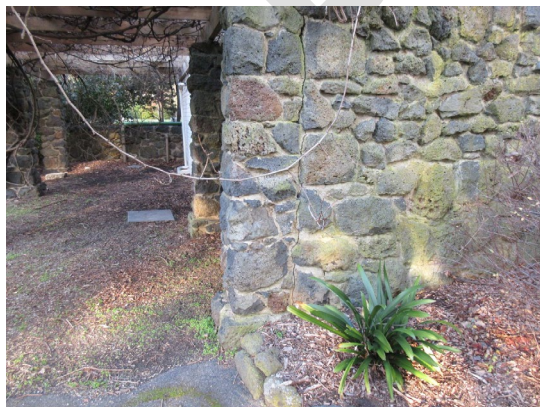
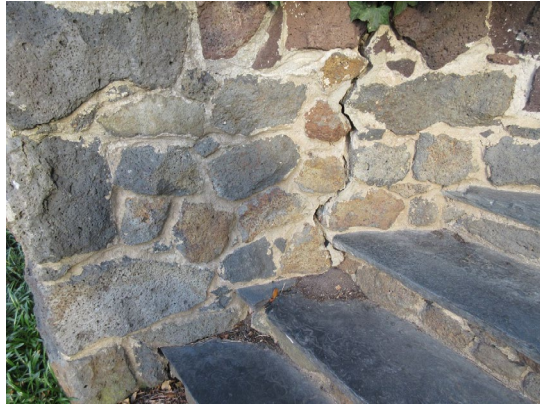
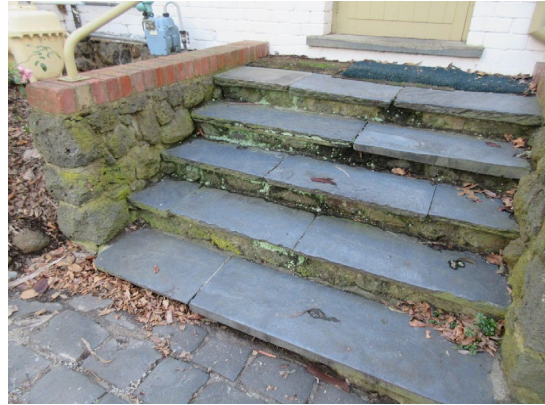
### External fabric

| Building Number | Building Name | Year |
|---|---|---|
| <p>Painted brickwork generally in good condition, some discolouration to cream-painted face bricks.</p> <p>Red brick clinker dressings at windows and quoins are well-preserved.</p> <p>Minimal rust to wrought iron external light fittings and decorative grilles.</p> | | |

| <p>Steel casement windows in good condition with no rust visible.</p> <p>All doors appear to be intact and functional.</p> <p>Bluestone plinths, pergola piers, garden walls and tapered chimneys are generally in good condition. Some cracking to bluestone wall on norther façade, at north-west corner near vine-covered pergola, and near steps at north garden.</p> <p>External steps to north elevation do not meet current compliance and require upgrades including handrails, nosings and tactile indicators. Joints between paving stones have weathered in some locations and should be repair to mitigate trip hazard.</p> <p>Balcony membrane appears in fine condition with minor lichen growth, however water staining noted to the eastern end below.</p> <p>Balcony brick piers are leaning forward likely due to decay of low level embedded metal.</p> | | |

Repoint cracking to bluestone wall and monitor for further movement, if condition changes investigation by structural engineer to determine cause to be undertaken.

Prepare and paint steel casement windows, where rust spots are noted treat rust and complete spor prime prior to repainting.

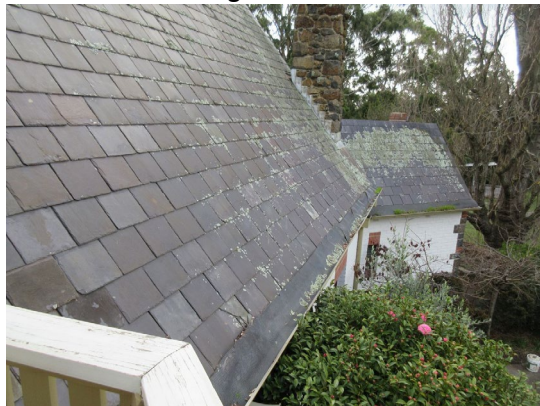
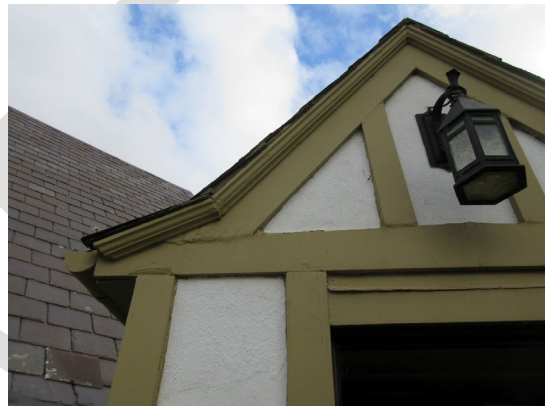
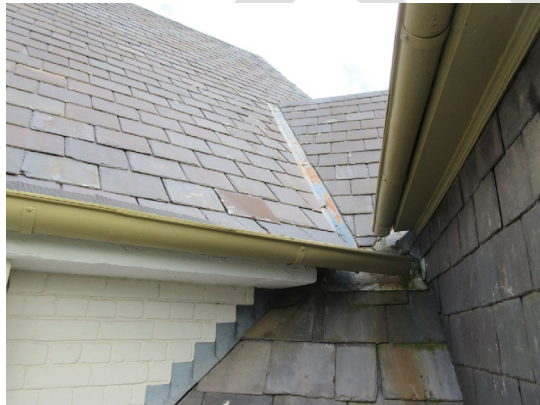
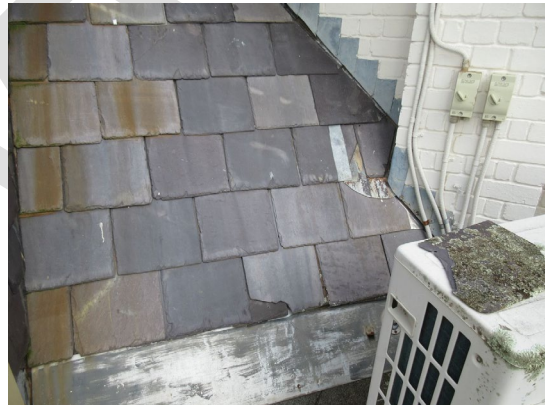
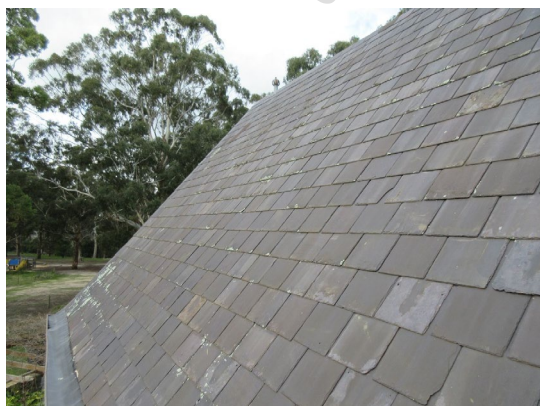
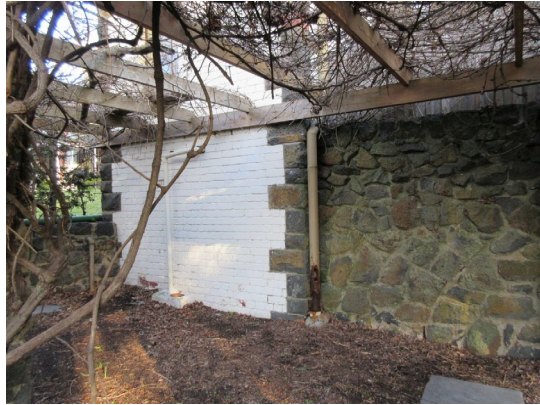
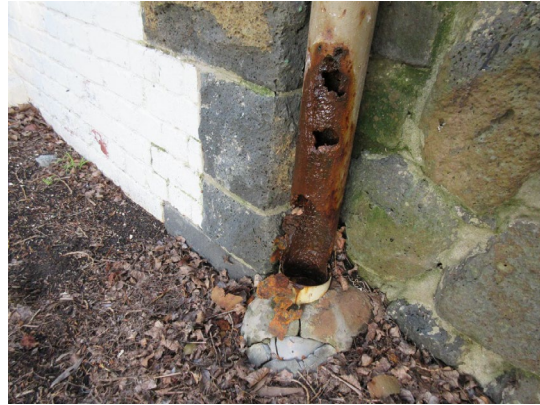
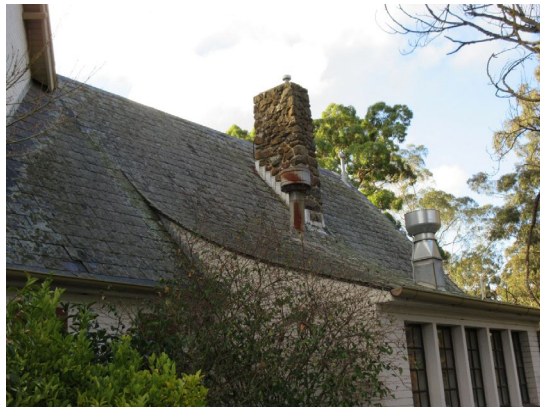
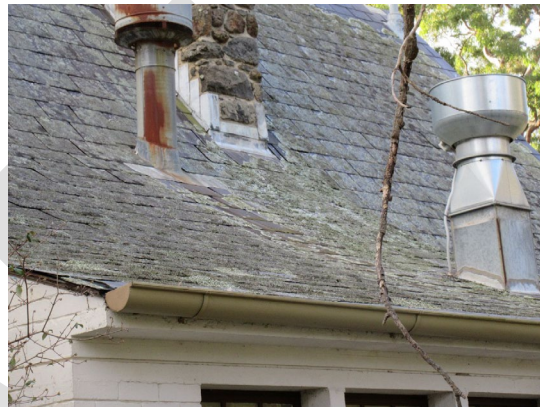
### Roof and rainwater goods

| Condition of roof/rainwater goods | Fair | 1 |

Clean out gutters and replace rusted downpipes, ensure all rainwater good are working effectively.

Remove leaf guards from gutters and replace rusted downpipes.

Undertake repairs to slate roof or complete full replacement.

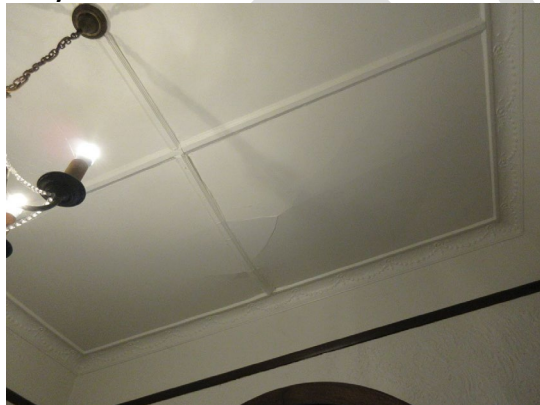
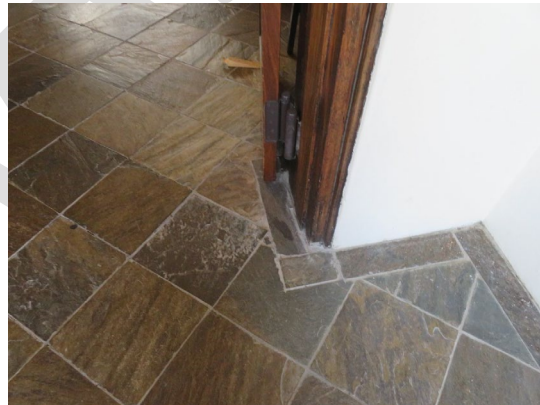
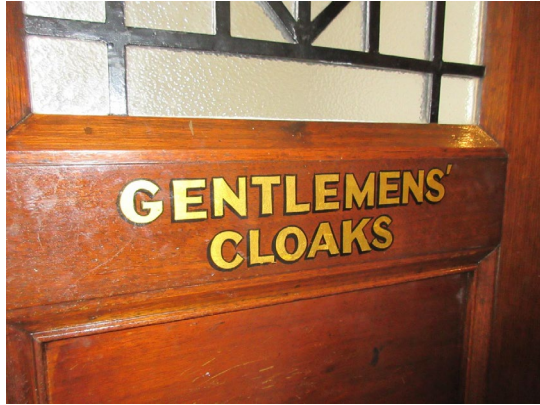
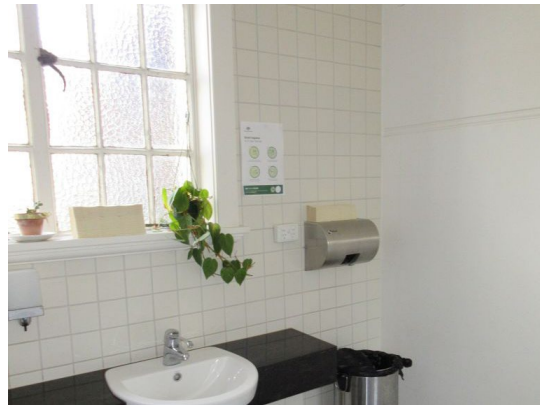
### Entry Hall and Bathrooms

| <p><i>Entrance Hall</i></p> <p>Good condition overall.</p> <p>Expressed baton sheet ceiling cracked and sagging in localised area.</p> <p>Bathrooms good condition overall.</p> <p>Stairwells to each side are carpeted with broad timber balusters and squared newels. Generally in good condition with areas of loss to timber joinery having been painted over. Upgrades required to meet current compliance.</p> <p><i>Main reception and loggia</i></p> <p>Dark timber panelling and cream plaster walls in good condition, some wear to timber panels and timber joinery. Oregon hammer beam roof and plaster ceiling appears to be in good condition.</p> <p>Broken glass in door to western wing.</p> <p>Staining on walls/ceiling to western end.</p> <p>Eastern corner of the loggia has evidence of leaking/water damage.</p> <p><i>Western Wing</i></p> <p>Rooms in varied condition with cracking along cornices to most.</p> <p>Removal of downlights to 'kitchen' room has been completed without repairs to the penetrations in the ceiling, door frame has moved based on unpainted section along architrave.</p> <p>Evidence of water damage, staining and sagging to 'pantry' room.</p> <p><i>Eastern Wing</i></p> <p>Back of house area with the kitchen and stores rooms. Generally, in poor condition and lacking maintenance with discoloration to ceilings throughout. General wear and tear to timber joinery and flooring, staining to walls and build-up of grime and grease.</p> <p>Ceiling sagging in main kitchen, no water damage visible.</p> <p>Ceiling cracked at cornices in cool store,</p> <p>Ceiling cracked and sagging in office, currently used for as a storage room.</p> <p><i>Mezzanine Balconies</i></p> <p>Timber joinery, balustrade, panels and plaster walls in good condition overall.</p> <p>Main north (external) balcony over the loggia is accessible via a small dormer door on each side of the mezzanine. The eastern door appears sealed shut, the western door is very tight.</p> | | |

Repair cracked and sagging ceiling, prepare and paint as part of works.

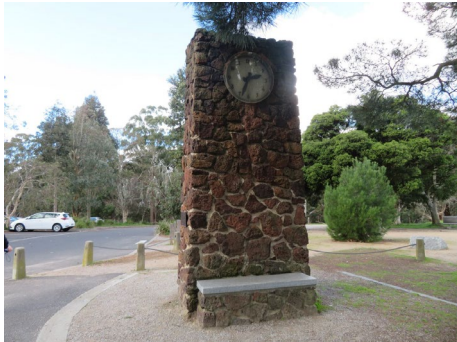
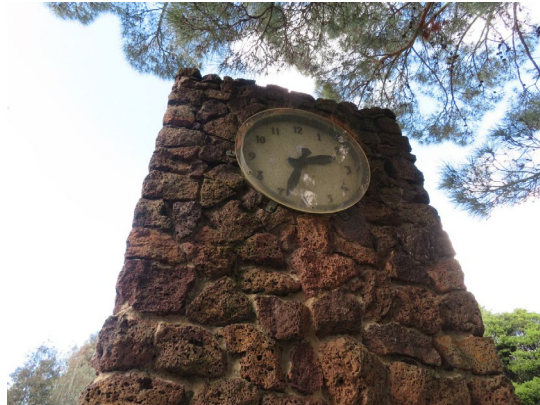
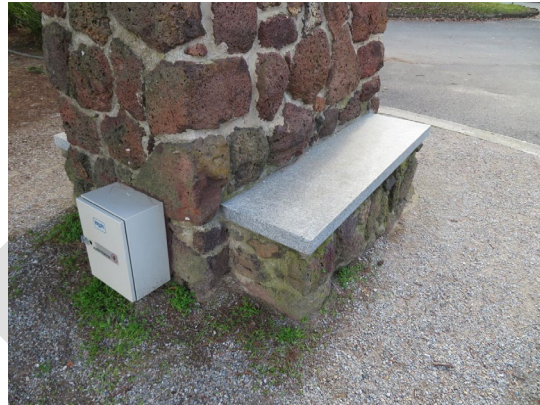
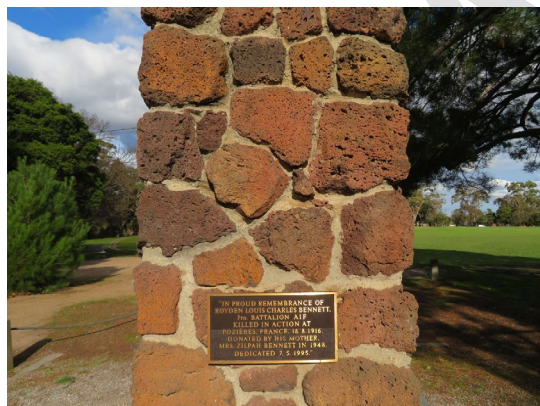
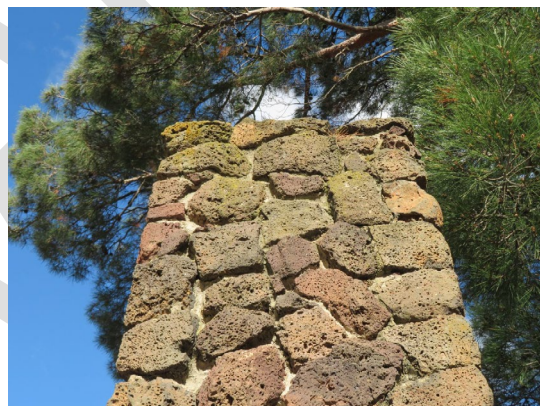
| Building Number | Building Name | Year |
|---|---|---|
| | A simple tapered rectangular structure made from random basalt rubble with bench-type seats and clock faces with bronze numerals back-to-back on the two principal elevations, which are covered in Perspex (added 1958). The clock mechanism is electric and accessed from above / small box to side. | |
| Wear and discolouration to Perspex clock-cover.<br>Time on both clock faces is incorrect.<br>No signs of chipping or cracking on grey granite bench-type seats.<br>Mould/mildew visible on random basalt rubble seating and tower base.<br>Bird droppings on tower.<br>Glazed grey-granite clock face appears in good condition.<br>Structure surrounded by granitic gravel (replaced 1993 concrete paving). | | |
| Condition of external building fabric | Fair | 1 |
| Condition of roof/rainwater goods | Fair | 1 |

Replace discoloured Perspex on clock and correct the time on both faces.

Minor repointing of stonework where mortar degraded.

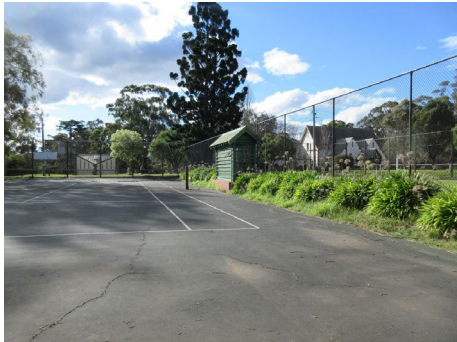
| Building Number | Building Name | Year |
|---|---|---|
| | The tennis court area contains one grass (c. 1934) and two hard surfaced asphalt (c. 1933) tennis courts bordered by a Cyclone wire fence supported by square timber posts. Two courtside tennis shelters are small timber structures with open fronts onto the court, and square latticed sides. | |
| Condition not noted in Appendix B.<br>Report notes that most structures are “dilapidated and in need of repair and maintenance.” Recommends reinstating original paint colours (shelters and fence); Roman (half-round) tile shelter roofs; galvanised wire mesh fence. Courts require resurfacing with an appropriate hard playing surface, preferably of a dark colour. | | |

| Assessment rating | | |
|---|---|---|
| <p><b>Urgent</b></p> <p><i>Eastern shelter</i></p> <p>Replace rotten bargeboard and fascia across the whole structure</p> <p>Replace ceiling lining, cleaning out debris in roof space, note presence of possum faecal matter likely.</p> <p><i>Western shelter</i></p> <p>Replace cracked and slipped terracotta tiles</p> <p>Replace rotten barge board and fascia across the whole structure.</p> <p>Replace ceiling lining, cleaning out debris in roof space, note presence of possum faecal matter likely.</p> <p><b>Priority A</b></p> <p>Replace timber joinery and reinstate/replace lattice where missing or deteriorated.</p> <p>Prepare and paint timber joinery and lattice, and engage in ongoing maintenance painting.</p> <p>Resurface two asphalt courts to remove cracking and trip hazard, investigation of tree root management to occur as part of works.</p> <p><b>Priority C</b></p> <p>Replace or repair benches in both shelters.</p> <p><i>Western shelter</i></p> <p>Reinstate original ceiling lining to western side.</p> | | |

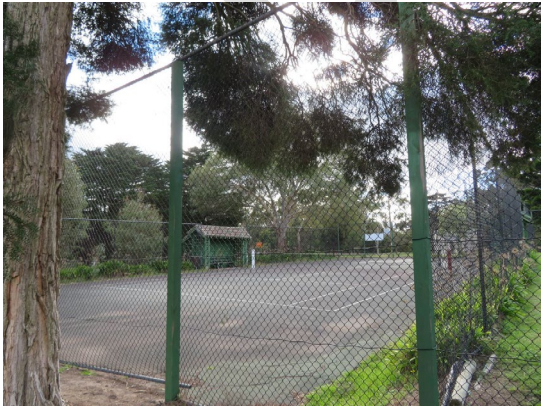
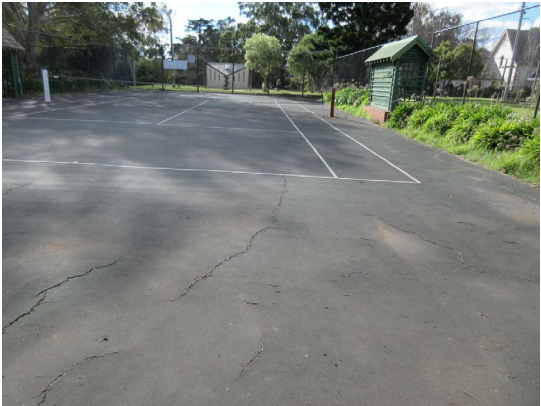
| Building Number | Building Name | Year |
|---|---|---|
| Both asphalt courts have significant cracking and uneven surfaces. Cyclone wire fence intact, in fair condition overall.<br><i>Eastern shelter</i><br>Significant weathering and deterioration to timber posts, lattice and external facing timber boards. Crack in concrete paving. Missing side lattice. Lack of general maintenance painting.<br><i>Western shelter</i><br>Significant weathering and deterioration to timber posts, lattice and external facing timber boards. Tiles appear to be in fair condition, overgrown with dirt and grass. Lack of general maintenance painting. | | |

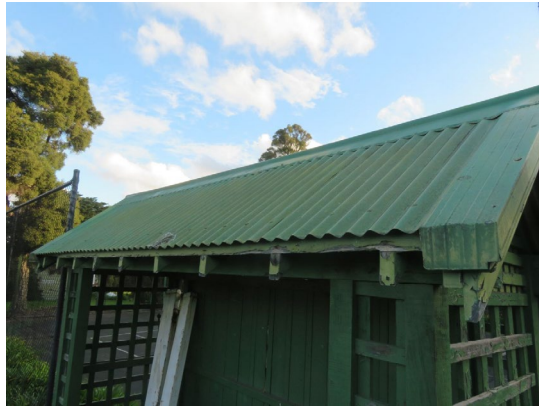
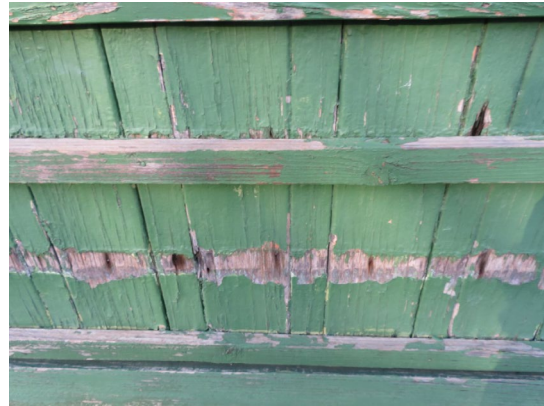
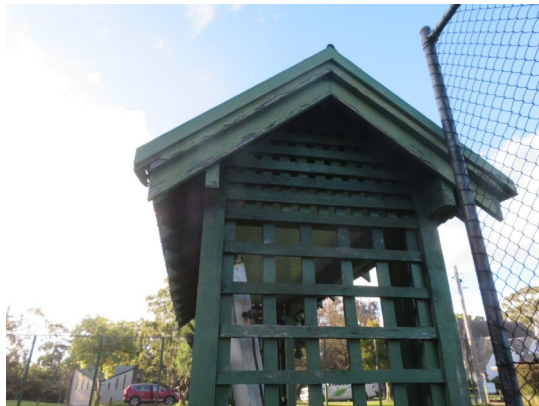
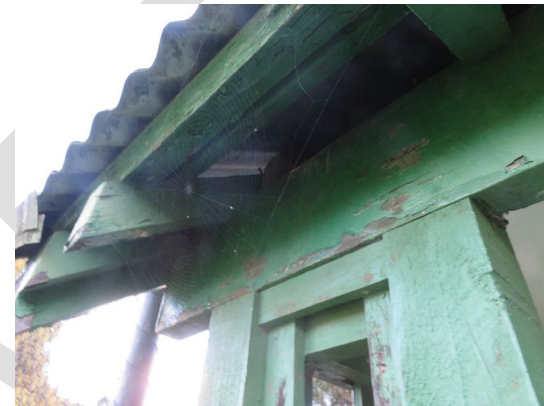
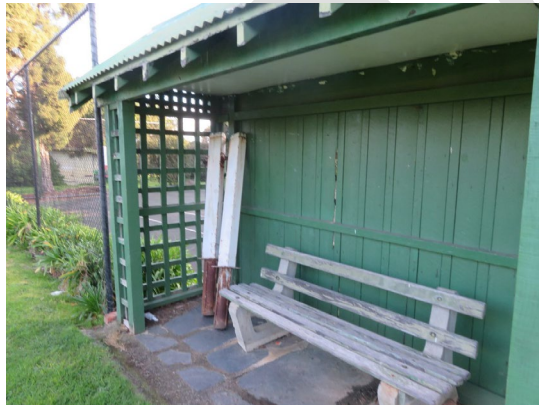
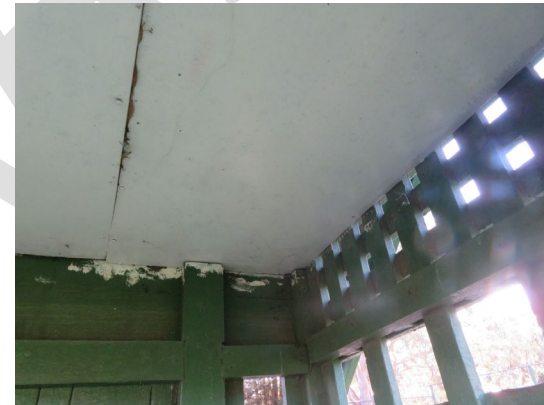
Eastern shelter

| Building Number | Building Name | Year |
|---|---|---|
| <i>Eastern shelter</i><br>Galvanised corrugated iron roof on shelters in fair condition overall. Significant weathering to painted timber bargeboard, fascia and eaves, splintering wood and flaking paint.<br><i>Western shelter</i><br>Terracotta tiles in fair condition overall, some cracked and slipped with lichen growth. Significant weathering to painted timber bargeboard, fascia and eaves, splintering wood and flaking paint. | | |
| <i>Eastern shelter</i><br>Timber benches in poor condition. Internal faces of shelter infilled with timber boards, replacing the original lattice. Fibre cement sheet ceiling in poor condition. Lack of general maintenance painting.<br><i>Western shelter</i><br>Seats in poor condition. Fibre cement sheet ceiling in poor condition, collapsing and large holes on western side, possums entering roof cavity. Lack of general maintenance painting. | | |

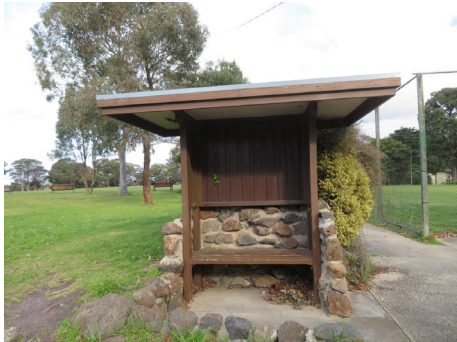
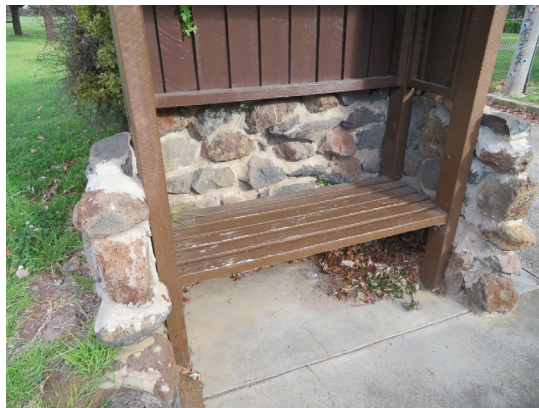
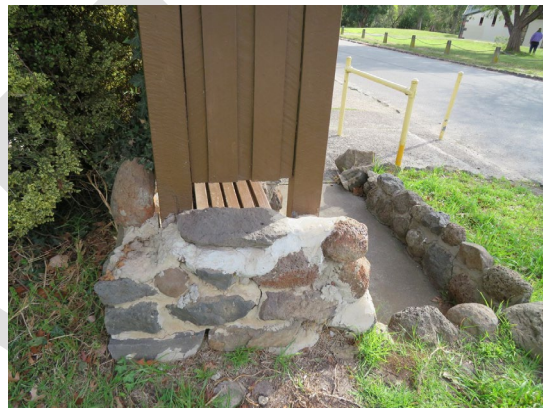
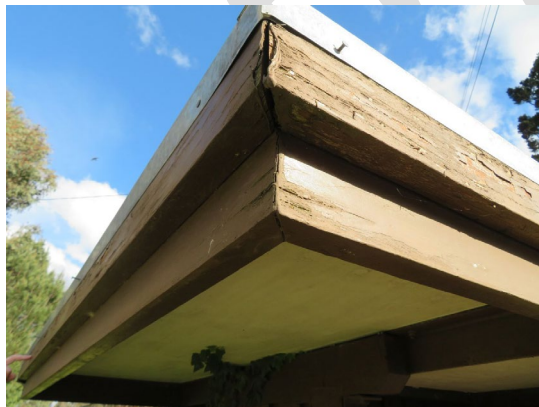
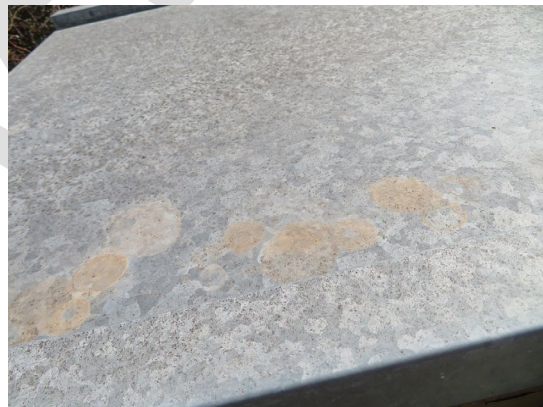
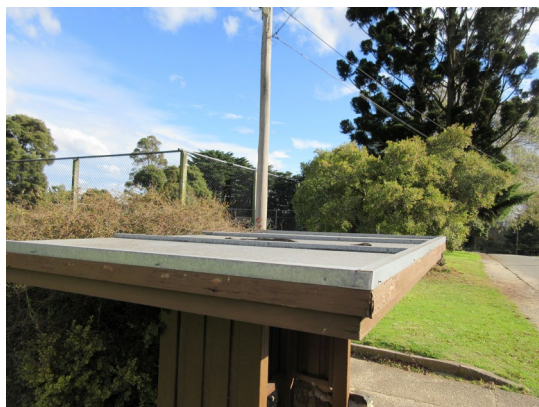
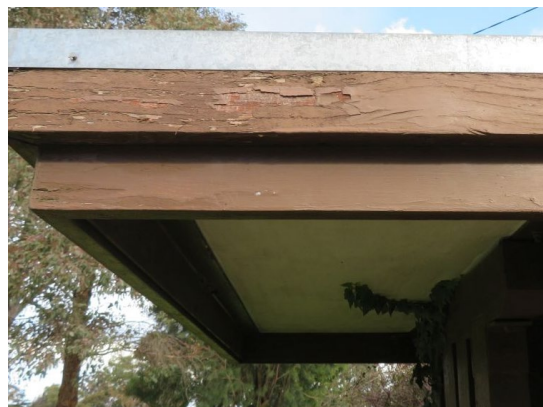
| Building Number | Building Name | Year |
|---|---|---|
| | A small timber, flat-roofed shelter set on a random rubble basalt base which connects to a similar wall running between the tennis courts and the former putting green. | |
| Roof sheeting appears to be in fair condition, some circular patches / discoloration likely bird droppings.<br>Weathering to fascia and bargeboard including timber splitting and paint flaking. | | |
| External facing timber lining boards in good condition, appear recently painted and no chips or cracks visible.<br>Unsympathetic repairs undertaken to rubble wall with excess mortar.<br>Vegetation overgrown to rear, with climber along the ceiling and between lining boards. | | |
| Ceiling lining, likely fibre cement sheet, in fair condition.<br>Internal-facing timber boards in fair condition, back section has been painted a different colour.<br>Climber growing between lining boards from rear.<br>Paint flaking on timber bench. | | |

Replace fascia and barge board were badly weathered to corners.

Rebuild sections of rubble wall where unsympathetic repairs have been undertaken.

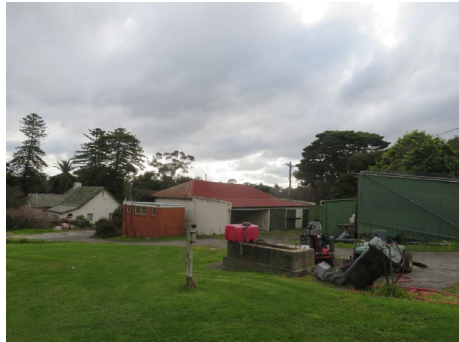
| Building Number | Building Name | Year |
|---|---|---|
| | Hosts a variety of structures of different ages including a brick toilet block (c. 1960s-70s), several corrugated iron sheds, a tray deck clad shed, a horse trough, a small brick and glass propagating shed, and a vine-covered pergola. | |
| <p><i>Corrugated iron sheds</i></p> <p>Significant rust to gutters and downpipes. Fascia deteriorating and weather damaged. Corrugated iron sheets of skillion roofs lifting and roof sagging.</p> <p><i>Toilet block</i></p> <p>Gutter in poor condition with rust visible to underside. Fascia shows signs of decay at corner and general paint reaching end of life. Metal flashings painted with paint failure and loss throughout.</p> <p><i>Propagating shed</i></p> <p>Roof sheeting broken / deteriorated, capping heavily rusted.</p> | | |
| <p>Asphalt / gravel road to area in poor condition.</p> <p><i>Corrugated iron sheds</i></p> <p>Poor condition overall. Metal cladding is generally rusted, loose and/or bent. Some open and some with lockable timber doors.</p> <p><i>Toilet block</i></p> <p>Masonry in fair condition overall. Louver windows appear operable and intact.</p> <p><i>Propagating shed</i></p> <p>Broken glass. Weathered, detaching and missing timber cladding. Door collapsing. Paint has reached end of life and is flaking and lost to timber work. Brickwork in fair condition. Paving / concrete to perimeter in varied condition with vegetation growing throughout joints.</p> <p><i>Vine-covered pergola</i></p> <p>Vine is significantly overgrown, weathered timber structure.</p> <p><i>Trough</i></p> | | |

| Fair condition, some cracking to concrete. Paint or chemical stains. Debris to inside of trough. | | |
| <p><i>Corrugated iron sheds</i></p> <p>Poor condition, metal cladding and timber joinery is highly weathered.</p> <p><i>Toilet block</i></p> <p>In use internally, appears functional.</p> <p><i>Propagating shed</i></p> <p>Broken joinery and glass inside, inaccessible.</p> <p><i>Vine-covered pergola</i></p> <p>Inaccessible due to vine overgrowth.</p> | | |

| <p><b>Urgent</b></p> <p><i>Corrugated iron sheds</i></p> <p>Stabilize sagging sections of roof, noting this may require removal of materials being stored in roof structure.</p> <p>Evacuate roof condition at height, assume full extent of roof sheeting requires replacement.</p> <p>Replace gutters, flashings and downpipes.</p> <p><i>Propagating shed</i></p> <p>Re-roof with new clear sheeting, flashing and ridge capping.</p> <p>Replace broken glass.</p> <p>Replace timber door</p> <p>Prepare and paint all timber joinery, replacing minor areas of missing or weather cladding.</p> <p><b>Priority A</b></p> <p>Remediation road to works area, putting in place ongoing maintenance programme.</p> <p><i>Corrugated iron sheds</i></p> <p>Prepare and paint all timber and painted metal elements excluding metal wall cladding.</p> <p><i>Toilet block</i></p> <p>Replace gutter and fascia, paint metal flashing as part of these works.</p> <p><i>Propagating shed</i></p> <p>Remove vegetation to paving / concrete to perimeter.</p> <p><i>Vine-covered pergola</i></p> <p>Remove overgrowth and inspection condition of timber structure to determine ongoing retention.</p> | | |
