Falls to Hotham Alpine Crossing: Preliminary Environmental Assessment report

Prepared for: Parks Victoria

Report 20083 — Version 1.5 — Final Report, September 2021

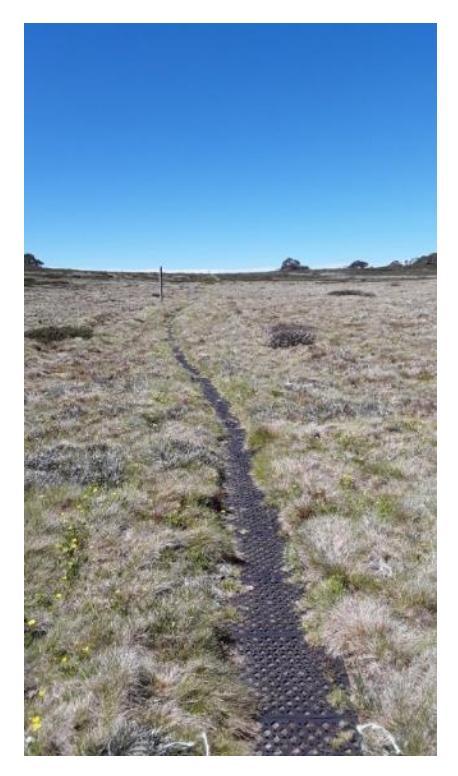
Image 2. Black matting track surface along a section of existing track, Bogong High Plains (December 2020), (Image credit

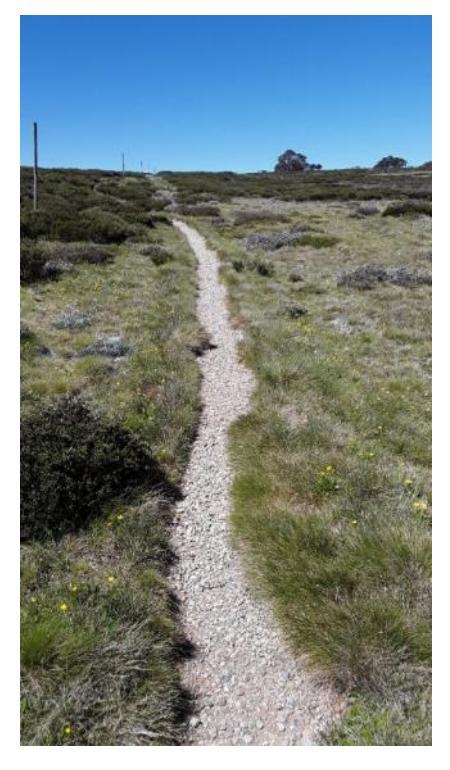
Image 3. River pebbles track surface along an existing track, Bogong High Plains (December 2020), (Image credit:))

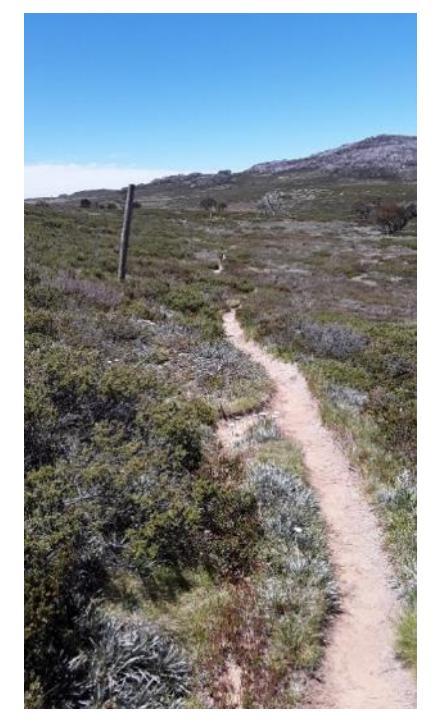
Image 4. Bare earth track, Bogong High Plains (December 2020), (Image credit:

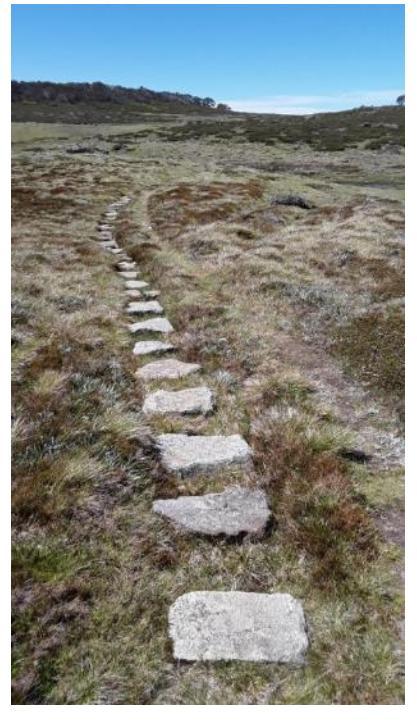
Basalt stepping stones and logs have been used to manage wetter sections of the track across the Bogong High Plains in sections 2, 4 and 6-8. However, soil surrounding basalt stepping stones has washed away in some locations, possibly making it difficult for walkers to balance on the now elevated stones. Evidence of off-track walking was observed in these locations (Image 5).

Image 5. Basalt stepping stones and off-track walking (right side of image) through damp grassland across the Bogong High Plain (December 2020), (Image credit:

- Stepping stones offer permanent stable substrates for wet areas but depending on spacing, may encourage off-track walking which was observed in some places.
- Logs were observed to deteriorate over time in damp areas and are difficult to walk on. This encourages off-track walking. They would also be impacted by fire.
- Steel grid bridges have been installed in the assessment area and surrounds and may be suitable to span sensitive, significant communities and fauna habitat. These would be able to withstand the weight of snow while being permeable enough to allow snowmelt, rain and light to reach vegetation below. They would also be able to withstand low intensity fires.

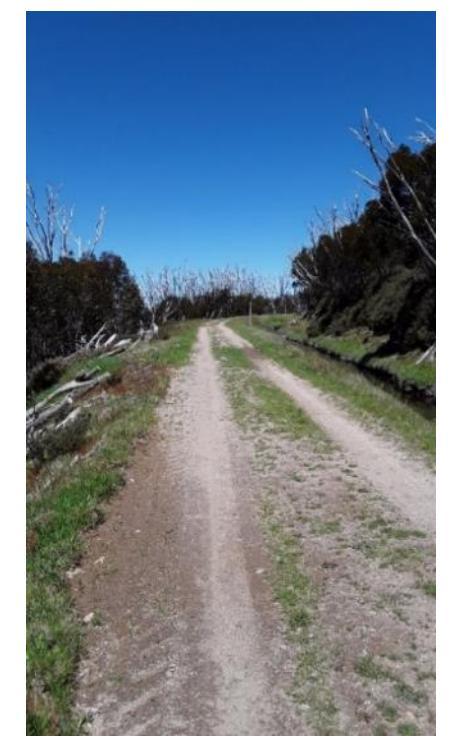
Image 8. Management vehicle track (crushed rock surface) along Langford Aqueduct (December 2020), (Image credit:

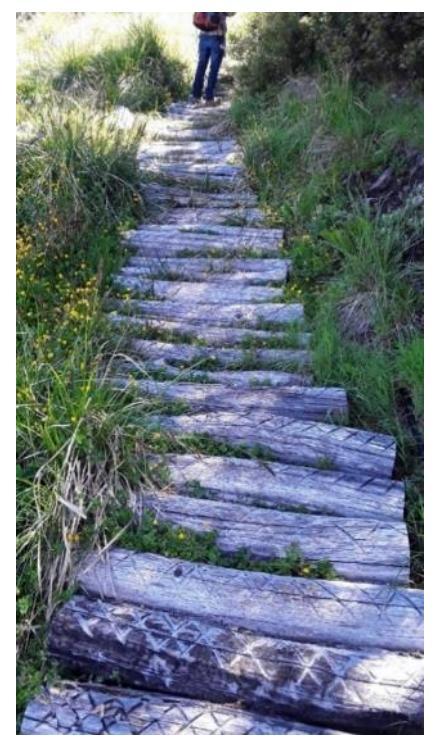
Parallel logs arranged along the contours of slopes appear to fail over time, as the logs effectively support one another and easily go askew if one of them begins to fail. The logs are difficult to walk on due to their rounded profile, they can become very slippery, are susceptible to rotting and slumping, and often end up partially submerged in mud (Image 10 and 11). This has resulted in hikers walking off-track adjacent to the parallel logs. This was evident in seepage areas associated with Damp Grassland and Sub-alpine Woodland EVCs in section 12, particularly where the elevation decreases toward Weston Hut.

Image 9. Parallel logs laid along contour lines used to stabilise part of Westons Spur Track (December 2020), (Image credit:

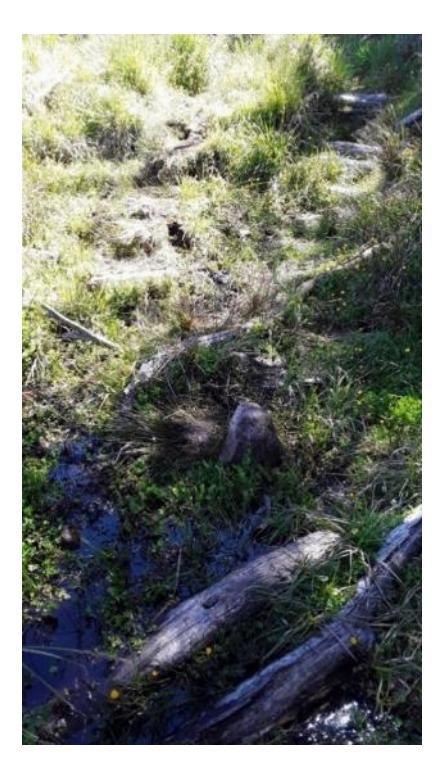
Image 10. Failed section of log track with pugging along Westons Spur Track (December 2020), (Image credit:

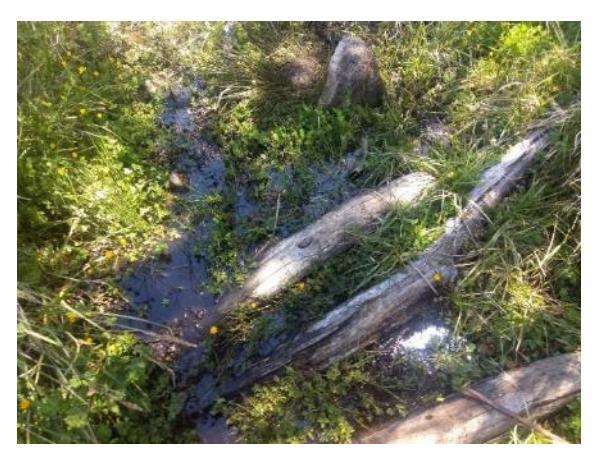
Image 11. Displaced, sunken logs as part of a log crossing on Westons Spur Track (December 2020), (Image credit:

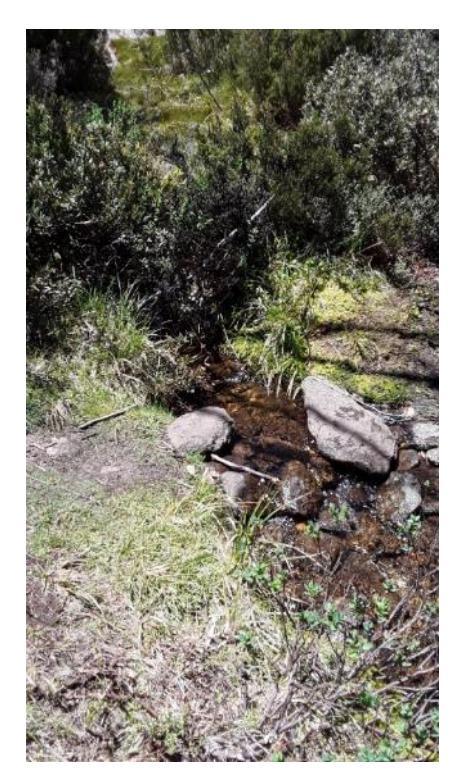
In some steep and wet areas of track with no artificial substrate, track edges had become degraded by horses and off-track pedestrian traffic. Trampling has led to vegetation damage and loss resulting in bare ground, soil compaction, and erosion forming deep channels, particularly where the track intersects damp areas such as those supporting Alpine Bog Community and Damp Grassland. This was most obvious in sections 2, 6-9 and 11 (Appendix 1) (Images 12-17).

Image 14. Trampled streamside vegetation across narrow linear Alpine Bog Community on the Australian Alps Walking Trail between Big River Fire Trail and Langford Aqueduct (December 2020), (Image credit:))

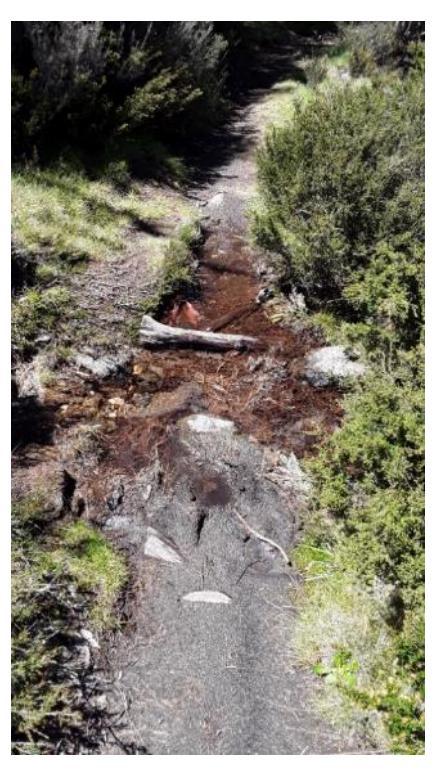
Image 15. Trampled vegetation across a drainage line on Heathy Spur Track (December 2020), (Image credit:

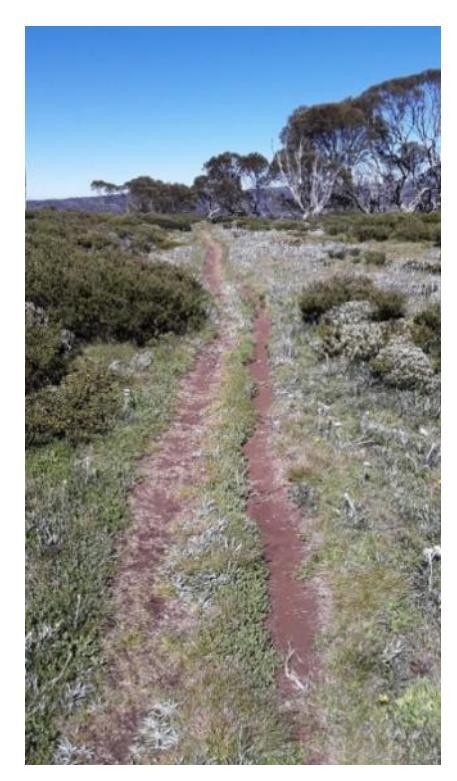
Image 16. Off-track walking by hikers widening the trail on the Bogong High Plains (December 2020), (Image credit:))

- Reduce the proposed track width to 600 mm or less.
- Limit widening of existing tracks to where this may protect natural values, for example, for mitigation of areas damaged by off-track walking.
- Use existing vehicle tracks to provide opportunities for side-by-side walking, which would minimise vegetation and fauna habitat removal that might otherwise occur along new or narrower existing sections of track.

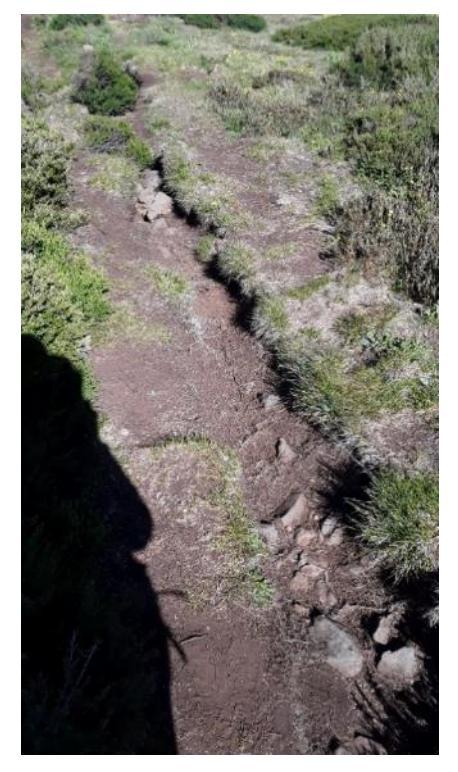
Image 17. Channelised, compacted track widened by hikers walking off-track to avoid the channelised section on the Bogong High Plains (December 2020), (Image credit:

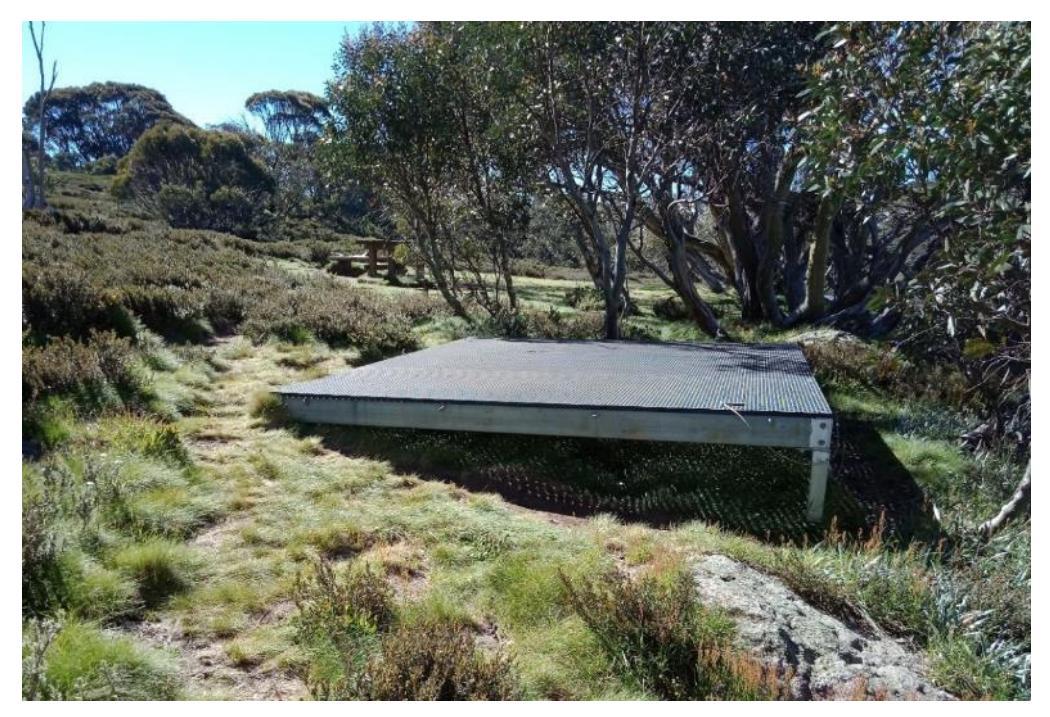
Image 19. Existing camping area with elevated camping platform at overnight node 1, Bogong High Plains, near Cope Hut (December 2020), (Image credit:

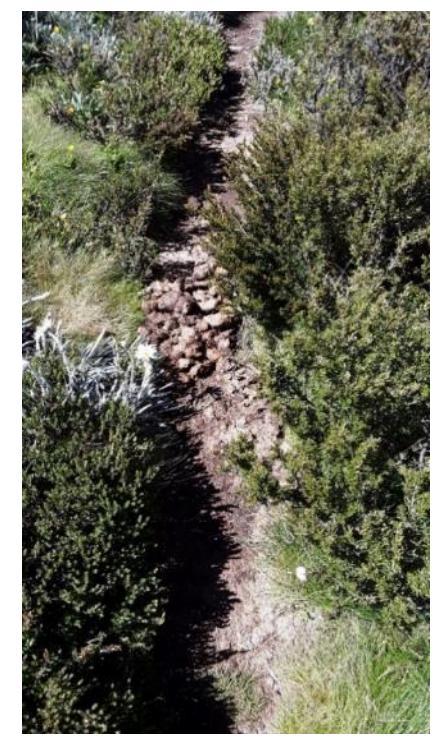
Image 88. Evidence of horses along Heathy Spur Track (December 2020), (Image credit:

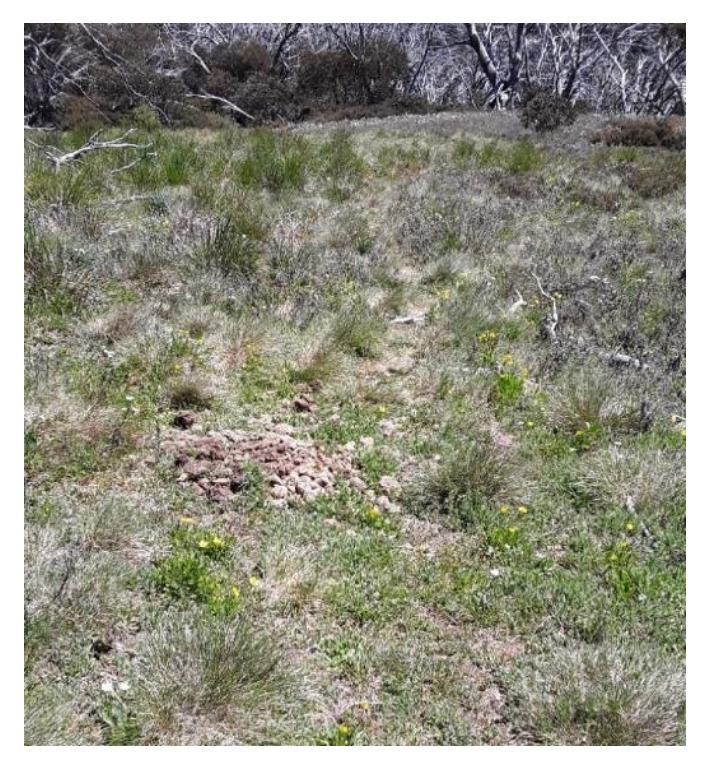
Image 89. Evidence of horses at Tawonga Huts (December 2020), (Image credit:

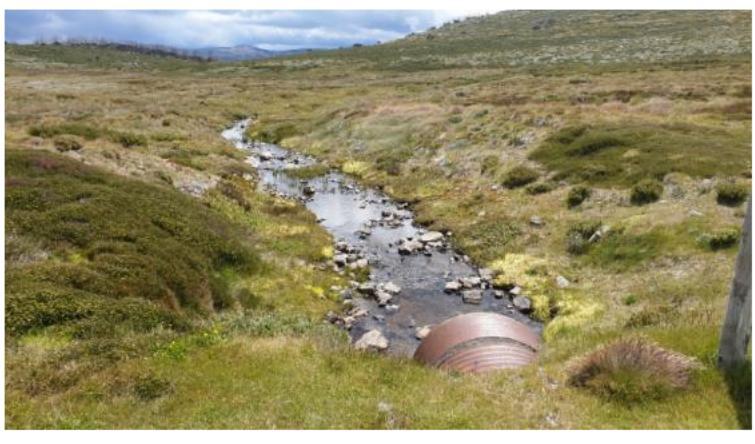
Image 95. Existing Culvert crossing on Watchbed Creek, Fainter Fire Tail (December 2020), (Image credit: Water Technology)

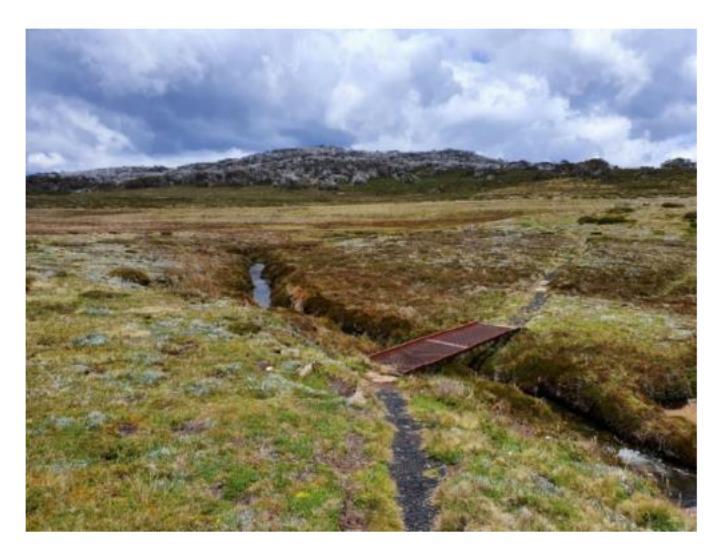
Image 97. Existing waterway crossing in the form of a small grated bridge on Cope Creek (December 2020), (Image credit: ______, Water Technology)

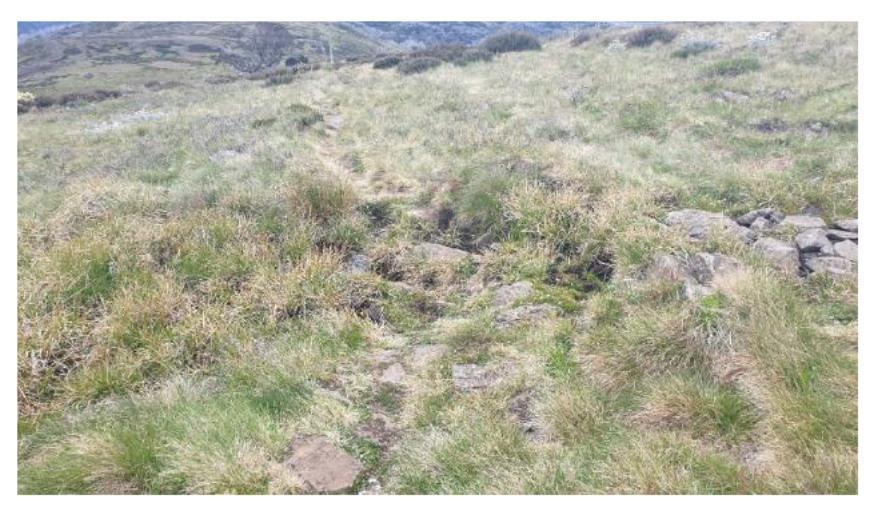
Image 98. The existing track intersects a minor surface water flow path between pole 333 and Fainter Fire Trail (December 2020). (Image credit: ______, Water Technology)

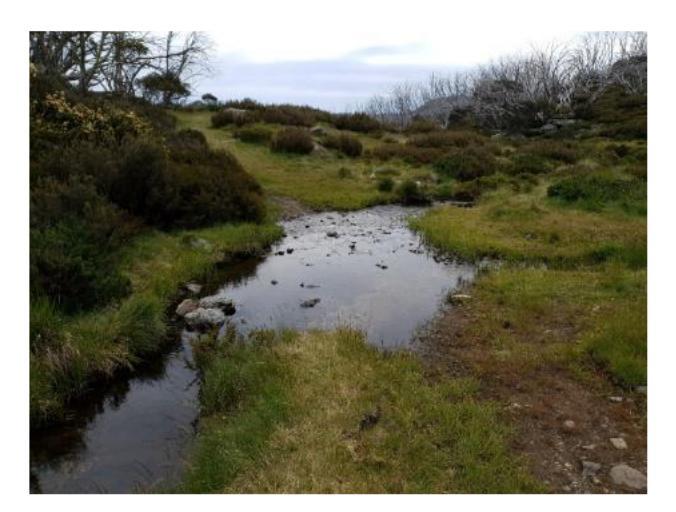
Image 100. Track to overnight node location C through Tawonga Hut Creek on the Fainter Fire Trail (December 2020), (Image credit: , Water Technology)

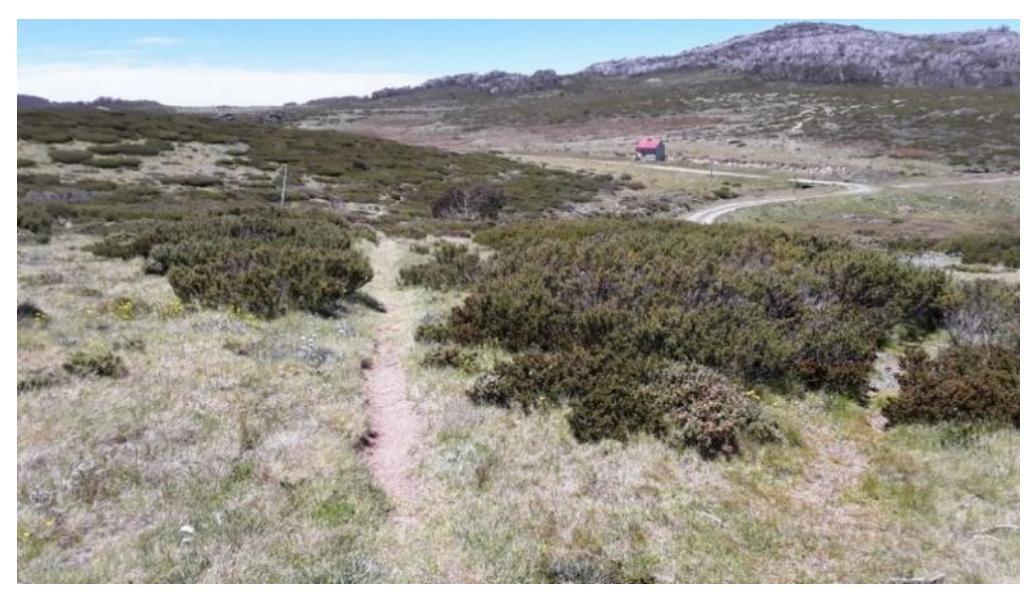
Image 103. View toward Cope Saddle Hut (SEC Hut) showing a secondary track parallel to the main track which is marked by a snow pole and located on higher ground further from the aqueduct (out of frame to the south) (December 2020), (Image credit:

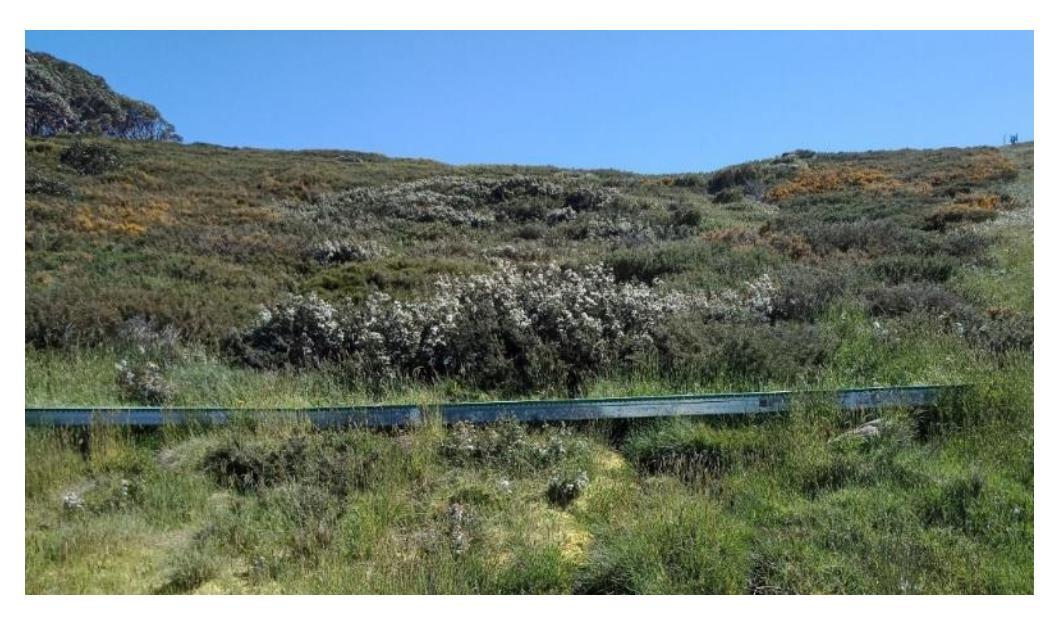
Image 104. Example of steel bridging over a drainage line intersecting Pretty Valley Road within the Falls Creek Alpine Resort boundary (December 2020), (Image credit: Any track surfacing should include remediation of sections of channelised track created by hikers and horses.

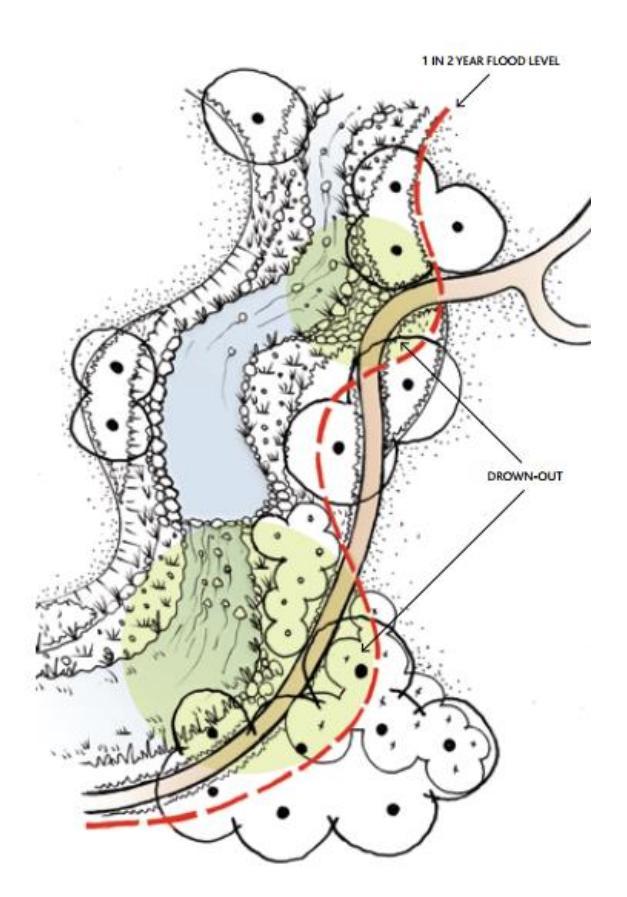
Figure 2. Schematic of a drown-out arrangement (source: Melbourne Water's Shared Pathways Guidelines)

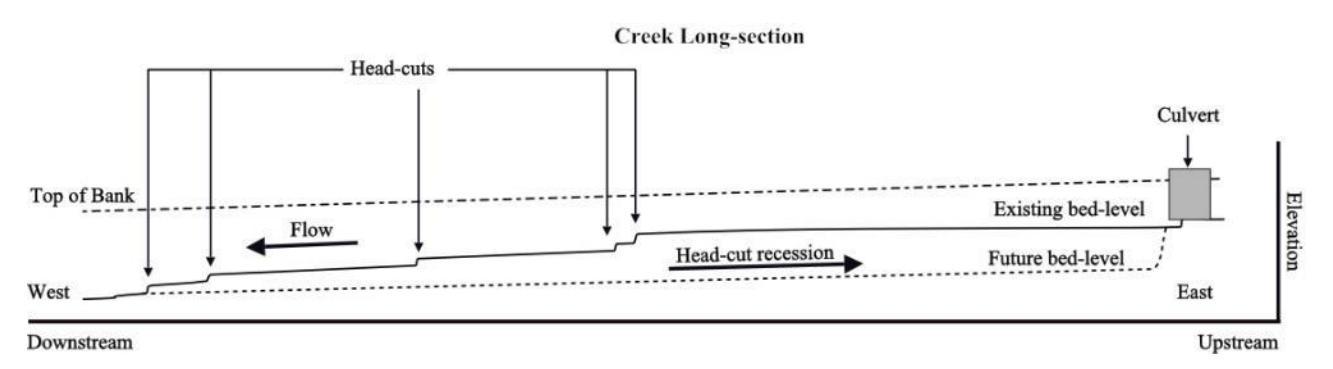
Figure 3. Conceptual diagram of knickpoint recession showing head-cuts moving upstream
